# Northville Elementary School

## Roof Report & Roof Replacement Recommendations

Draft Report, November 15, 2024  
Final Report, November 21, 2024

**Silver Petrucelli & Associates, Inc.**

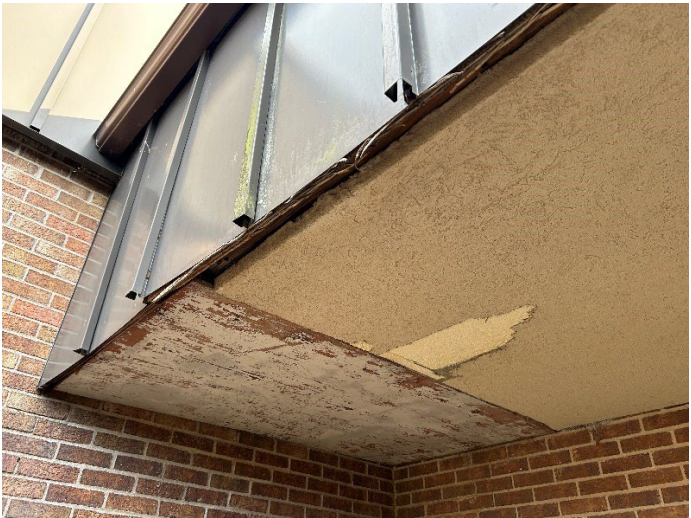
Failed metal standing seam panels & soffit

Lastly, the perimeter metal standing seam fascia is in poor condition and should be replaced as part of any future roofing operations. Various locations of these panels are rusted/rotted and there is no remedy for repairing them, therefore, replacement is the only option. Most of the vented screens at the bottom edge of these panels, is missing and or rotted/failed.

- Remove and replace all aluminum gutters & downspouts
- Remove & replace perimeter standing seam metal fascia
- Clean & inspect existing roof deck
- Install 5" rigid insulation to meet R-30 energy code requirement

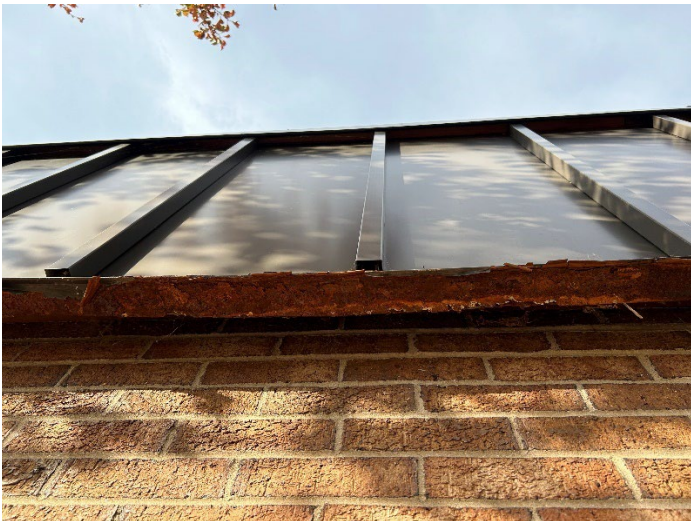
Failed metal standing seam panels

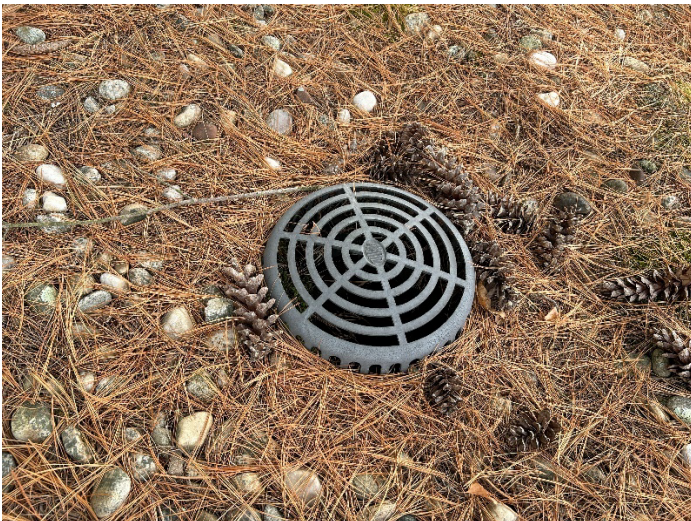
Typical roof drain – roof 1 (trees overhanging roof above)

It appears that the 40 existing roof drains had not been replaced or modified over the last 40 years ago, and therefore, all of the drains are original to the building. Based on visual observation of these drain, they all appear to be in poor condition. There is also no secondary drainage system designed into the current Northville School roof system and therefore, should any roof drain fail, it would flow over the perimeter metal gravel stop.

- Remove & replace existing 40 roof drains
- Remove & replace existing 28 HVAC exhaust fan wood curbs/flashing
- Remove & replace 4 existing pitch boxes
- Remove & replace 23 existing vent stack flashings

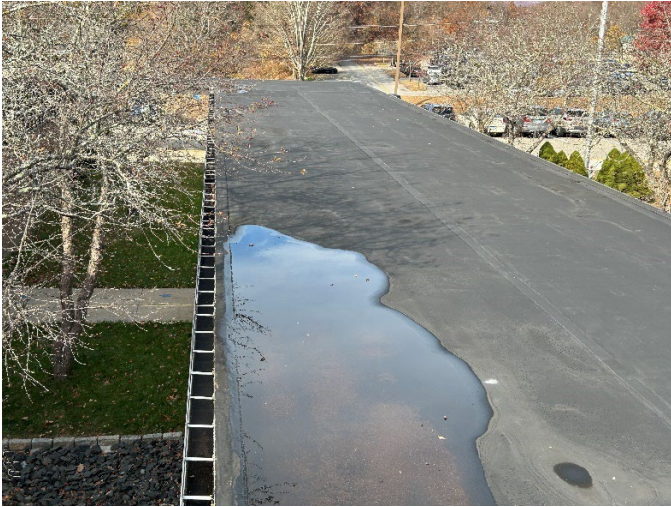
The 63,989 s.f. of Low slope EPDM membrane roofs (ballasted and non-ballasted) at Northville Elementary School (roofs 1, 2, 3, 4, 5, 6 & 7) are generally in poor condition. It is the opinion of SPA that these roofs are the original roofs to the facility making them 30-40 years old, depending on location. Equally, the perimeter metal flashing and EPDM counter flashings are also in poor condition. There was considerable ponding (or signs of ponding in the past) on many of the low sloped roofs on the day of our site visit, indicating that the roofs are not adequately sloping/draining to the existing roof drains. Numerous trees were also noted as overhanging the roof, with many leaves/debris present on the roof surfaces and in the drains. The Mechanical 28 curbs, 4 pitch boxes and 25 vent stacks are also in poor condition. The 40 roof drains, which all appear to be original, are in poor condition and do not have much serviceable life left in them. There are numerous EPDM patches throughout the roof areas indicating leaks that were present in the past. Not only has the EPDM membrane reached the end of its useful life, the EPDM seams, in numerous locations have failed, creating additional pathways for the water to infiltrate the facility.

Significant ponding on low slope roofs – roof 7 (canopy)

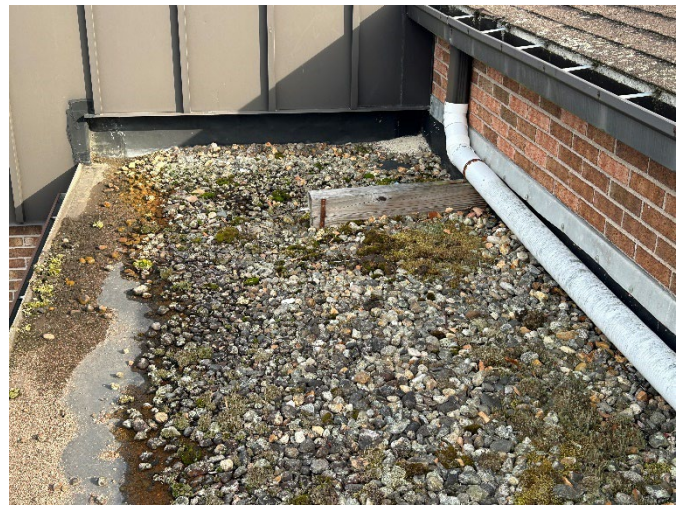
moss growth is an indication of standing water

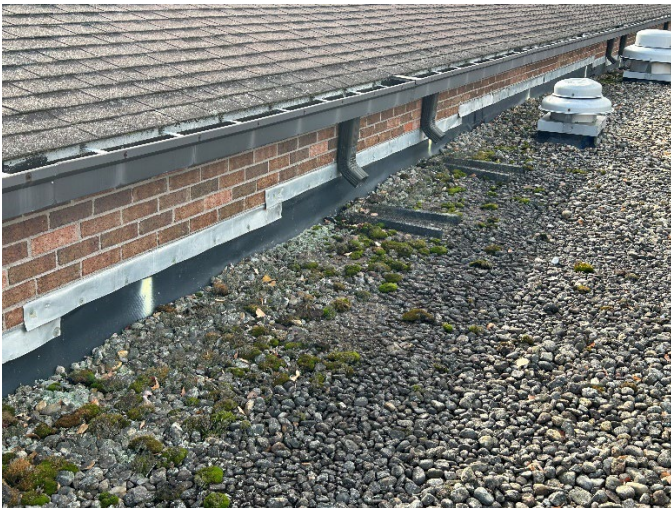
moss growth is an indication of standing water

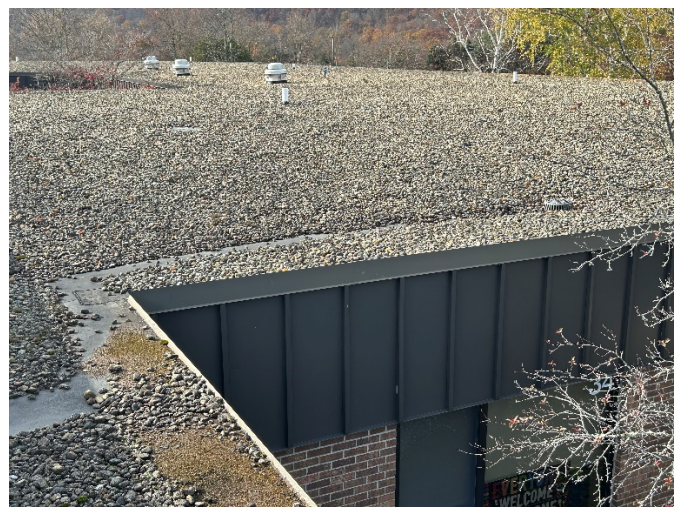
typical condition of low sloped ballasted membrane

- Remove existing Ballast on all roof except 5 & 6
- Remove existing EPDM membrane
- Remove existing rigid insulation below membrane
- Remove and replace all wood blocking & perimeter gravel stop/metal flashing

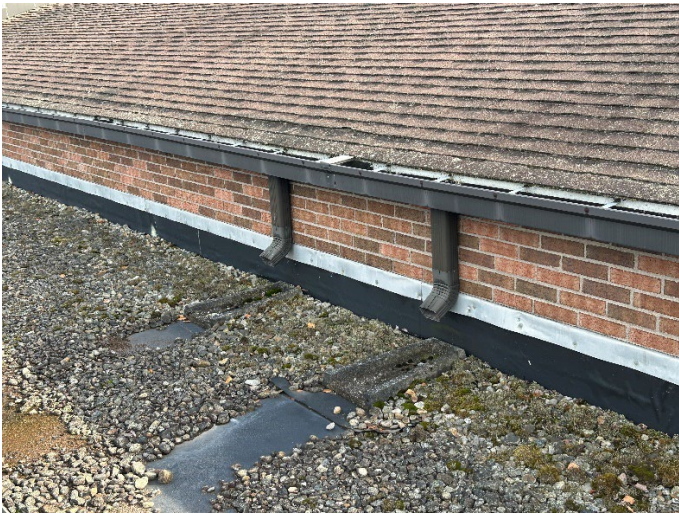
The 26,543 s.f. of sloped asphalt shingles at Northville School (roofs A&B) are generally in very poor condition. It is the opinion of SPA that these roofs are the original roofs to the facility making them 30-40 years old, depending on their location. Many of the shingles are showing signs of overheating resulting in cracking/failing & sliding. This is likely due to the fact that there is no ventilation below these shingles, which is now an IBC code requirement. Equally, the perimeter metal flashing & aluminum gutters/downspouts are in marginal condition and should be replaced along with the roof shingles. The one built in gutter on the north side of roof B should be eliminated and roofed over to avoid future water infiltration opportunities.

General condition of sloped roof & gutters/downspouts

- Remove & replace 2 existing vent stack flashings
- Remove existing asphalt shingles & building paper/ice & water shield
- Remove existing built -in gutter on North Side
- Remove and replace all aluminum gutters & downspouts
- Clean & inspect existing roof deck
- Install new vented nailable deck board
- Install new Ice & water shield over all wood decks
- Install new Asphalt shingles
- Entire system to be a minimum warranty of 30 years

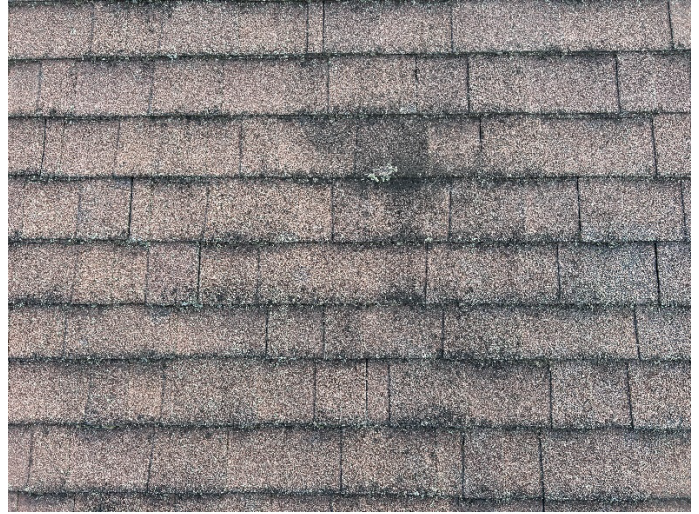
Typical condition of sloped asphalt shingle roofs

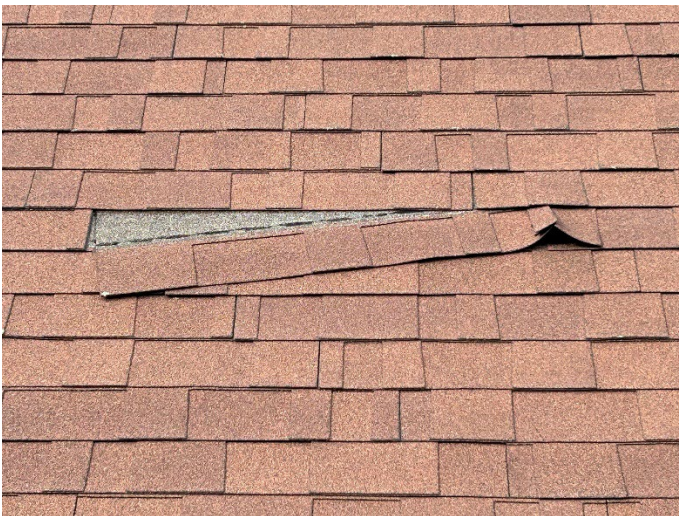
Failed Asphalt shingle at sloped roofs

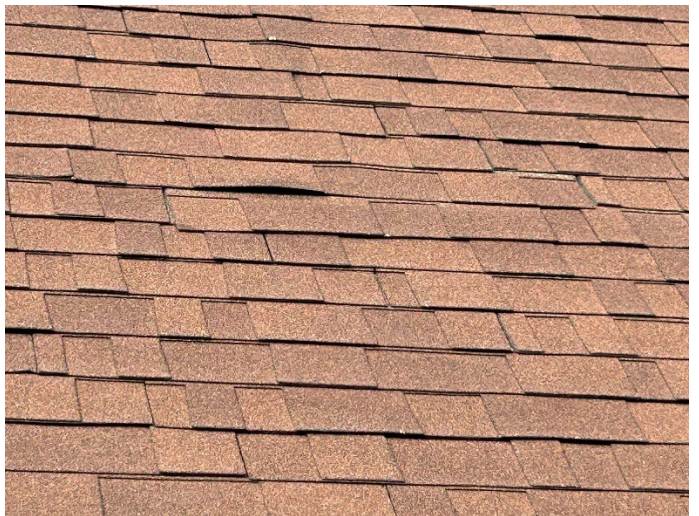
failed, curling & lifting asphalt shingles – sloped roofs
