Comstock Park Public Schools

2022 Facility Assessment

Executive Summary

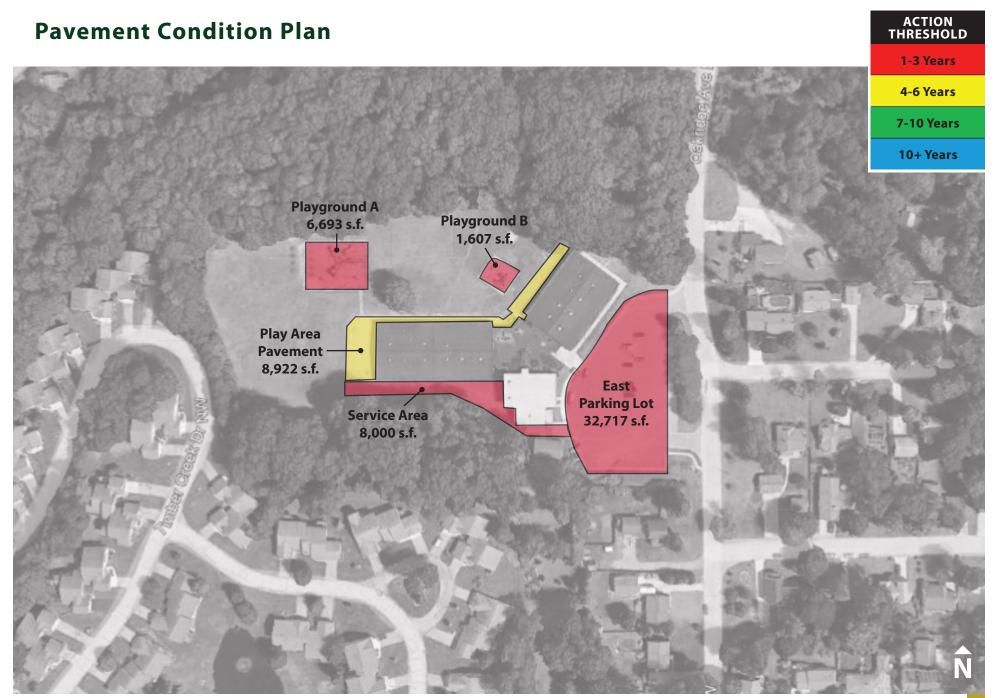
Civil and Site - Photos

1.0 Civil & Site Assessment					
Site Signage					
(Select Drop-down or Overwrite)		\$0			
Pavement					
East Parking Lot	Mill and Repave due to wear, cracking and alligatoring.	\$98,400	\$103,320		
Concrete Sidewalks	Replace across front of school duel to settling, heaving and cracking.	\$4,200	\$4,410		
Concrete Sidewalks	Replace across front of school due to settling, heaving and cracking.	\$6,600		\$8,448	
Service area	Mill and repave due to wear, cracking and alligatoring.	\$24,000	\$25,200		
Parking Striping/Paint	Restripe lot due to re-paving.	\$1,200	\$1,260		
(Select Drop-down or Overwrite)		\$0			
Landscaping					
Lawn Areas	Repair settling and erosion from roof water on hill	\$20,000	\$21,000		
Trees	Prune trees at entry for sight lines	\$1,000			
(Select Drop-down or Overwrite)	, ,	\$0

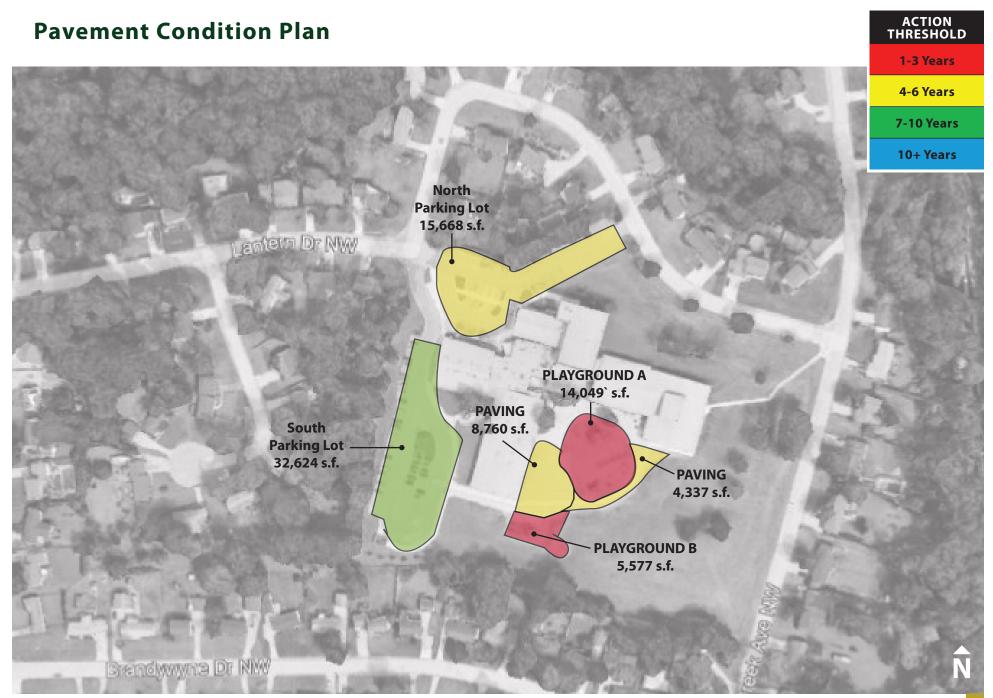
Civil and Site - Photos

1.0 Civil & Site Assessment						
Sita Siamaga						
Site Signage (Select Drop-down or Overwrite)		\$0				
Pavement						
North Parking Lot	Crack and seal repair to extend life of pavement.	\$1,000	\$1,050			
North Parking Lot	Mill and Repave due to wear and cracking.	\$47,004		\$60,165		
South Parking Lot	Crack and seal repair to extend life of pavement.	\$1,400	\$1,470			
South Parking Lot	Mill and Repave due to wear and cracking.	\$97,872			\$144,851	
(Select Drop-down or Overwrite)		\$0				
Landscaping				-		
Trees	Remove Stumps, fill holes and seed area due to tree removal.	\$15,000	\$15,750			
(Select Drop-down or Overwrite)		\$0

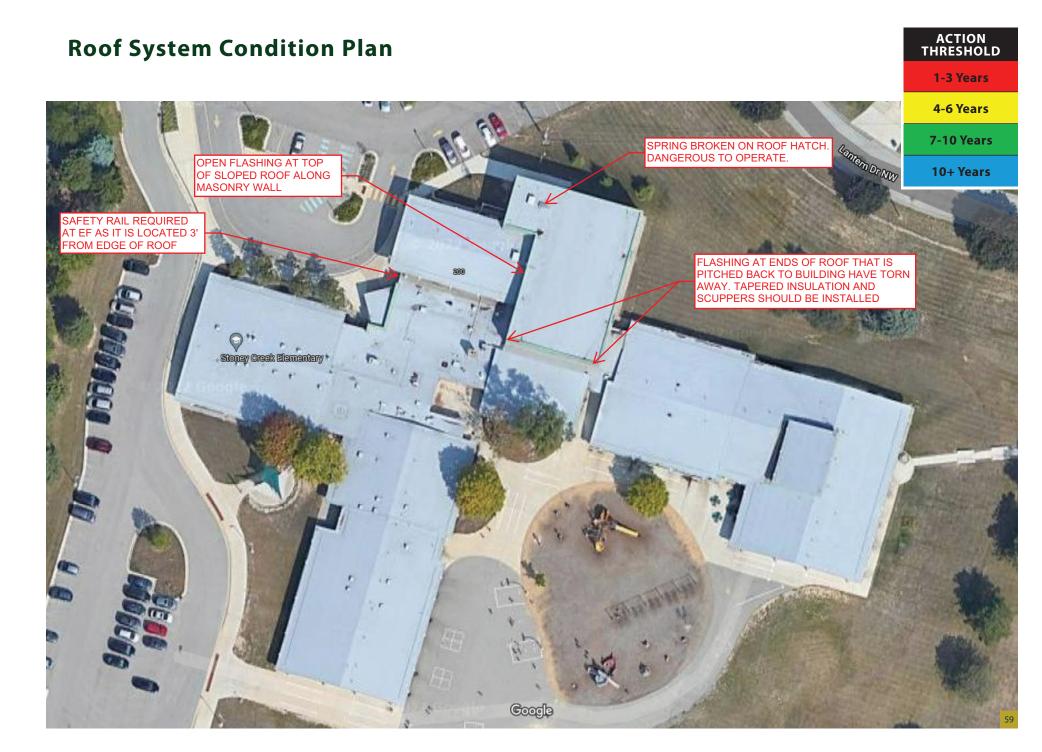
Roof System - Photos

5.0 Roof System Assessment					
Roofing Membrane					
TPO	Seams are beginning to come loose in some areas	\$3,750			
(Select Drop-down or Overwrite)		\$0			
Drainage Components					
Secondary Roof Drains	Estimated 50% of required by current code	\$0			
Tapered Insulation	Tapered insulation should be added to shed water away from gym wall as it is ruining the finishes below	\$5,980	\$6,279		
(Select Drop-down or Overwrite)		\$0			
Roof Membrane Protection					
Adhered Rubber Pads	Installed below overhead roof lines and at roof access ladders	\$0			
(Select Drop-down or Overwrite)		\$0			
Perimeter / Fascia / Soffit					
Term Bar / Counterflashing	Top of term bar is not sealed and counterflashing is loose (verification of sealant at other term bar should be completed)	\$9,000	\$9,450		
(Select Drop-down or Overwrite)		\$0			
Rooftop Penetrations					
Roof Access Hatch	Broken assist spring and is very dangerous to operate	\$6,500	\$6,825

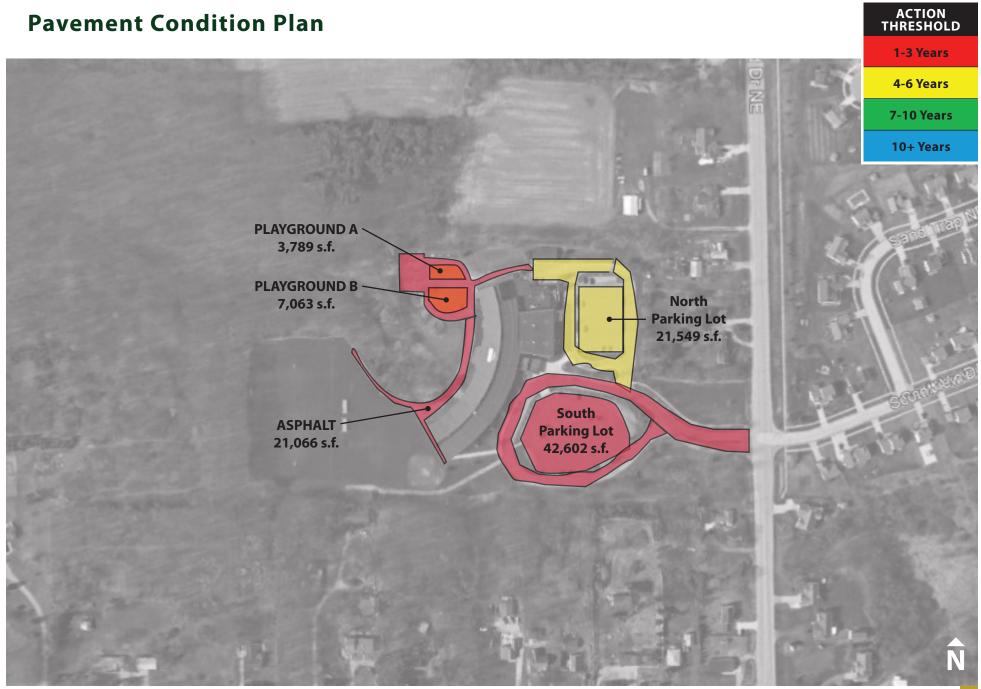
Civil and Site - Photos

1.0 Civil & Site Assessment					
Site Signage			. 1		
Traffic / Pedestrian Control	Replace Various signs on Campus due to fading and weathering.	\$2,000	\$2,100		
(Select Drop-down or Overwrite)		\$0			
Pavement					
North Parking Lot	Crack and seal repair to extend the pavement life	\$1,300	\$1,365		
North Parking Lot	Mill and Repave due to cracking and wear.	\$64,500		\$82,560	
South Parking Lot	Mill and Repave due to cracking wear and alligatoring.	\$127,800	\$134,190		
Parking Striping/Paint	Re-stripe due to re-pavement.	\$1,000	\$1,050		
Parking Striping/Paint	Re-stripe due to re-pavement.	\$1,500	\$1,575		
Concrete Sidewalks	Replace cracked Sidewalk due to heaving and cracking.	\$3,000	\$3,150		
(Select Drop-down or Overwrite)		\$0	·
