FACILITIES CONDITION ASSESSMENT

Rivendell Interstate School District

Rivendell Academy East & West Wings | Samuel Morey Elementary | Westshire Elementary

September 25, 2025

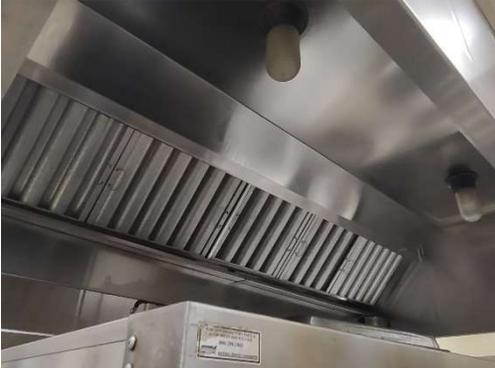
<p>Grill hood to exhaust fan - noise dampening needed. Added burners requested by staff.</p>

<p>Fill and drains to be upgraded on food service line.</p>

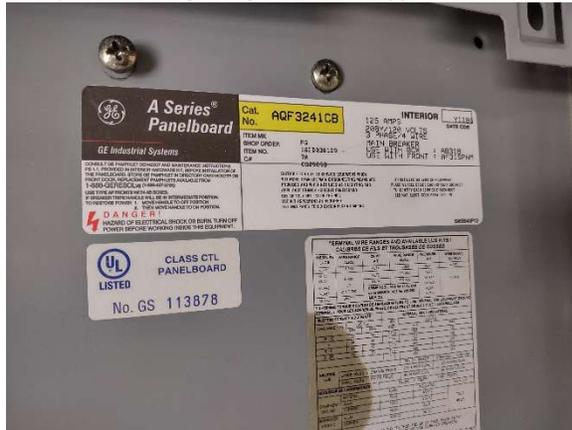
Sub panel for lighting circuits – typical

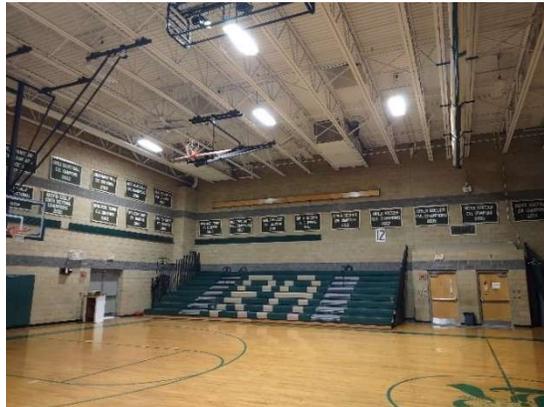
T-8 lighting in the gym.

T-8s should be replaced with LED.

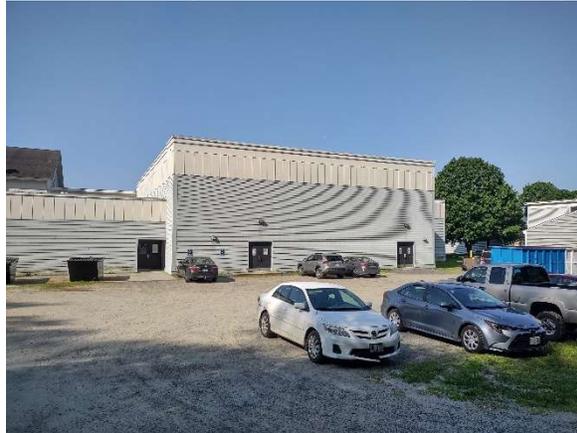
Exterior flood lights limited, showing signs of age.

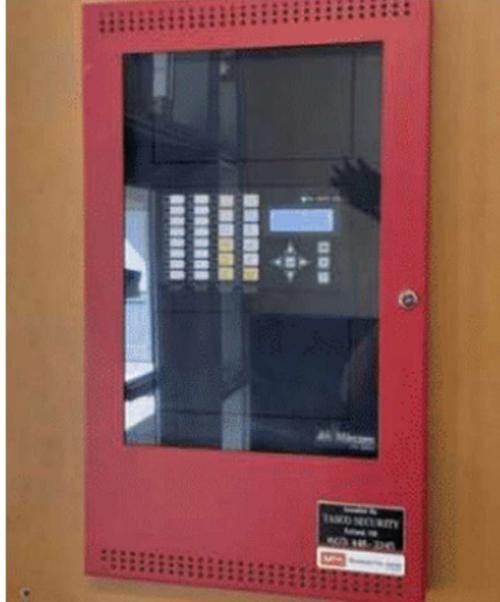
The main fire alarm panel. There were no violation notes on the front cover.

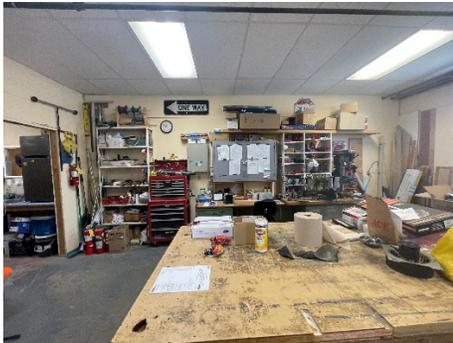
Floor	Fair condition. Concrete has crack near sink. Painted finish has worn off. Recommendation – Repair crack and recoat surface.
		Walls/ Columns	Fair condition for shop space; walls have dings, dents, scrapes.
		Ceiling	Fair condition for shop space.

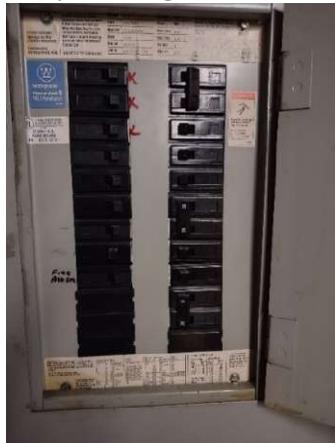
Sub panel original to the facility. Shows signs of corrosion and age.

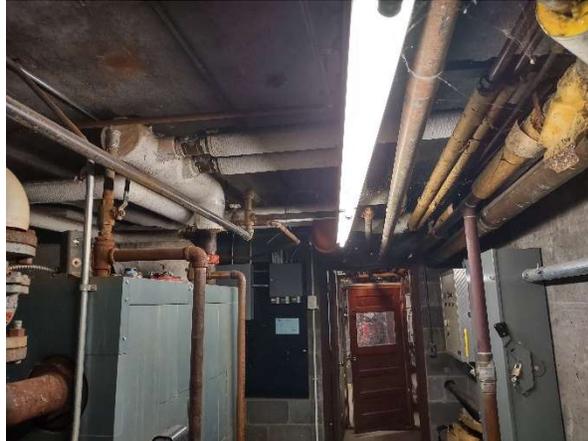
T-8 lighting in the boiler room.

T-8s should be replaced with LED.

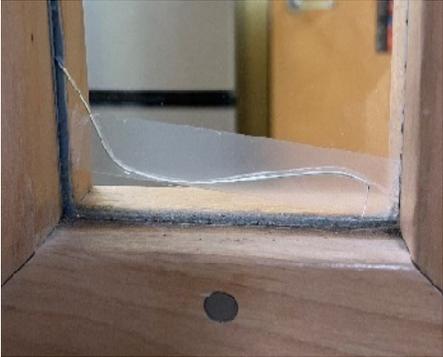
15.	Nurse 3121		
		Floor	Good condition.
		Walls/ Columns	Good condition.
		Ceiling	Good condition.
		Doors	Good condition. Glass lite cracked inside. Recommendation – Replace door with new glass light.

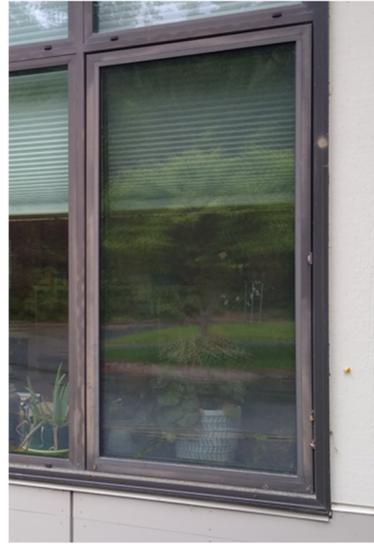
Siding	<p>Fair condition overall. Isolated areas of very poor conditions; deterioration / chipping at bottoms of vertical siding boards where they meet the water table and over some openings (see window section and door section below).</p> <p>Recommendation – Replace all chipped / damaged conditions. Refinish to match existing. Approximately 10% of façade.</p>

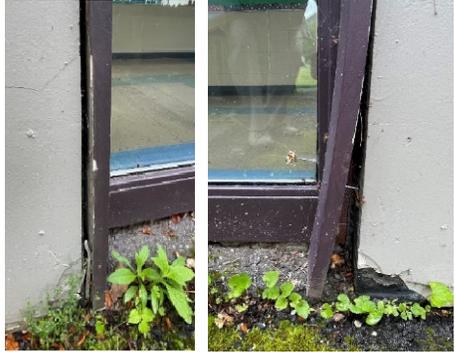
Additional areas of siding damage at windows specifically. Refer to above siding section for recommendations.

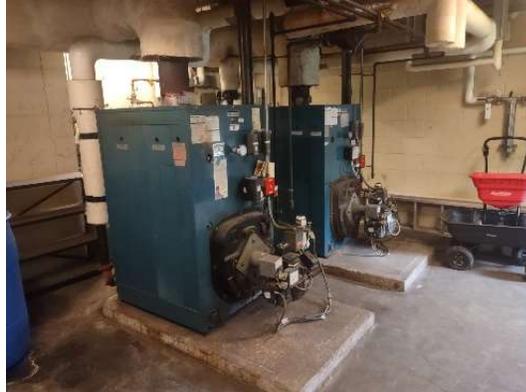
Boiler #1 and boiler #2 are in very good condition.

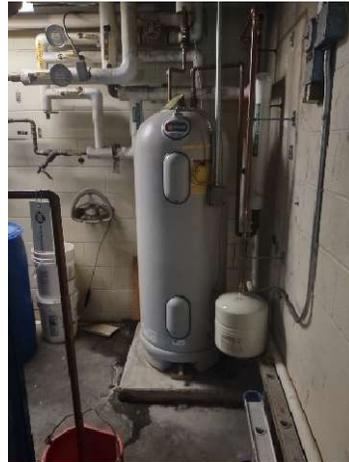
Electric hot water heater and piping – very good condition.

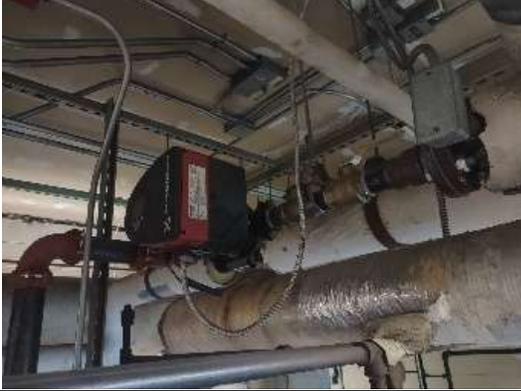
New auto control valves – Very good condition

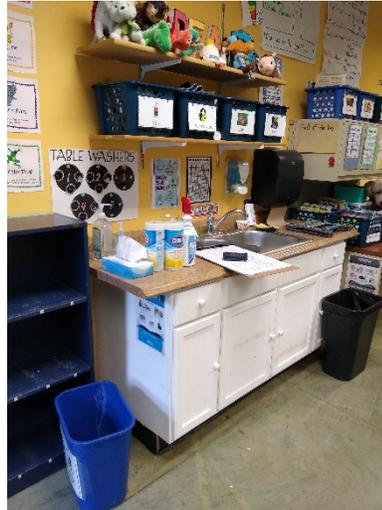
38" sink counter laminate but no clear ADA access below.
 Recommendation – Install ADA access sink cabinet with proper counter height.

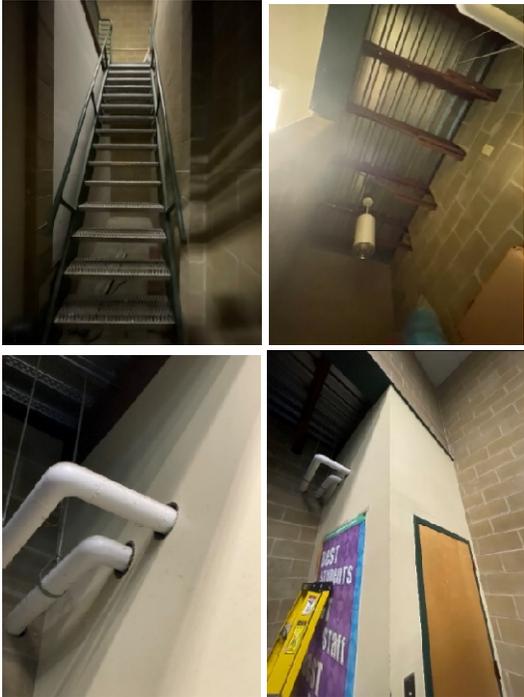
<p>Space is in good condition overall; however, door is rated but only portions of the wall are sealed to meet the required 2-hour rating.</p>

Recommendation – Verify the seal is complete around the perimeter of the mezzanine mechanical space. If not complete, then apply proper seal.
