NEW MILFORD BOARD OF EDUCATION

Facilities Subcommittee Report

RE: Structural Engineering Review of Roofing Installation

New Milford High School

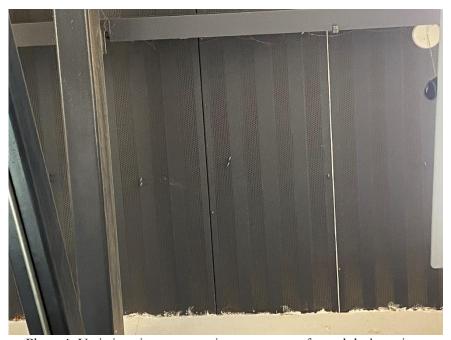
- 1. Each of the areas observed has acoustic cellular deck. In each case, most screws penetrate at the solid portion of the acoustic deck (where the top sheet metal corrugation abuts the bottom flat sheet metal panel) but there were occasions where screws were observed through the perforated cellular portion of the deck (see photo #1).

Photo 1: Variations in screw spacing, some at perforated deck sections

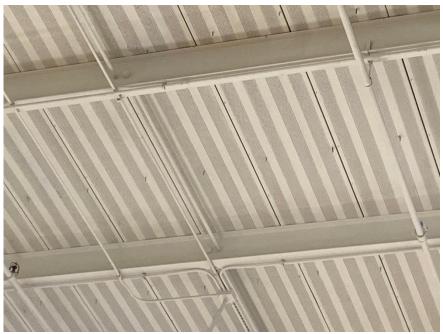
- 2. Single screws were noted at many locations in all the spaces observed (see photos #2 & 3).
- 3. In all the spaces observed, the spacing of screws varied significantly. There were areas where the spacing exceeded 5 feet (see photo #4), which was the maximum spacing indicated on the Garland shop drawings. Some, but not all, of these variations relate to dormers on the roof.

Photo 2: Line of single screws at gymnasium

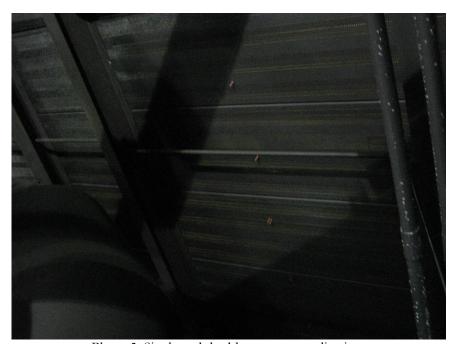
Photo 3: Single and double screws at auditorium

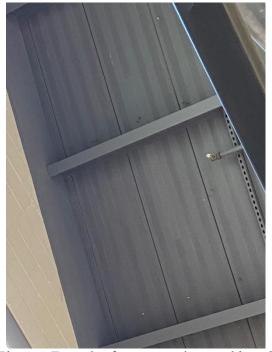
Photo 4: Excessive fastener spacing at gable end

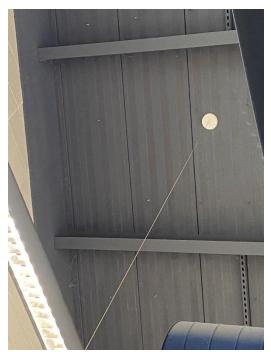
- 4. The shop drawings indicate clips at the ends of each panel at a spacing of 18". Generally, screws were noted at this spacing, but there were locations where they were not. Some 18" intervals were skipped, and other varied (see photos #5 & 6).

Photo 5: Variations in clip spacing

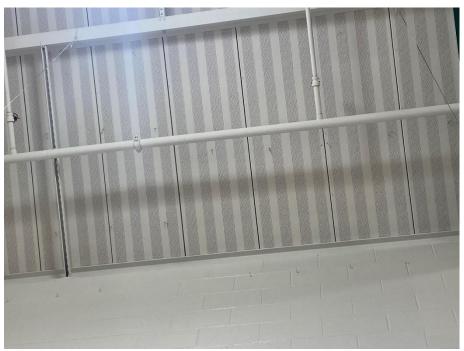
Photo 6: Variations in clip spacing and single screws

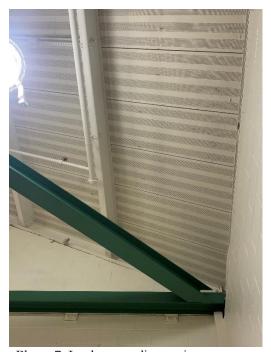
- 5. The prescribed 2'-7" clip spacing at corners was not observed (see photo #7).
- 6. At some locations, the prescribed 3'-11" spacing at perimeters was exceeded (see photo #8). Only single screws were visible at some of these locations.

Photo 7: Inadequate clip spacing at corner

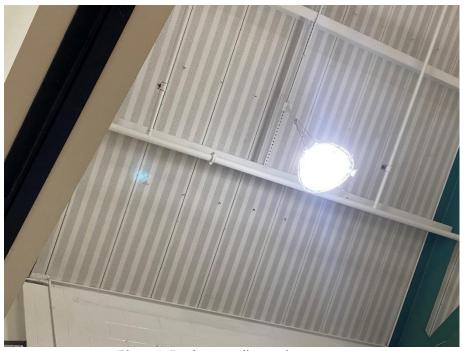
Photo 8: Inadequate clip spacing at eave
