# Midland Public Schools

## Facilities Assessment

March 16, 2026

## Executive Summary + Table of Contents

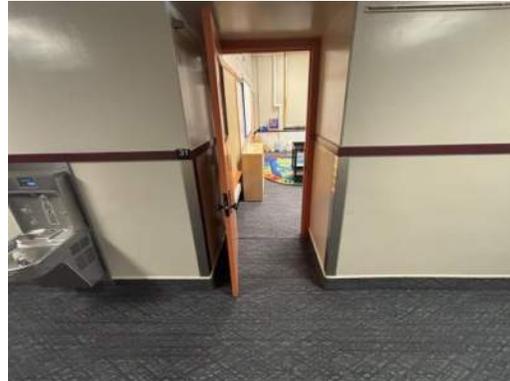
Existing Classroom Entry

Carpenter Pre-Primary Center is the oldest facility in the district and exhibits architectural systems that are largely original and identified for near-term replacement throughout the assessment. The building envelope includes aging masonry walls and are starting to no longer provide adequate thermal performance, or weather resistance. Roofing systems are documented as being at or beyond typical service life, with replacement identified in the near-term timeframe due to condition. Interior layouts limit some flexibility, and offer poor adjacencies – particular in reference to toilet rooms, art, Spanish and cafeteria space. Interior finishes—including ceilings, flooring, and wall systems—have been updated as needed to provide additional classroom spaces, however all the upgrades are cosmetic in nature. Numerous ADA deficiencies are noted across the building, including restroom accessibility, door clearances, and egress routes. Collectively, the architectural findings indicate that addressing deficiencies would require extensive, building-wide intervention rather than isolated repairs.

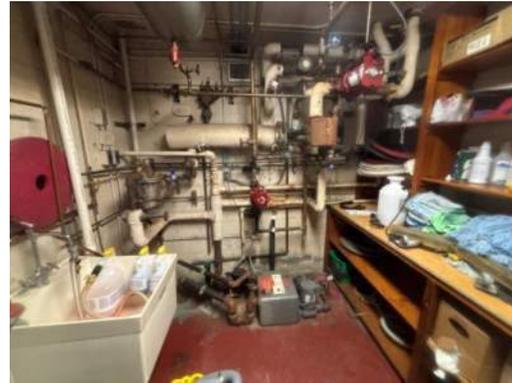
Existing Mechanical Equipment

Mechanical and plumbing systems at Carpenter are predominantly original and consistently identified in the assessment tables as requiring near-term replacement. HVAC systems are outdated, inefficient, and lack the ventilation capacity expected under current standards. Distribution systems are difficult to access, limiting maintainability and increasing the likelihood of service disruption. Plumbing infrastructure—including domestic water, sanitary waste, and storm drainage piping—is original and has experienced documented failures, leaks, and blockages. Fixtures are aged, inefficient, and do not meet current code or water-use standards. The tables indicate that mechanical and plumbing deficiencies are systemic rather than isolated, and that meaningful reinvestment would necessitate comprehensive system replacement across the building.

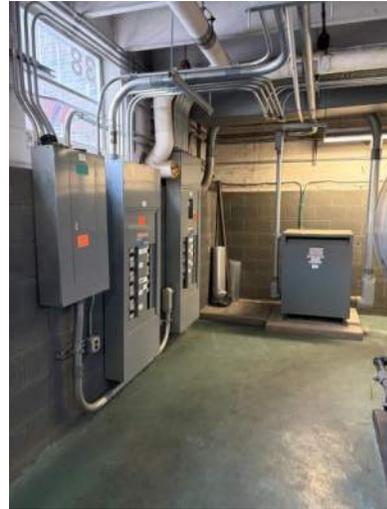
Existing Main Electrical Equipment

Electrical systems at Carpenter are identified as being at or beyond their useful life, with near-term replacement recommended throughout the assessment. Power distribution equipment and panelboards are from the early 2000s. Interior lighting systems, while having been retrofitted with LED lamps, are inefficient. Lighting controls do not meet current energy code requirements. Fire alarm and life-safety systems are aging and nearing end-of-life, with limited ability to integrate modern components. Technology and communications infrastructure is minimal and inadequate for current instructional or operational needs. The assessment clearly indicates that continued operation would require investment in the electrical, lighting, and technology systems.

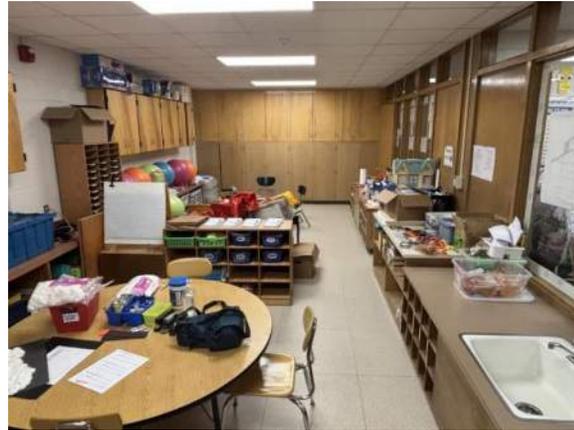
Existing Work/Storage Room

Overall, the architectural systems at Adams Elementary are in generally good condition, with many areas benefitting from recent renovations and additions completed around 2019. The building envelope, including masonry, windows, doors, and EIFS, is largely performing well, with only localized issues such as minor EIFS delamination and an isolated rusted lintel that should be addressed in conjunction with future roofing work. Roof systems are a mix of original and newer installations; older EPDM roofs are at or beyond their intended service life and should be planned for replacement, including code-required secondary drainage improvements. ADA accessibility is generally adequate, particularly in newer areas, though several deficiencies remain in older portions of the building, including restroom accessibility, door clearances, drinking fountain projections, and the need for additional automatic door operators, which should be addressed during future renovations. Interior finishes throughout offices, classrooms, corridors, cafeteria, media center, and gymnasium are largely in good to very good condition due to recent refreshes, with selective needs such as aging casework and delaminating restroom flooring. Life safety systems are functional and generally compliant, though future upgrades will be required to modernize the fire alarm system to voice communication, improve visibility at the main entrance, and evaluate emergency power strategies. Food service spaces, equipment, plumbing fixtures, and safety systems are newer and observed to be in good condition, with no immediate deficiencies noted.

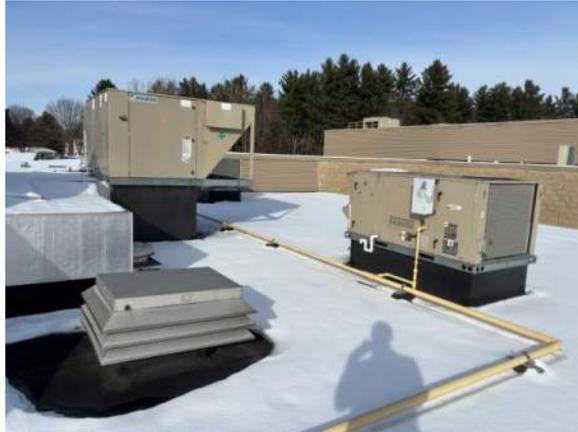
Existing Rooftop Equipment

Mechanical and plumbing systems reflect a combination of significant recent investment and aging original infrastructure. Boilers, rooftop units, air handling units, unit ventilators, controls, and most cooling equipment was replaced or upgraded in 2019 and remains in good condition with substantial remaining useful life. A small quantity of exhaust fans and terminal heat units (convectors, finned tube, etc.) still need replacement. General ventilation improvements are recommended including ventilation and conditioning of the corridors. Hydronic piping routed in tunnels is approaching the end of its useful life and needing replacement. Long-term planning consideration should be given to maximizing boiler efficiencies by lowering building equipment water temperatures. Plumbing systems present more significant long-term concerns: while fixtures and equipment in renovated areas are in good condition, much of the domestic water, sanitary, and storm piping in the original building dates to the 1960s, includes galvanized materials. These systems are at or beyond typical service life and should be planned for phased or comprehensive replacement, ideally coordinated with roof or major renovation projects to address storm drainage and overflow requirements.

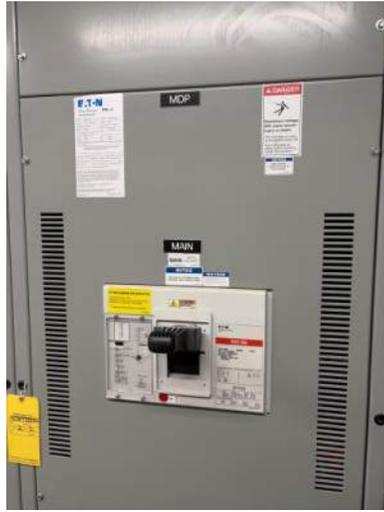
Existing Electrical Gear

Electrical systems at Adams Elementary are a mix of modernized components and aging legacy infrastructure. Site and exterior lighting were upgraded in 2017 and are in good condition, and much of the building has been retrofitted with LED interior lighting, though lighting controls do not fully meet current energy code requirements outside of recent bond work. Power distribution includes newer switchboards and panels alongside a substantial number of original 1960s panelboards that lack modern features such as surge protection and metering, indicating a need for long-term replacement planning. Classroom power distribution is limited, with insufficient receptacle coverage for modern instructional needs. No standby generator is currently provided, and future consideration should be given to adding generator capacity for life safety, emergency systems, and telecommunications. Communications and technology infrastructure is generally functional, with structured cabling and network equipment in place, though some systems—such as clocks, AV systems, and wireless access points approaching end of life—will require future upgrades to maintain reliability and instructional support.

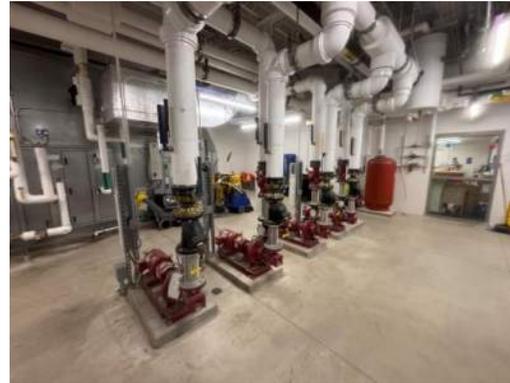
Existing HHW Plant Pumps

Mechanical and plumbing systems at Central Park Elementary are in good condition and reflect modern design standards consistent with the building's age. HVAC equipment, controls, and distribution systems are operating as intended, with sufficient remaining useful life and no systemic deficiencies identified. Ventilation is appropriately provided to occupied spaces and meets current code requirements. Plumbing systems, including domestic water, sanitary, and storm drainage piping remain well within expected service life, with no material performance concerns observed. Fixtures and equipment are in good condition, and only routine maintenance and long-term lifecycle planning are anticipated at this time..

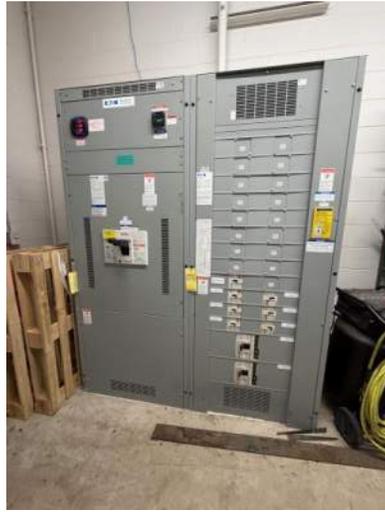
Existing Main Electrical Gear

Electrical systems at Central Park Elementary are modern and in good overall condition. Interior and exterior lighting systems are consistent with contemporary standards, and lighting controls generally meet current energy code requirements. Power distribution equipment is appropriately sized and configured for the facility's needs, with no widespread deficiencies noted. Classroom power and technology infrastructure adequately support instructional requirements but should be evaluated with any district-wide planning efforts for consistency. Emergency and life safety systems are functional and code compliant, and while standby generation may be evaluated as part of districtwide resilience planning, no immediate electrical system upgrades are required.

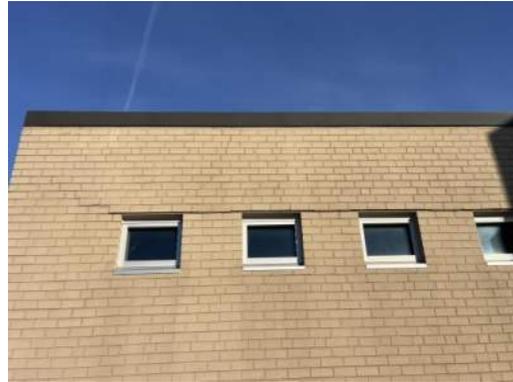
Chestnut Hill Elementary School consists of a mix of original construction and newer additions, resulting in varied conditions across architectural systems. The building envelope is generally in good condition, with exterior brick and windows performing well; however, localized masonry issues were observed, including missing control joint sealants, horizontal movement at steel lintels, and areas where perimeter landscaping is built up above finish floor elevation and should be corrected. The EPDM roof system, installed in 2009, is functioning as intended but is approaching an age where future replacement planning is appropriate. Interior spaces reflect a combination of recently renovated areas and older finishes, with corridors, ceilings, signage, and some classroom and restroom layouts benefitting from future modernization and ADA-related improvements. Food service spaces were completed as part of a recent addition and are in good condition with no near-term needs identified.

Existing Brick Cracking

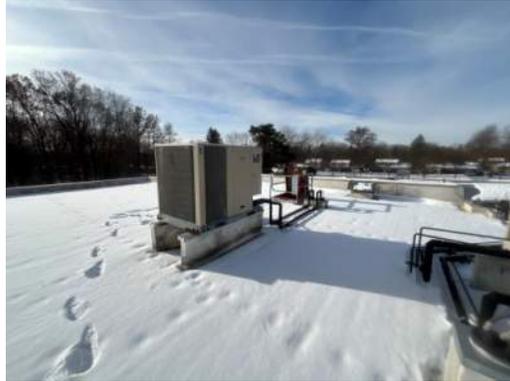
Existing Outdoor Condensing Unit

Mechanical systems at Chestnut Hill have seen targeted reinvestment in recent years, most notably the replacement of boilers and boiler plant accessories in 2021–2022 and the installation of new air handling units and condensing equipment serving newer additions. These systems are in good condition and operating as intended. Conversely, portions of the original hydronic and plumbing infrastructure remain in place from the 1950s and 1960s, particularly piping located in tunnels, which has reached the end of its expected service life. While currently functional, plan for phased piping replacement, insulation upgrades, and replacement of remaining original building equipment & ductwork.

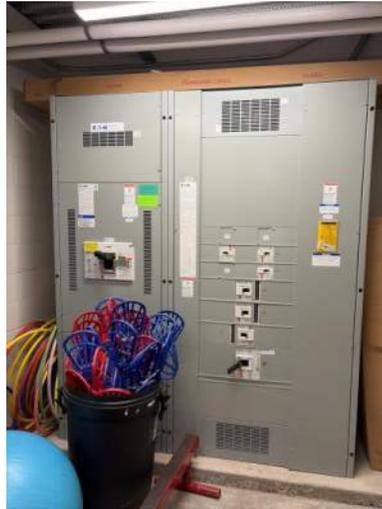
Existing Electrical Gear

Electrical systems at Chestnut Hill Elementary are a mix of modernized components and aging legacy infrastructure. Site and exterior lighting were upgraded recently and are in good condition, and much of the building has been retrofitted with LED interior lighting, though lighting controls do not fully meet current energy code requirements outside of recent bond work. Power distribution includes newer switchboards and panels alongside a substantial number of original panelboards that lack modern features such as surge protection and metering and are beyond their useful life. All of this points to the need for long-term replacement planning. Classroom power distribution is limited, with insufficient receptacle coverage for modern instructional needs. No standby generator is currently provided, and future consideration should be given to adding generator capacity for life safety, emergency systems, and telecommunications. Communications and technology infrastructure is generally functional, with structured cabling and network equipment in place, though some systems—such as clocks, AV systems, and wireless access points approaching end of life—will require future upgrades to maintain reliability and instructional support.

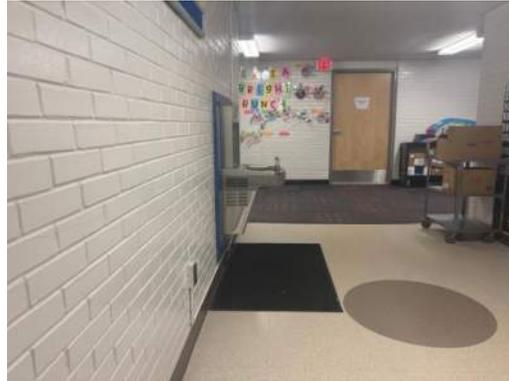
Plymouth Elementary School includes significant areas that were renovated or added in 2017, alongside original building components dating back to the mid-20th century. The building envelope is generally stable, with exterior walls, windows, and doors performing adequately. Minor maintenance items were identified, including repairs to masonry expansion joints, localized tuckpointing, and repainting of EIFS surfaces. Interior finishes show a clearer distinction between newer and older areas. Recently renovated offices, cafeteria, gymnasium, and media center are in good condition, whereas corridors, classrooms, and restrooms in the original portions of the building exhibit aging finishes, low ceiling heights, and layout inefficiencies. Several interior areas would benefit from future renovations to address ADA accessibility, improve wayfinding, and refresh dated finishes, particularly in student restrooms and classrooms.

Existing Drinking Fountain/ADA noted item

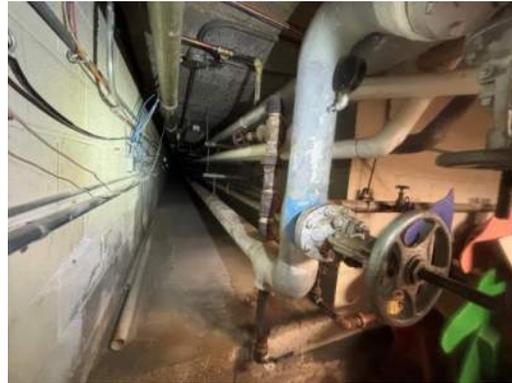
Existing Steam Tunnel/Equipment

Mechanical systems at Plymouth are a blend of newer equipment installed during recent bond work and original infrastructure that has exceeded or is approaching its expected service life. HVAC equipment serving newer additions and classrooms is in good condition, while portions of the distribution piping remain original and some minor equipment is in need of replacement. Steam heating systems limit building efficiency and boilers are beginning to approach end of life. Plumbing systems, including sanitary and storm piping, are largely original and are at end of useful life; piping and water heaters are both in need of replacement. Long-term replacement planning should focus on these infrastructure improvements and transitioning the building from steam to hot water heating.

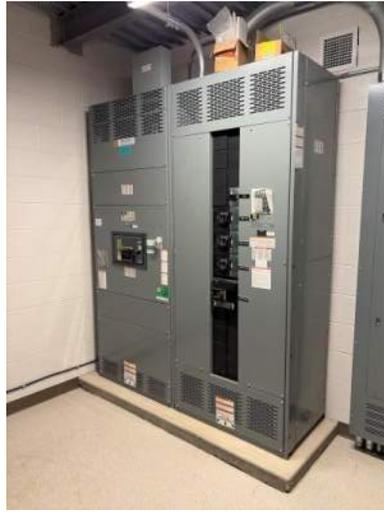
Existing Electrical Gear

Electrical systems at Plymouth Elementary are a mix of modernized components and aging legacy infrastructure. Site and exterior lighting were upgraded recently and are in good condition, and much of the building has been retrofitted with LED interior lighting, though lighting controls do not fully meet current energy code requirements outside of recent bond work. Power distribution includes newer switchboards and panels alongside a substantial number of original panelboards that lack modern features such as surge protection and metering and are beyond their useful life. All of this points to the need for long-term replacement planning. Classroom power distribution is limited, with insufficient receptacle coverage for modern instructional needs. No standby generator is currently provided, and future consideration should be given to adding generator capacity for life safety, emergency systems, and telecommunications. Communications and technology infrastructure is generally functional, with structured cabling and network equipment in place, though some systems—such as clocks, AV systems, and wireless access points approaching end of life—will require future upgrades to maintain reliability and instructional support.

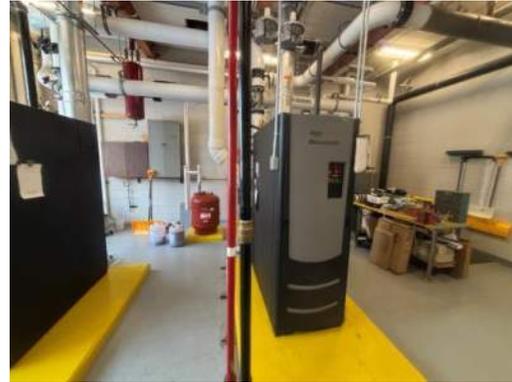
Existing Boilers

Mechanical and plumbing systems at Siebert include a combination of newer systems serving recent additions and original piping systems serving older portions of the building. HVAC equipment associated with newer construction is in good condition, including boilers, air handling equipment, and unit ventilators, while original hydronic, domestic, storm and sanitary piping systems are original to building construction and approaching the end of their typical service life. Fixtures throughout the building have been selectively upgraded and are generally in fair to good condition. Primary recommendations focus on replacement of aging piping systems and selective equipment replacements for terminal heating equipment and exhaust fans.

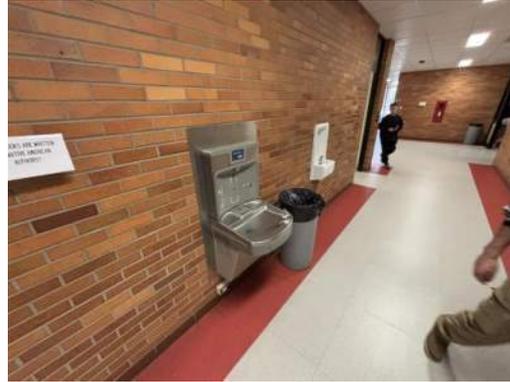
Jefferson Middle School is a large, facility with architectural systems that reflect its age and incremental renovations rather than comprehensive modernization. Exterior envelope components, including masonry walls, windows, and exterior doors, are generally serviceable but show signs of age-related deterioration and are approaching recommended replacement timelines. Roofing systems across the building vary by area, with several sections identified in the assessment tables for near- to mid-term replacement due to age and condition. Interior finishes throughout classrooms, corridors, locker rooms, and support spaces are significantly dated, with worn flooring, ceilings, and wall finishes noted across much of the building. Spatial layouts in older portions of the school do not align with current instructional models, limiting flexibility and adaptability. Accessibility deficiencies were identified in restrooms, entries, and vertical circulation, and life-safety upgrades are constrained by the building's original configuration. Collectively, the architectural findings indicate a facility that remains usable but requires substantial reinvestment to address aging systems and functional limitations.

Existing Drinking Fountain  
Extending into Corridor

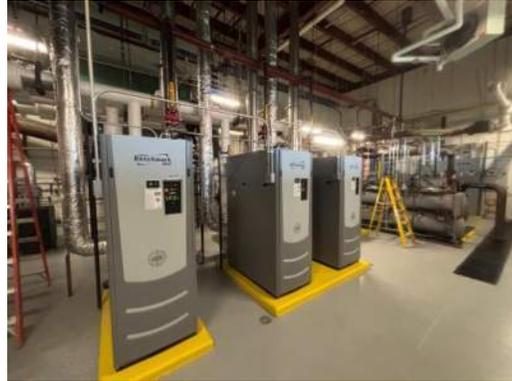
Existing Boiler Plant

Mechanical and plumbing systems at Jefferson Middle School represent a significant portion of the facility's overall need. HVAC equipment includes a mix of aging air handling units, terminal units, and distribution systems that are approaching or exceeding typical service life. Upgrades have been made to the boiler system, but the vast majority of equipment, piping, and ductwork is still in need of replacement. While updating hydronic piping, a new four-pipe system is recommended. Plumbing systems include extensive original domestic, storm, and sanitary piping that is at end of life with concerns of failure. Plumbing equipment has had selective replacement, with the remaining hot water heaters and storage tank equipment recommended for upgrades. The comprehensive replacement of mechanical and plumbing systems will represent a large investment for future reliability and operation of this building.

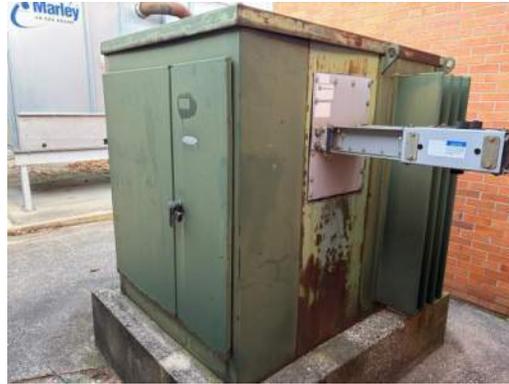
Existing Transformer

Electrical systems at Jefferson Middle School are functional but increasingly constrained by age and capacity. Power distribution equipment and panelboards span multiple vintages, with several identified for replacement due to age and limited capacity for modern instructional and technology loads. Interior lighting systems are predominantly older fixtures with retrofit LED lamps with limited or no automatic lighting controls, falling short of current energy code requirements. Emergency lighting and life-safety systems remain operational but are approaching replacement age. Technology infrastructure, including data, audiovisual, and instructional power, is insufficient in many classrooms but specialty spaces AV systems require replacement. The assessment identifies electrical upgrades as a necessary component of future renovations to improve safety, energy performance, and instructional flexibility.

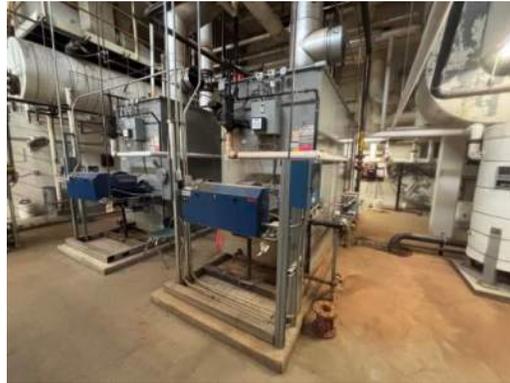
Existing Steam Boiler Plant

Mechanical and plumbing systems at Northeast Middle School are predominantly original and in need of immediate replacement. Recent equipment replacement of steam boilers and selective rooftop units have been a temporary fix but the majority of systems remain in poor condition. Inefficiency and ventilation are concerns, along with piping and ductwork that is years past its useful life. Plumbing systems—including domestic water, sanitary, and storm piping—are original with concerns for failures, leaks, and blockages, especially in underground and tunnel piping. Pool equipment is also in poor condition and identified for immediate replacement. Restoring mechanical and plumbing systems to acceptable performance will require near total replacement throughout the building.

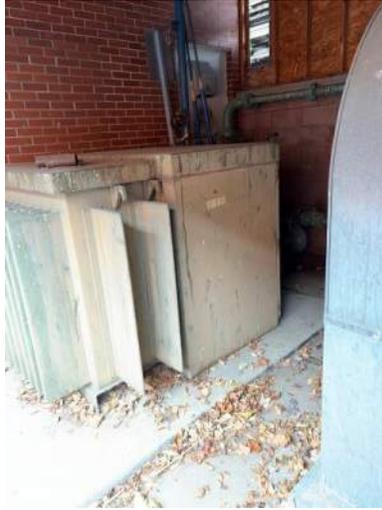
Existing Transformer

Electrical infrastructure at Northeast Middle School is outdated, undersized, and identified for comprehensive replacement. Power distribution equipment, panelboards, and branch wiring are almost all beyond useful life expectancy. Interior lighting has been retrofitted with LED lamps, but remains less efficient than modern fixtures. Lighting controls do not meet current energy codes. Fire alarm and life-safety systems are aging and nearing end-of-life, with limited ability to integrate modern components. Technology, communications, and instructional power systems are severely constrained and not capable of supporting current educational needs. The extent of electrical deficiencies reinforces the assessment's conclusion—and the district's internal determination—that continued investment is not practical, supporting decommissioning of the facility.

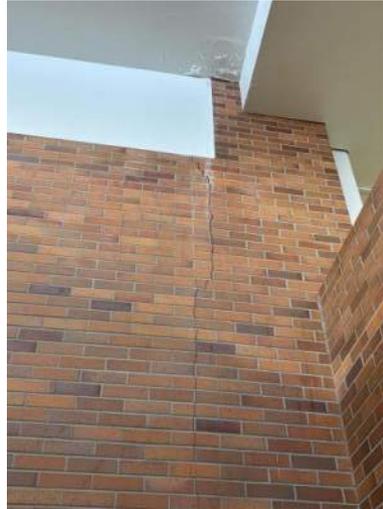
Existing Crack In Stair Up to Loft

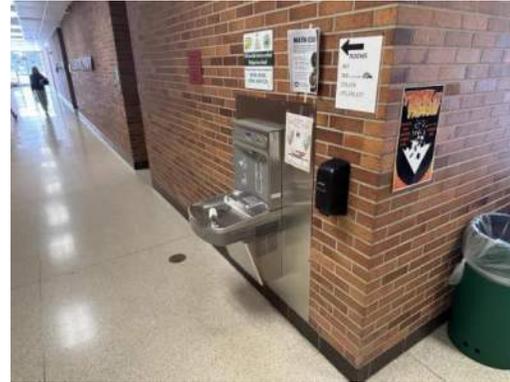
Existing Drinking Fountain/ADA Wing Wall Need

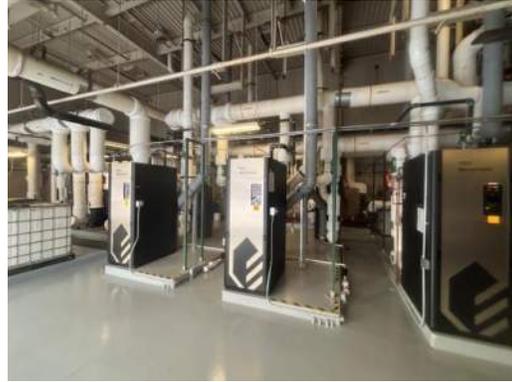
Existing Boiler Plant

Mechanical and plumbing systems at Dow High School are a mixture of recently updated systems and original piping and equipment. Newer boilers and air handling units were installed while chiller plant equipment, several air handling units, and a variety of terminal fans, unit ventilators, and perimeter heating equipment is at or beyond its useful life. Mechanical infrastructure needs such as piping and ductwork replacement are considerable. Several specialty space types such as the automotive shop or life skills classroom need to be updated for current standards. Plumbing systems include extensive original domestic, sanitary, and storm piping that is approaching or exceeding typical service life, and replacement of plumbing equipment is on the near horizon. Pool equipment is also in need of updating due to age and condition. Overall, while significantly improved in the last decade, there are still considerable needs to be addressed at Dow High School to maintain system efficiency and reliability.

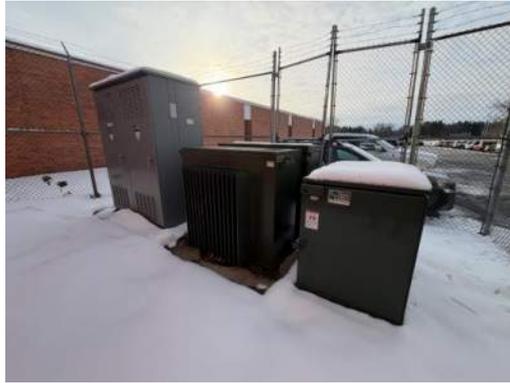
Existing Transformer

Electrical systems at Dow High School are functional but increasingly strained by age, capacity, and evolving instructional demands. Power distribution equipment includes older switchgear, unit substations, and panelboards identified for replacement within the planning horizon. Interior lighting systems vary by area, with many older fixtures retrofitted with LED lamps and lacking modern controls and failing to meet current energy standards. Emergency and life-safety systems remain operational but are approaching replacement age. Technology infrastructure, including classroom power, data, and audiovisual systems, is inconsistent and insufficient in older portions of the building. Electrical upgrades are identified as a critical component of future modernization efforts.

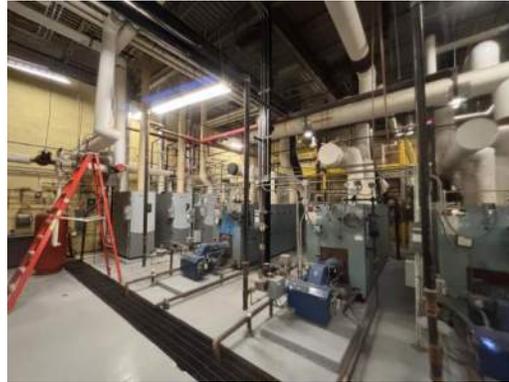
Existing Boiler Plant

Mechanical and plumbing systems at Midland High School are varied in age and condition, with significant replacement or upgrades to be considered. The separate steam and hot water plants are both approaching end of life, and consideration should be given to consolidation into one heating hot water system with improved efficiencies and maintenance. Air handling equipment including unit ventilators and air handling units is approaching or past its useful life, creating an opportunity to start converting the building to modern hot water heating technologies. Some improvements have been made through replacement of select air handling units and rooftop equipment. Infrastructure needs center on replacement of aging piping and ductwork systems still in use in the building. Plumbing infrastructure needs are similar, with domestic, sanitary, and storm system piping at or past its useful life, while plumbing equipment is in generally acceptable condition. Similar to the remaining high schools and middle schools in the district, a considerable amount of plumbing and mechanical scope should be accounted for to create reliable and efficient modern systems.

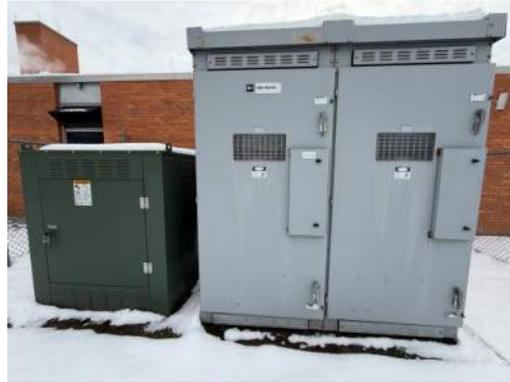
Existing Transformers

Electrical systems at Midland High School are generally functional but aging across much of the building. Power distribution equipment includes older panelboards and feeders identified for replacement based on age and capacity limitations. Interior lighting systems are a mix of newer and older fixtures retrofitted with LED lamps, with many areas lacking modern lighting controls and falling short of current energy standards. Emergency lighting and life-safety systems are operational but nearing end-of-life. Technology infrastructure needs improvement, with much of the equipment approaching end of useful life and needing updating. Large spaces are in need of AV system updates. Electrical upgrades are identified as necessary to support safety, efficiency, and instructional requirements.

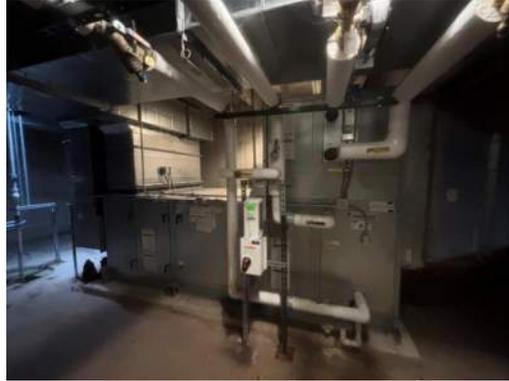
Existing Indoor AHU

Central Park Auditorium has benefited from recent upgrades to the Central Park campus; most major equipment and infrastructure has been recently remodeled and is in good condition, with chilled and hot water fed from the adjacent elementary school. Some equipment remained during the renovations and is in need of replacement, including an air handling unit and VUVs serving support spaces along with various terminal heating equipment. Plumbing equipment was also replaced, though underground sanitary and storm piping have reached the end of their useful life.

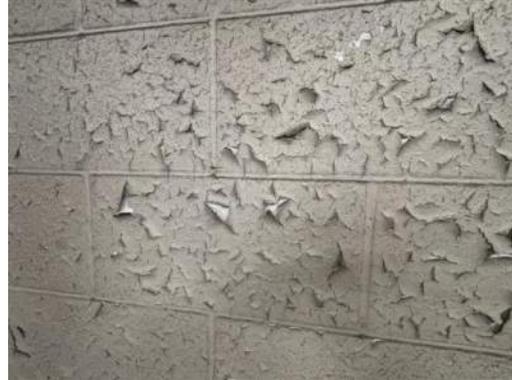
Existing Peeling Paint
