MANDATORY PRE-BID MEETING MINUTES

PROJECT: ANDREW LEWIS MIDDLE SCHOOL- RE-ROOF AREA L

INFRARED DRONE SURVEY

IR SCAN OF SELECTED LOW SLOPE, FULLY ADHERED EPDM ROOF SECTION

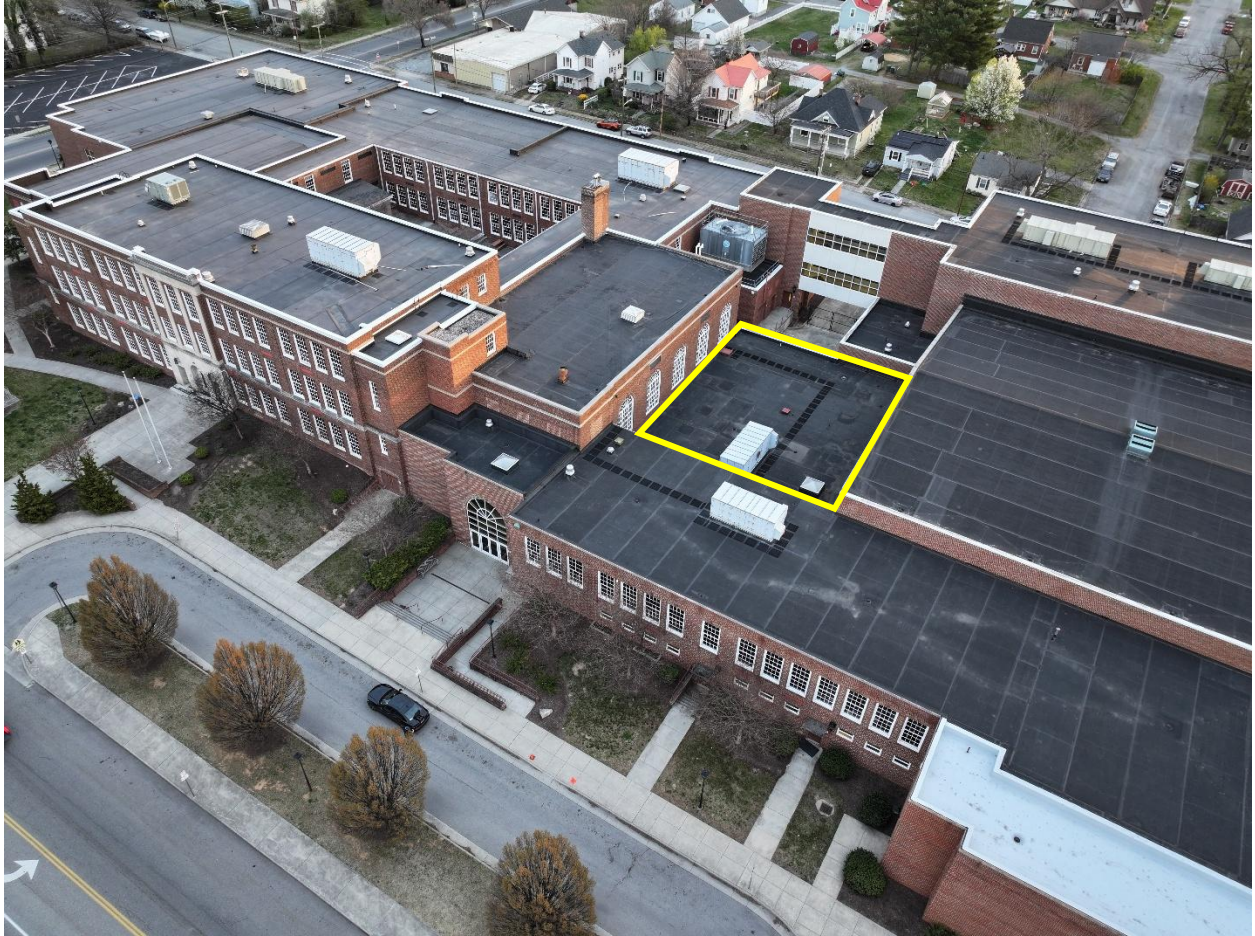
ROOF SECTION LOCATION FOR REFERENCE

While there are a couple of small areas of temperature anomalies that are indicative of sub-membrane moisture, there are many pinpoint temperature spikes that are not. There is a pattern of similarly sized patches associated with these readings, indicative of inexact repairs following probable equipment removal. Gaps in the replacement insulation are allowing heat loss from the interior, making the thermal envelope less secure.

- a) **Students return to school on August 18, 2025**
- b) **The building permit fee will be waived.**
- c) **The infrared moisture scan is provided herein. The areas indicating moisture shall be removed to the roof deck and all wet insulation shall be removed and replaced as per the design documents. If damaged or rusted roof decks are encountered in this process they shall be patched or repaired accordingly.**

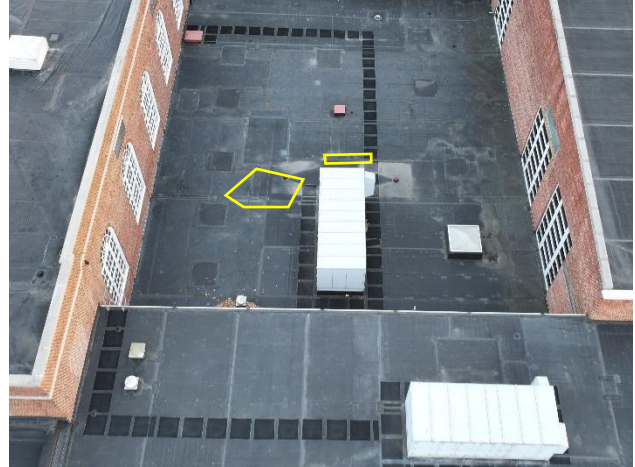
ROOF 1

There is an area to the left of the mechanical unit indicative of water infiltration. A second area of concern is just beyond the unit and will show up better in following images. Spots marked with "A" are insulation gaps. "B" indicates roof drains, and "C" vent pipes.

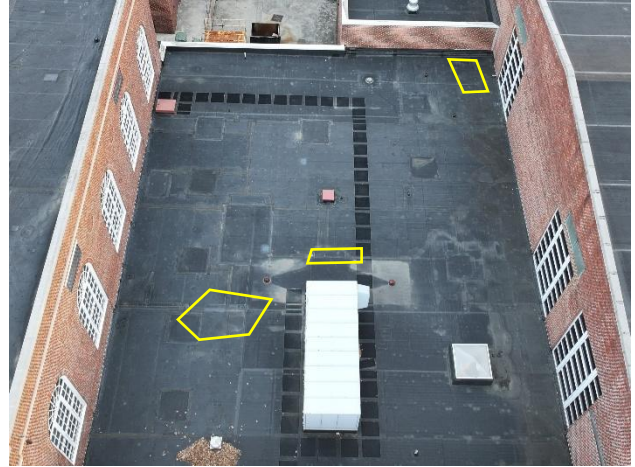
ROOF 1

An area partially concealed by the radiant heat wash from the adjacent masonry wall is likely subsurface moisture. Spots marked with "A" are insulation gaps. "B" indicates roof drains, and "C" vent pipes.

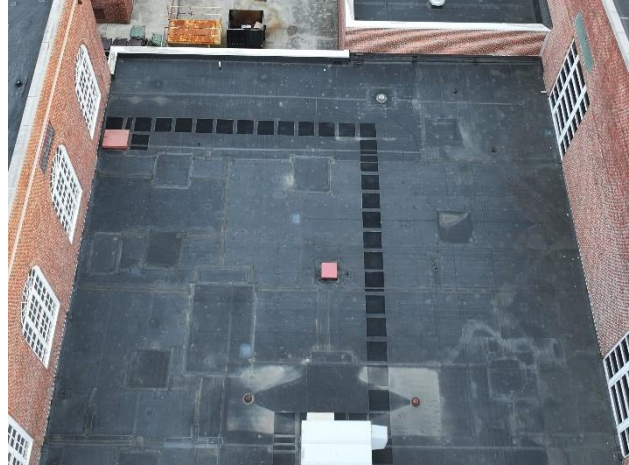
ROOF 1

This is another view of areas already mentioned.

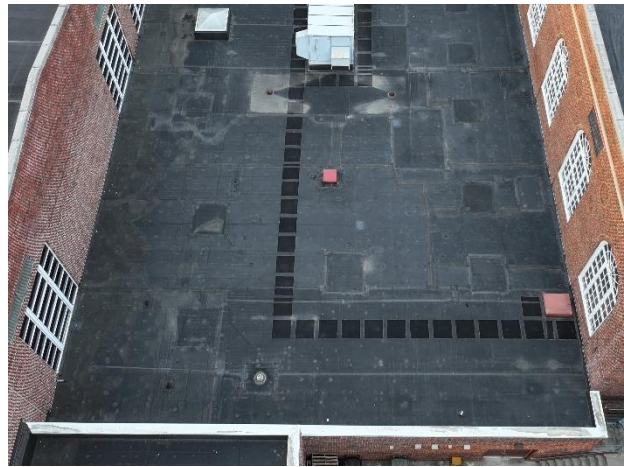
ROOF 1

Switching camera angle, the area in the lower left is more pronounced.

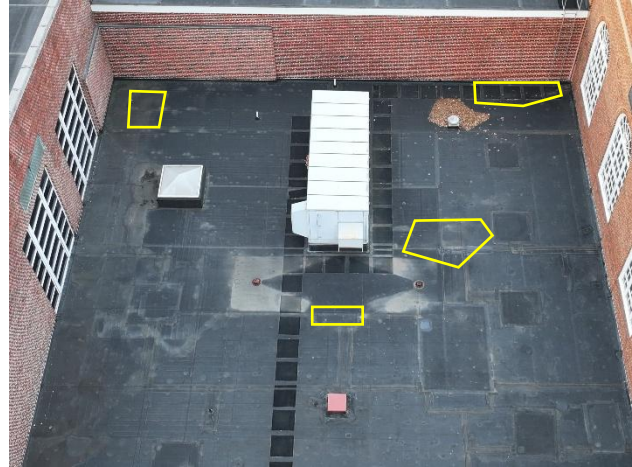
ROOF 1

Two new areas of concern are shown in this image. In the upper left is a probable area of wet insulation. Under the walkway pads by the ladder is another suspect area. The pile of leaves and the heat exhaust of the fan unit read warmer, but are not associated with moisture issues.

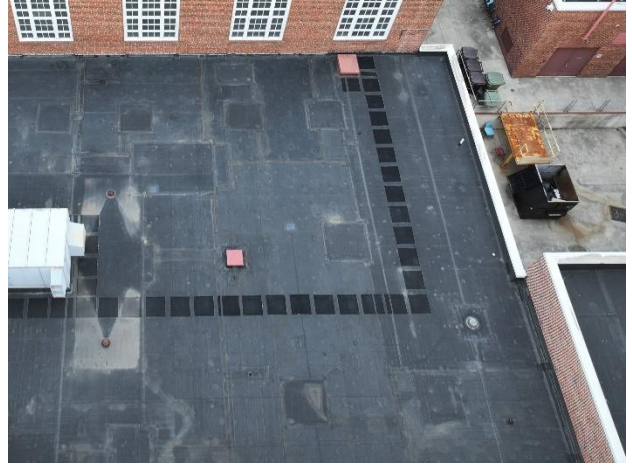
ROOF 1

Yet another camera angle of this small section of roof.

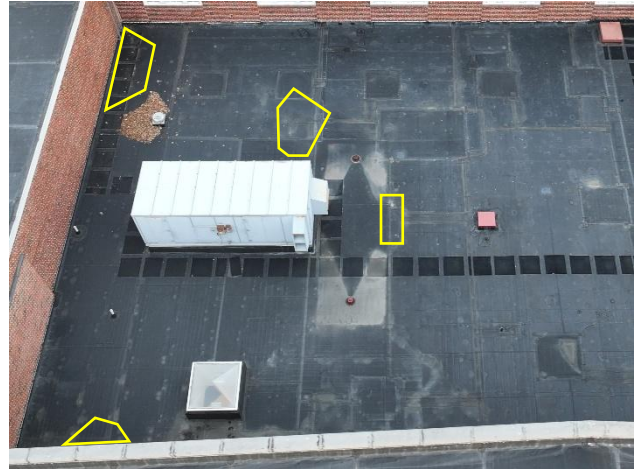
ROOF 1

The two areas at the west end of this roof are more defined from this camera angle.
