RE: Drinking Water Sampling – Jennings Senior High School
8850 Cozens Avenue
Jennings, MO 63136
Project Number: 923235

OCCU-TEC, Inc. (OCCU-TEC) is pleased to present the following report for drinking water sampling completed at Jennings Senior High School in Jennings, Missouri. The sampling was requested and approved by Mr. Henry Ilges of Jennings School District (JSD). OCCU-TEC completed drinking water sampling of all potential drinking water sources, sources used in food preparation, cleaning, and utensil cleaning. Drinking water sampling was completed in accordance with the requirements set forth in Missouri Senate Bill #681/662 known as the "Get the Lead Out of School Drinking Water Act".

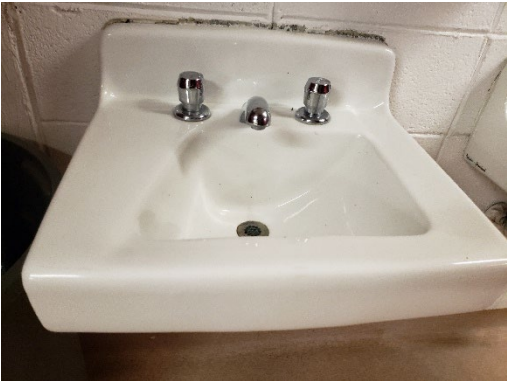
| ID: | 235-JHS-02 | Location: | Pool Women's Locker | |

| | | Locker Room Sink, Left (Non-Functional) | | |

| Recommended Action: | | Replace Fixture/Unit and Resample | | |

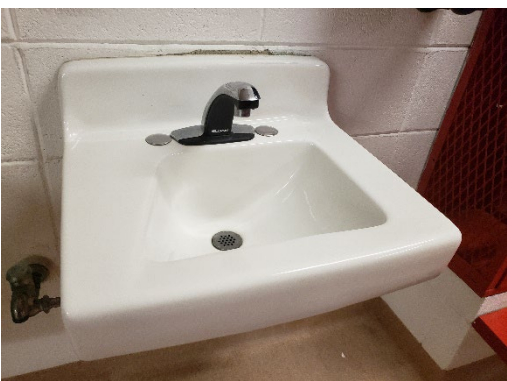
| ID: | 235-JHS-03 | Location: | Pool Women's Locker | |

| | | Locker Room Sink, Right (Non-Functional) | | |

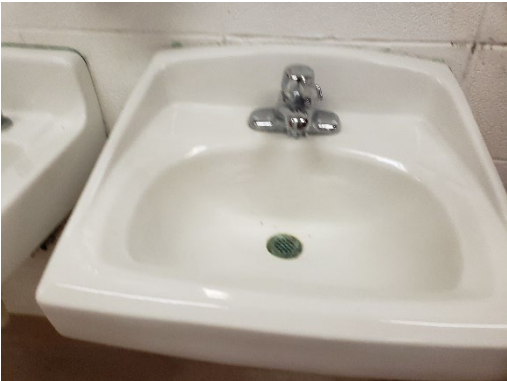
| ID: | 235-JHS-05 | Location: | Pool Men's Locker | |

| Sample ID | Location | Type | Result (ug/L) |
|---|---|---|---|
| 235-JHS-05 | Pool Men's Locker | Locker Room Sink | 106 |

| | | Locker Room Sink, Right | | |

| Recommended Action: | | Replace Fixture/Unit and Resample | | |

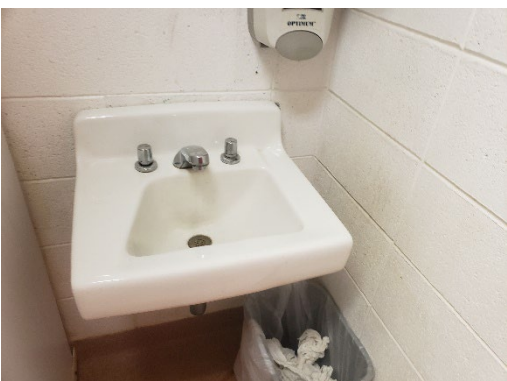
| ID: | 235-JHS-06 | Location: | Pool Men's RR | |

| Sample ID | Location | Type | Result (ug/L) |
|---|---|---|---|
| 235-JHS-06 | Pool Men's Restroom | Restroom Sink | 26.1 |

| | | Restroom Sink | | |

| Recommended Action: | | Replace Fixture/Unit and Resample | | |

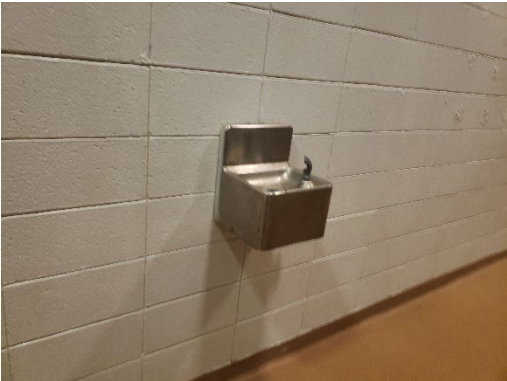
| ID: | 235-JHS-08 | Location: | Pool Deck | |

| | | Standalone Drinking Fountain Bubbler (Non- Functional) | | |

| Recommended Action: | | Replace Fixture/Unit and Resample | | |

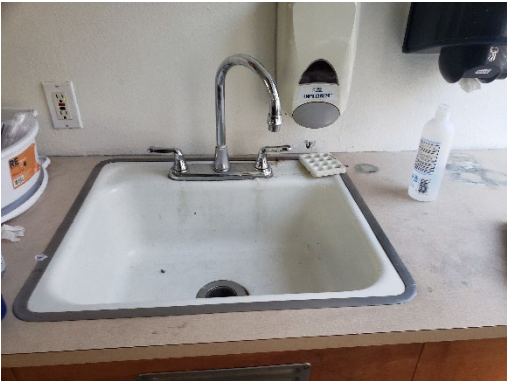
| ID: | 235-JHS-14 | Location: | S218 | | |

| Sample ID | Location | Type | Result (ug/L) |
|---|---|---|---|
| 235-JHS-14 | S218 | Classroom Sink | 5.7 |

| | | Classroom Sink | | | |

| | | Replace Fixture/Unit and Resample | | | |

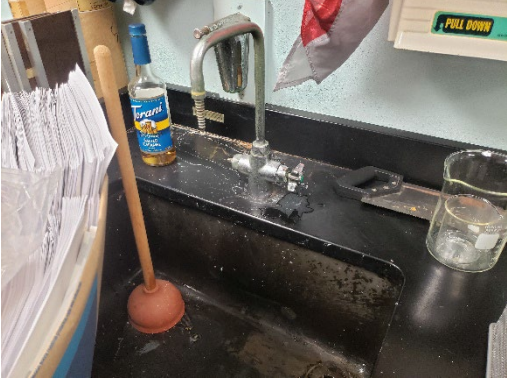
| ID: | 235-JHS-15 | Location: | S215 | | |

| | | Science Closet Sink | | | |

| | | Replace Fixture/Unit and Resample | | | |

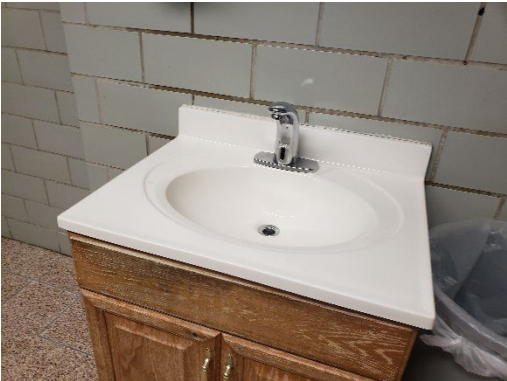
| ID: | 235-JHS-20 | Location: | S200 Men's RR | |

| | | Restroom Sink | | |

| Replace Fixture/Unit and Resample | | | | |

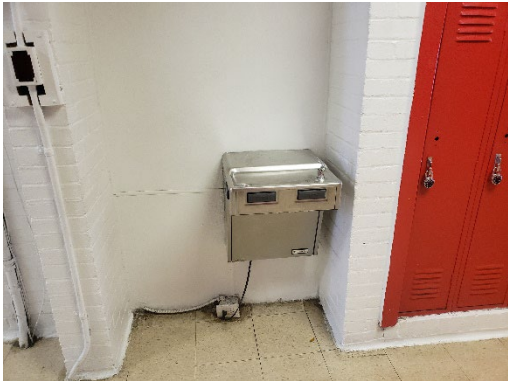
| ID: | 235-JHS-29 | Location: | E220 Hall |

| | | Standalone Drinking Fountain Bubbler | |

| Recommended Action: | | Replace Fixture/Unit and Resample | |

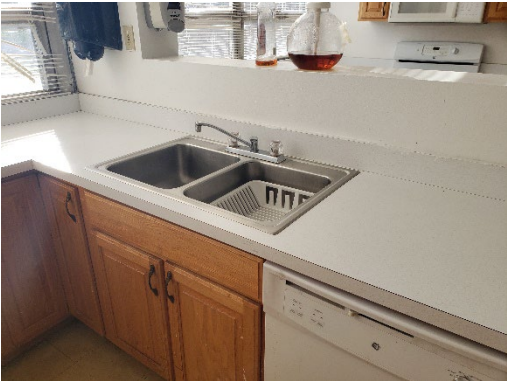
| ID: | 235-JHS-38 | Location: | E137, FACS | | |

| | | East Station Sink, Center Unit | | | |

| | | Replace Fixture/Unit and Resample | | | |

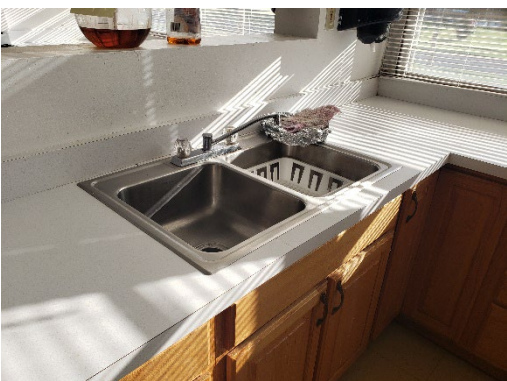
| ID: | 235-JHS-39 | Location: | E137, FACS | | |

| | | East Station Sink, Right Unit | | | |

| | | Replace Fixture/Unit and Resample | | | |

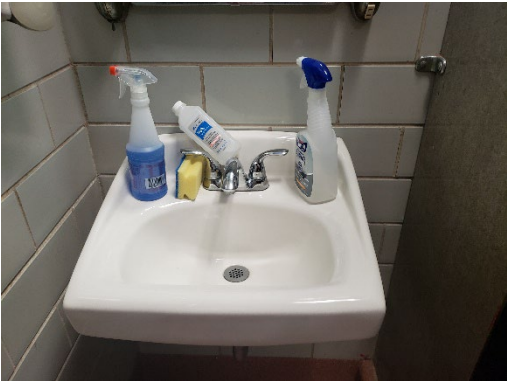
| ID: | 235-JHS-53 | Location: | EG4 Locker Rm Office | | |

| | | Restroom Sink | | | |

| | | Replace Fixture/Unit and Resample | | | |

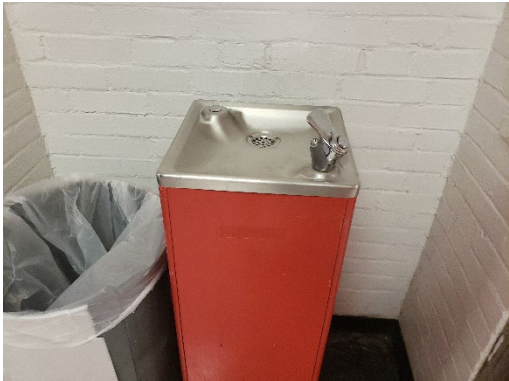
| ID: | 235-JHS-62 | Location: | E100 Hall | |

| | | Standalone Drinking Fountain Bubbler (Low Flow, No Sample) | | |

| | | Replace Fixture/Unit and Resample | | |
