RE: Drinking Water Sampling – Northview Elementary School
8920 Cozens Avenue
Jennings, MO 63136
Project Number: 923235

Drinking Water Assessment
Northview Elementary School
Jennings School DIstrict

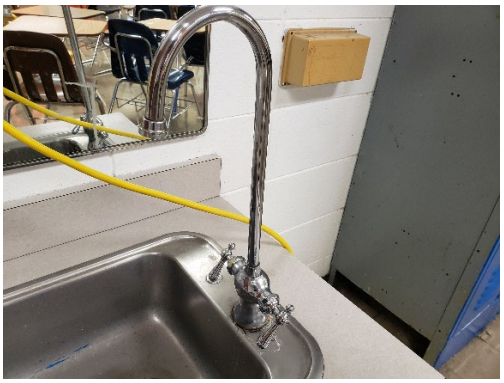
ID:	235-NVE-05	Location:	CL-208		
Photo:

Manufacturer:	American Standard		
		Description:			
		Classroom Sink			
		Result:	8.1	ppb	
		Date Sampled:	8/9/2023	By:	NJ
Recommended Action:		Replace Fixture/Unit and Resample

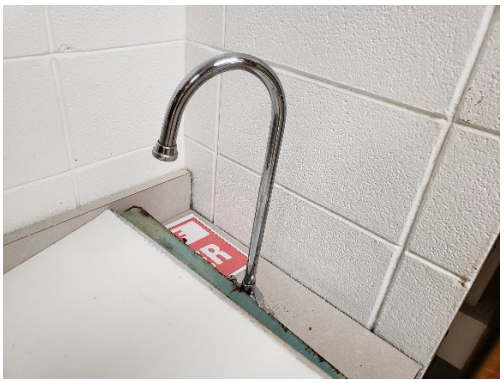
ID:	235-NVE-20	Location:	CL-218		
Photo:

Manufacturer:	American Standard		
		Description:			
		Classroom Sink (Non-Functional)			
		Result:	N/A	ppb	
		Date Sampled:	8/9/2023	By:	NJ
Recommended Action:

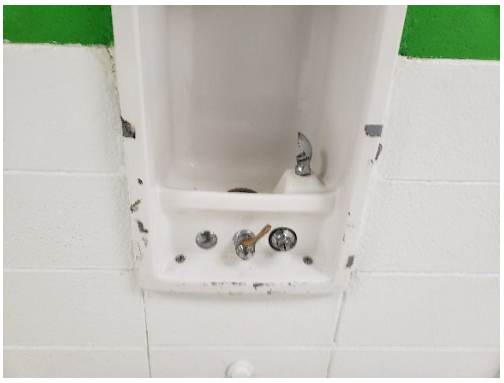
ID:	235-NVE-22	Location:	200 Hall West	
Photo:

Manufacturer:	Halsey-Taylor	
		Description:		
		In-Wall Drinking Fountain Bubbler		
		Result:	4.5	ppb
		Date Sampled:	8/9/2023	By: NJ
Recommended Action:

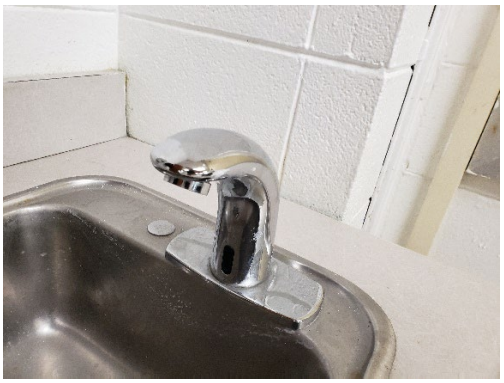
ID:	235-NVE-29	Location:	CL-214		
Photo:

Manufacturer:	Sloan		
		Description:			
		Classroom Sink			
		Result:	4.8	ppb	
		Date Sampled:	8/9/2023	By:	NJ
Recommended Action:

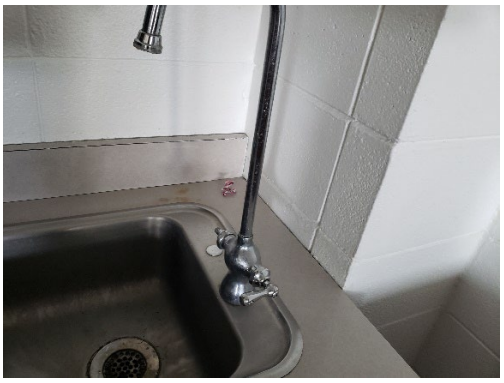
ID:	235-NVE-45	Location:	CL-103	
Photo:

Manufacturer:	American Standard	
		Description:		
		Classroom Sink		
		Result:	4.4	ppb
		Date Sampled:	8/9/2023	By: NJ
Recommended Action:

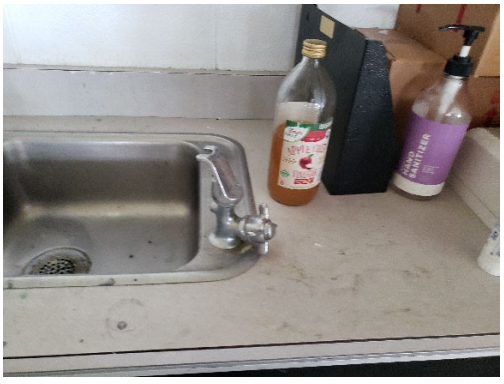
ID:	235-NVE-48	Location:	CL-105		
Photo:

Manufacturer:	American Standard		
		Description:			
		Classroom Drinking Fountain Bubbler (Non-Functional)			
		Result:	**N/A**	ppb	
		Date Sampled:	8/9/2023	By:	NJ
Recommended Action:

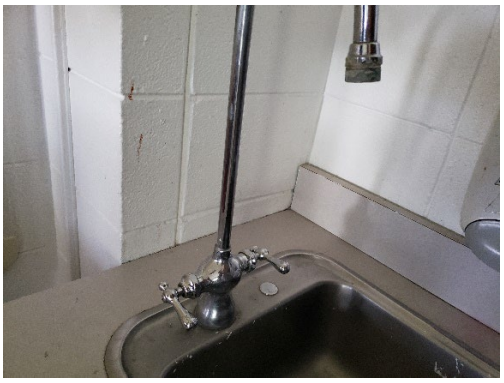
ID:	235-NVE-57	Location:	CL-108		
Photo:

Manufacturer:	American Standard		
		Description:			
		Classroom Sink			
		Result:	6.4	ppb	
		Date Sampled:	8/9/2023	By:	NJ
Recommended Action:		Replace Fixture/Unit and Resample

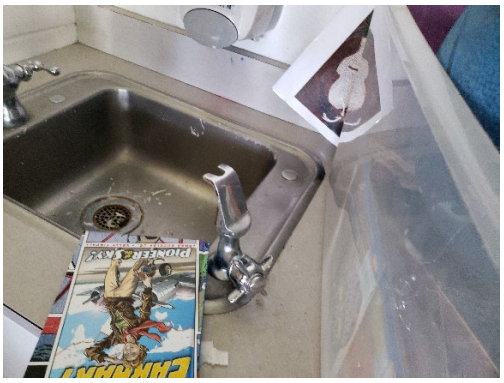
ID:	235-NVE-58	Location:	CL-108		
Photo:

Manufacturer:	American Standard		
		Description:			
		Classroom Drinking Fountain Bubbler (Non-Functional)			
		Result:	N/A	ppb	
		Date Sampled:	8/9/2023	By:	NJ
Recommended Action:

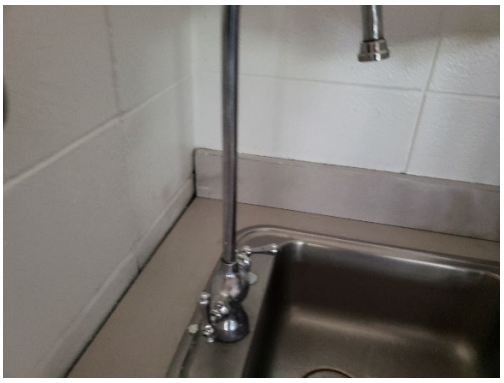
ID:	235-NVE-61	Location:	CL-110		
Photo:

Manufacturer:	American Standard		
		Description:			
		Classroom Sink			
		Result:	**15.3**	ppb	
		Date Sampled:	8/9/2023	By:	NJ
Recommended Action:	**Replace Fixture/Unit and Resample**

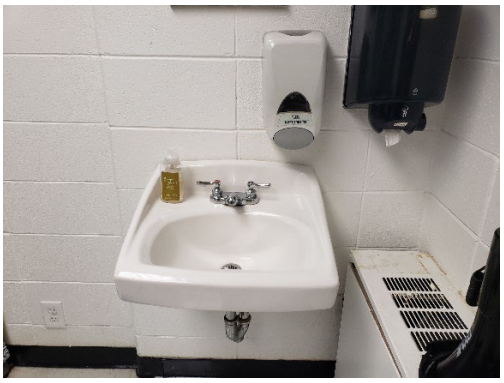
ID:	235-NVE-67	Location:	116 Counselor's Office	
Photo:

Manufacturer:	Chicago Faucet Co.	
		Description:		
		Office Sink		
		Result:	**11.8**	ppb
		Date Sampled:	8/9/2023	By: NJ
Recommended Action:	**Replace Fixture/Unit and Resample**
