RE: Drinking Water Sampling – Hanrahan Elementary School
8430 Lucas and Hunt Rd
St. Louis, MO 63136
Project Number: 923235

Drinking Water Assessment
Jennings Junior High School
Jennings School DIstrict

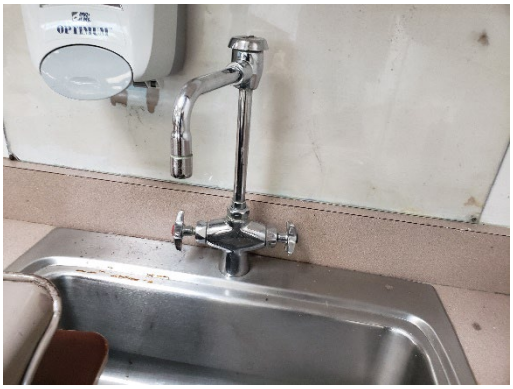
ID:	235-JMS-39	Location:	S104	
Photo:

Manufacturer:	Chicago Faucet Co.	
		Description:		
		Classroom Sink, Right (Non-Functional)		
		Result:	N/A	ppb
		Date Sampled:	8/10/2023	By: NJ
Recommended Action:

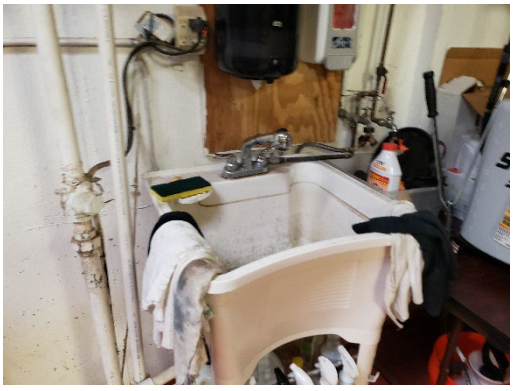
ID:	235-JMS-75	Location:	Maintenance Room	
Photo:

Manufacturer:	Unknown	
		Description:		
		Maintenance Sink		
		Result:	**26.4**	ppb
		Date Sampled:	8/10/2023	By: NJ
Recommended Action:		**Replace Fixture/Unit and Resample**

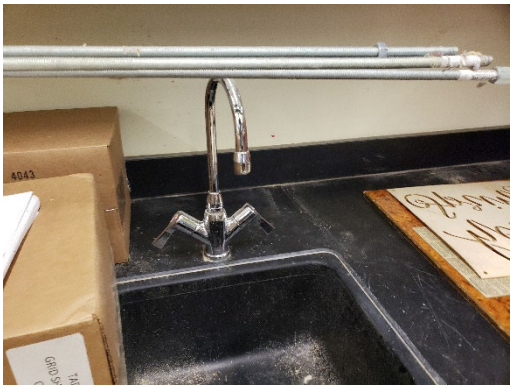
ID:	235-JMS-79	Location:	W105 Lab	
Photo:

Manufacturer:	Moen	
		Description:		
		South Wall Lab Sink, Center		
		Result:	2.2	ppb
		Date Sampled:	8/10/2023	By: NJ
Recommended Action:

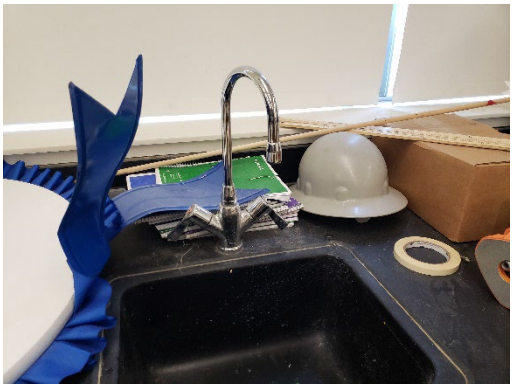
ID:	235-JMS-83	Location:	W105 Lab	
Photo:

Manufacturer:	Moen	
		Description:		
		North Wall Lab Sink, Right		
		Result:	**7.9**	ppb
		Date Sampled:	8/10/2023	By: NJ
Recommended Action:	**Replace Fixture/Unit and Resample**
