# Northville Elementary School

## Roof Report & Roof Replacement Recommendations

Draft Report, November 15, 2024  
Final Report, November 21, 2024

**Silver Petrucelli & Associates, Inc.**

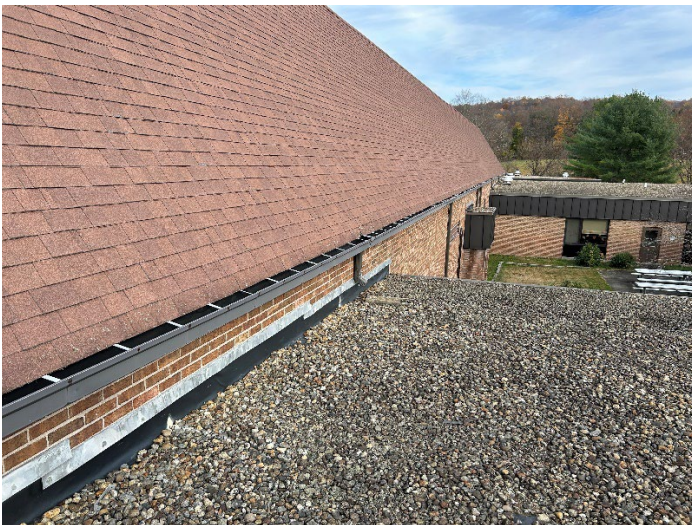
Exterior Brick & Concrete Block walls – sloped roof A

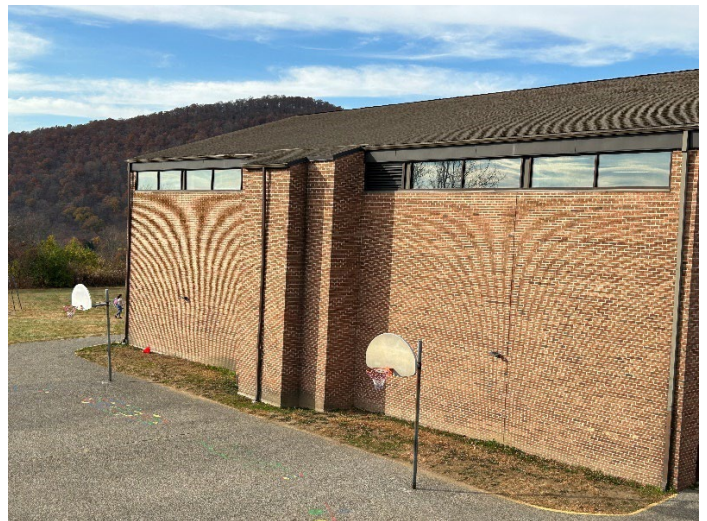
Exterior Brick & Concrete Block walls – sloped roof B

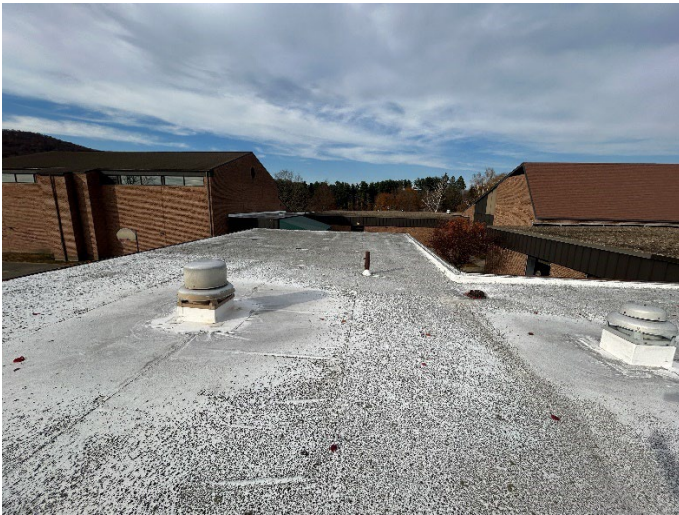
Roof 5, low slope single ply membrane roof

The 63,989 s.f. of Low slope EPDM membrane roofs (ballasted and non-ballasted) at Northville Elementary School (roofs 1, 2, 3, 4, 5, 6 & 7) are generally in poor condition. It is the opinion of SPA that these roofs are the original roofs to the facility making them 30-40 years old, depending on location. Equally, the perimeter metal flashing and EPDM counter flashings are also in poor condition. There was considerable ponding (or signs of ponding in the past) on many of the low sloped roofs on the day of our site visit, indicating that the roofs are not adequately sloping/draining to the existing roof drains. Numerous trees were also noted as overhanging the roof, with many leaves/debris present on the roof surfaces and in the drains. The Mechanical 28 curbs, 4 pitch boxes and 25 vent stacks are also in poor condition. The 40 roof drains, which all appear to be original, are in poor condition and do not have much serviceable life left in them. There are numerous EPDM patches throughout the roof areas indicating leaks that were present in the past. Not only has the EPDM membrane reached the end of its useful life, the EPDM seams, in numerous locations have failed, creating additional pathways for the water to infiltrate the facility.

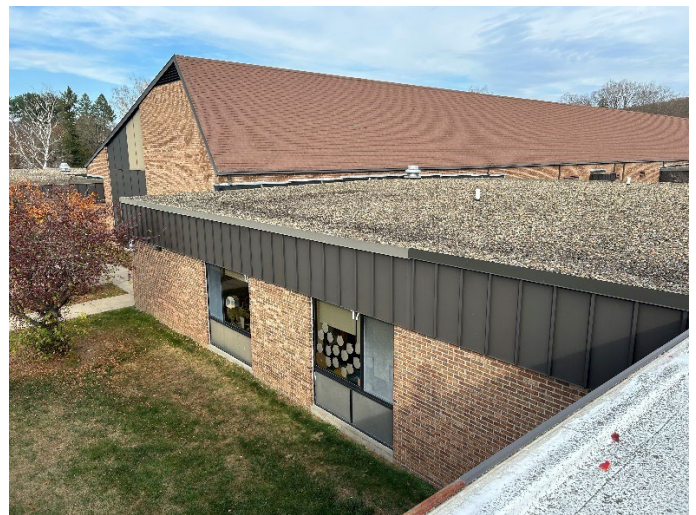
low slope roof 4 (note standing seam metal fascia panel)

Lastly, the perimeter metal standing seam fascia is in poor condition and should be replaced as part of any future roofing operations. Various locations of these panels are rusted/rotted and there is no remedy for repairing them, therefore, replacement is the only option. Most of the vented screens at the bottom edge of these panels, is missing and or rotted/failed.

- Remove and replace all aluminum gutters & downspouts
- Remove & replace perimeter standing seam metal fascia
- Clean & inspect existing roof deck
- Install 5" rigid insulation to meet R-30 energy code requirement

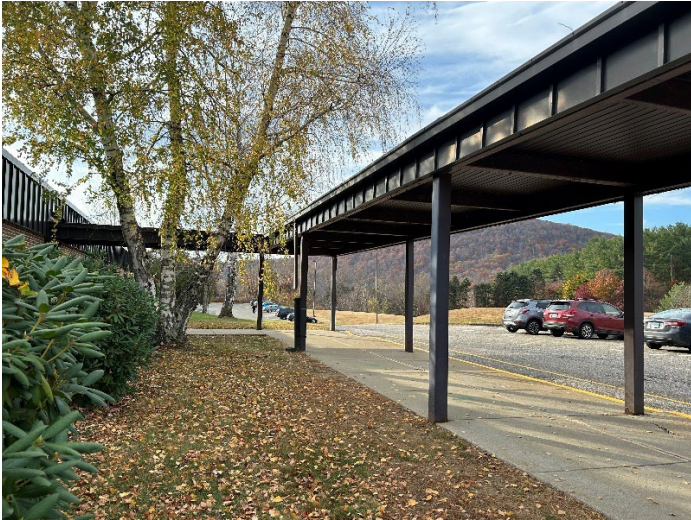
Can Canopy of North side of Building

- Scrape, prime and paint all steel at canopy
- Repair all damaged exterior soffits
- Entire system to be a minimum warranty of 20 years

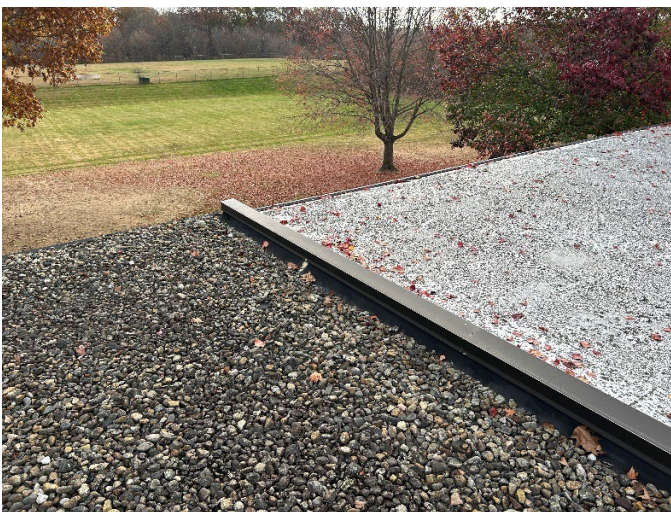
Roof transition between roofs 4 & 5

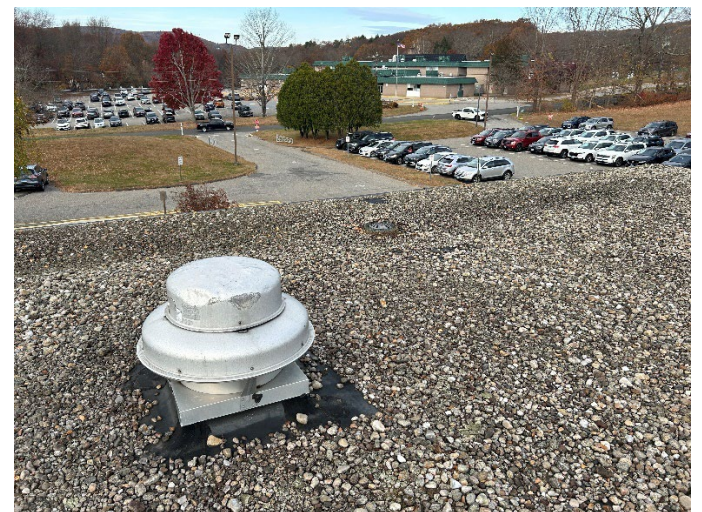
Typical HVAC exhaust fan detail

- Remove & replace existing 40 roof drains
- Remove & replace existing 28 HVAC exhaust fan wood curbs/flashing
- Remove & replace 4 existing pitch boxes
- Remove & replace 23 existing vent stack flashings
