Comstock Park Public Schools

2022 Facility Assessment

Executive Summary

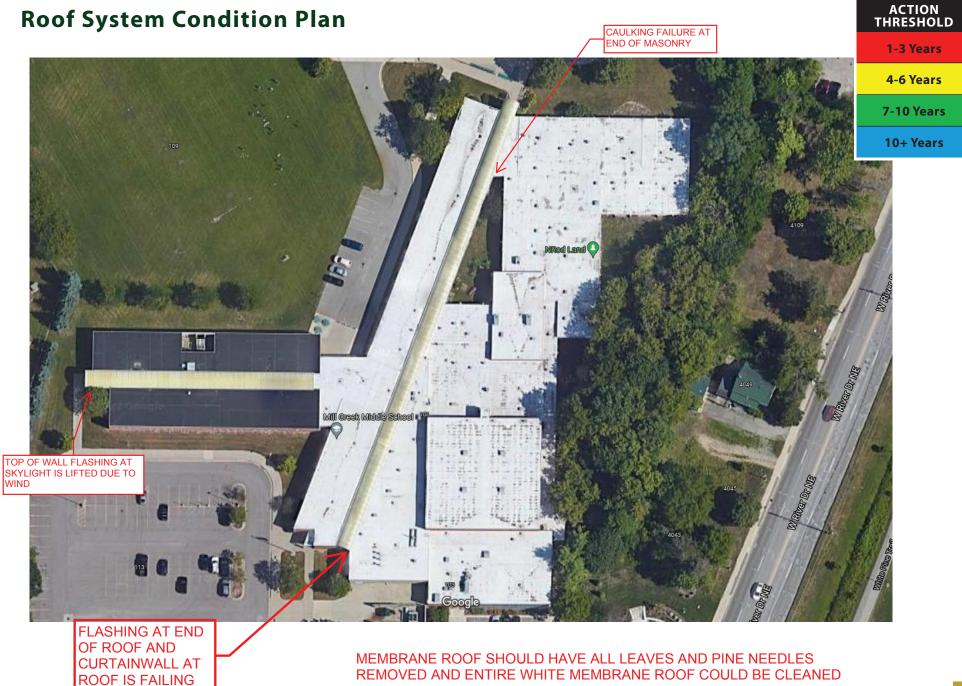
Roof System - Photos

(Select Drop-down or Overwrite)		\$0			
Miscellaneous Rooftop Equipment					
Ladders	Ladder recommended to access high roof	\$500	\$525		
(Select Drop-down or Overwrite)		\$0

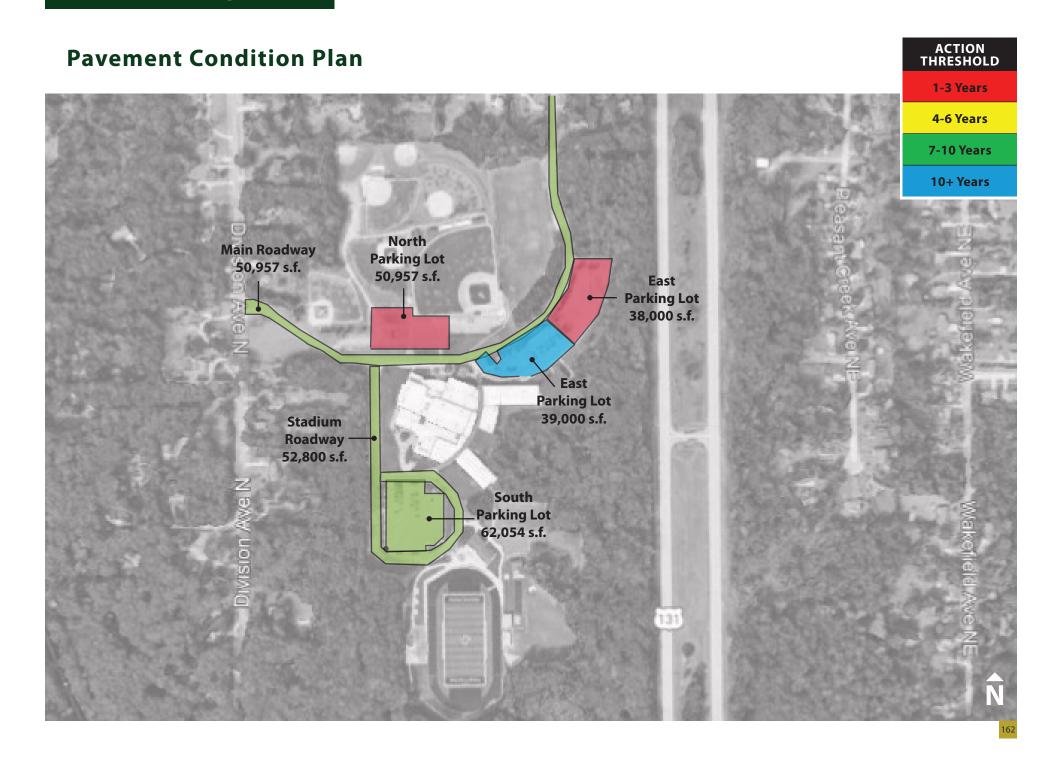
Civil and Site - Photos

Main roadway	Mill and repave due to cracking and wear.	\$201,600			\$298,368	
Stadium Roadway	Crack repair to extend life of pavement.	\$3,200	\$3,360			
Stadium Roadway	Mill and repave due to cracking and wear.	\$158,400			\$234,432	
Parking Striping/Paint	North, South and East parking lots due to repavement of parking lot.	\$5,000	\$5,250			
(Select Drop-down or Overwrite)		\$0				
Landscaping						
Trees	Clearing and Maint at entries to extend visibility at drive entries.	\$10,000	\$10,500			
(Select Drop-down or Overwrite)		\$0				
Subcategory / Area						
(Select Drop-down or Overwrite)		\$0
