FACILITIES CONDITION ASSESSMENT

Rivendell Interstate School District

Rivendell Academy East & West Wings | Samuel Morey Elementary | Westshire Elementary

September 25, 2025

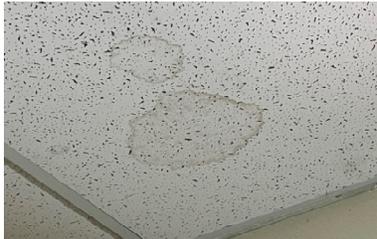
Recommendation – Replace ACT tiles.
		Doors	Fair condition, no immediate action required. Fire rated doors on hold open.
		Borrowed Lites	N/A
		Millwork	N/A
5.	Lower-Level Vestibule South		
		Floor	Good condition.
		Walls/ Columns	Good condition.
		Ceiling	Fair condition. ACT has stains. Recommendation – Replace stained tile. Verify there are no active water leaks. Replace unseated tiles.

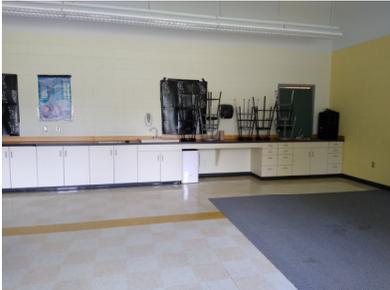
Floor	Fair condition – VCT. No immediate action required.
		Walls/ Columns	Good condition.
		Ceiling	Good condition.
		Doors	Fair condition. Wood doors fair but steel frame is unprotected. Recommendation – replace existing door frame with protected steel frame.
		Borrowed Lites	N/A
		Millwork	Not in compliance with ADA regulations; base cabinets at 3’-4”, lacks knee space. Recommendation – Replace base cabinets with ADA compliant units.

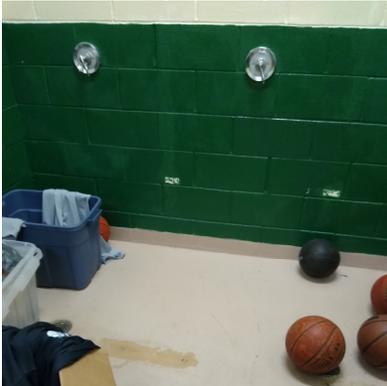
Walls/ Columns	Good condition.
		Ceiling	Good condition.
		Doors	Good condition.
		Borrowed Lites	N/A
		Millwork	N/A
14.	Boys / Girls Locker Room 1109		Boys locker room has 2'-0" wide clear area at low urinal. Recommendation – Reconfigure space to meet minimum 30" wide urinal size (currently 2'-0").
		Floor	Poor condition. Epoxy worn in shower areas. Poor condition at the remainder of Locker room floors. Recommendation – replace all locker room tile and remaining flooring.

Walls/ Columns	Fair condition. Gang Shower stalls removed leaving unpatched holes in CMU walls and in floors. Recommendation – Patch, repair, repaint holes to match existing space.
		Ceiling	Fair condition, no immediate action required. Acoustic deck.
		Doors	Poor condition – Door frames from hallway to locker rooms to all be confirmed as requiring fire rating. Recommendation – Install new doors and hardware.
		Borrowed Lites	N/A

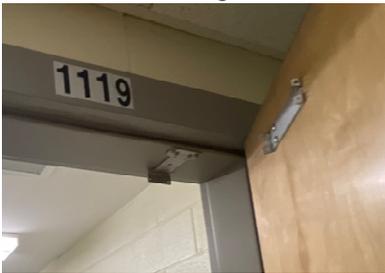
Doors	Fair condition. Dings and marks, basic wear to door. Hinges show significant wear. Closer is missing but hardware on door is still present. Recommendation – Repair and replace door hardware including closer arm.

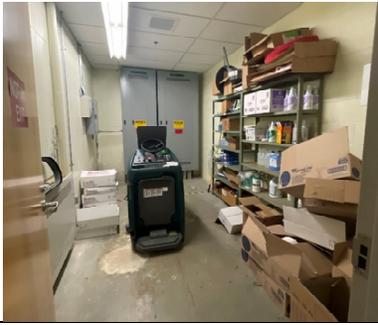
23.	Electrical 1123		
		Floor	Poor condition. Exposed cracking and chipping of concrete floor. Recommendation – patch, repair, and seal concrete floor.
		Walls/ Columns	Fair condition.

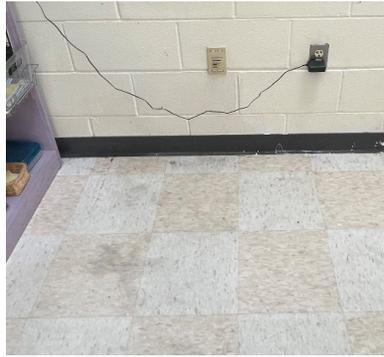
Walls/ Columns	Fair condition. Main walls / whiteboard walls have many scuffs, marks and general wear. Recommend repainting CMU walls.

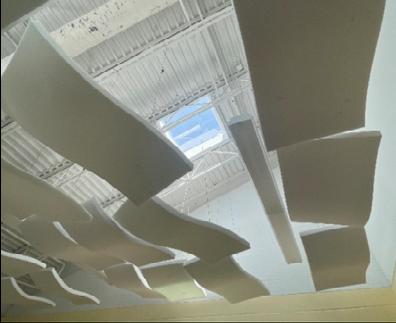
Ceiling	<p>Fair condition. GWB soffits have some scuffs, marks and general wear. Recommend repainting GWB soffits.</p>

<p>ACT dropped ceiling clouds are in fair condition. However, they need to be realigned and spaces out evenly with the intended pattern.</p>

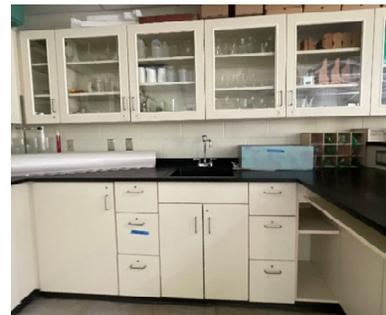
Walls/ Columns	Good condition.
	Ceiling	Good condition.
	Doors	N/A
	Borrowed Lites	N/A
	Millwork	<p>Fair condition – Millwork and counters all rooms generally. 38” height work counters with 34” ADA portion at each space.</p> <p>Poor condition – Approximately 10% of laminate faces of counters peeling off.</p> <p>Recommendation – Repair delaminated portions.</p>

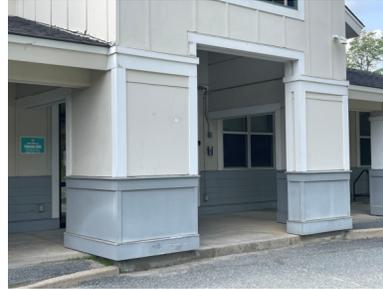
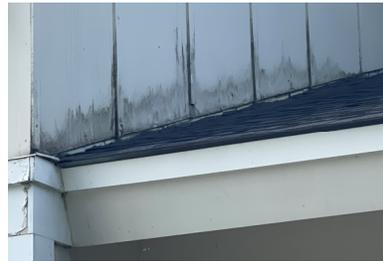
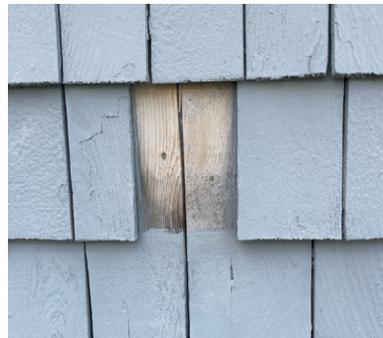
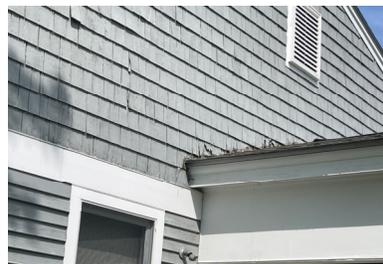
1.	General: Site elements are not included in the scope of work of this review.	
2.	Walls	
	Foundation	Good condition.
	Siding	<p>Fair condition. Wood clapboards and trim boards have peeling paint and paint appears faded; most prevalent around entry drop off area.</p> <p>Recommendation – Repair, Prep, and repaint clapboards and trim. Replace clapboards beyond repair. Replace missing shingle siding and repair deteriorated portions of shingle siding and vertical board and batten siding where it meets and shows excessive warping.</p>

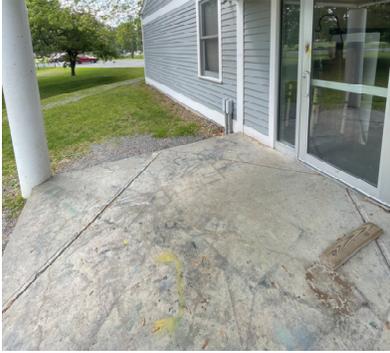
3.	Elements [e.g. Columns]	Concrete Pads at Exterior Doors	<p>Concrete foundation in poor condition. Recommendation – Repair cracks, clean misc. paint and seal all concrete pads.</p>

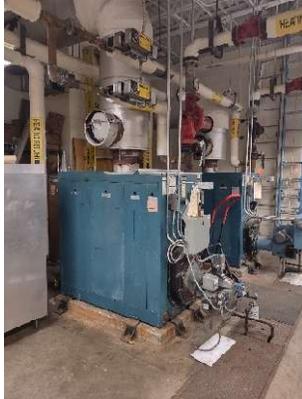
Main Boiler Room Boiler #1 with an oil service burner and boiler. This existing burner/boiler was installed in 2001 has 2 zones, was installed in accordance with code, is well maintained but is at the of its service life. LN Consulting recommends that this equipment be upgraded.

Boiler #1 at the end of its service life.

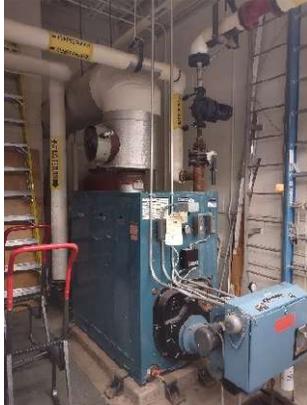
Main Boiler Room Boiler #2 with an oil service burner and boiler. This existing burner/boiler has 2 zones, was installed in accordance with code, is well maintained, and is 24 years into its 30 year service life. LN Consulting recommends that this equipment be upgraded.

Boiler #2 at the end of its service life.

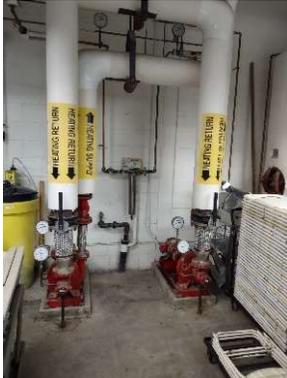
<p>Heating zone circulation pumps – good to fair condition.</p>

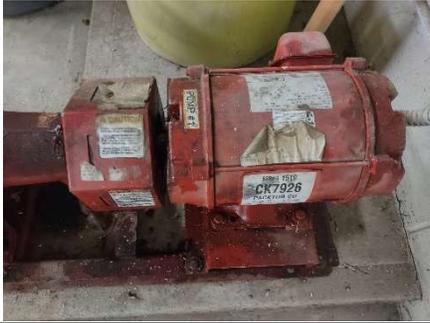
<p>Fair condition – circulation pump and motor</p>

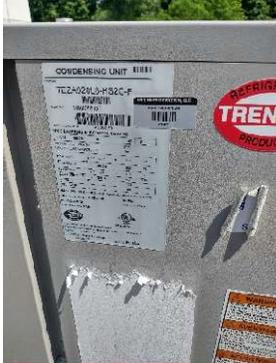
<p>Outdoor condenser unit #2.</p>

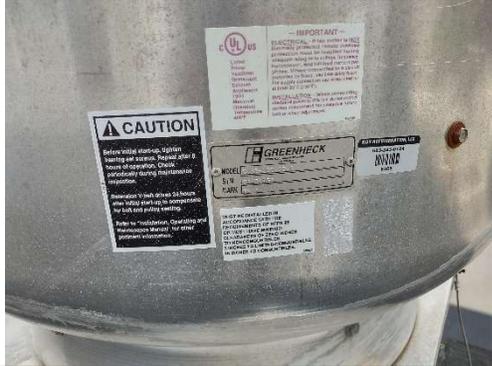
<p>Smaller kitchen exhaust fans.</p>

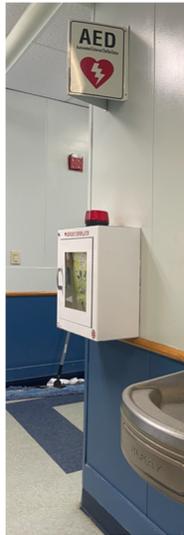
<p>The following doors have no handle: Patient Room 2143. Storage 2144. Recommendation – Provide push/pull hardware if leverset with latch is not desired.</p>
		Distance Between Sequential Doors	In Compliance.
3.	Accessible Route		
		Path to Public Areas/ Elevator	In Compliance.
		Minimum Width	In Compliance.
		Protruding Objects greater than allowed 4"	<p>AED is in surface mounted cabinet. Recommendation – Install AED in semi-recessed AED cabinet.</p>

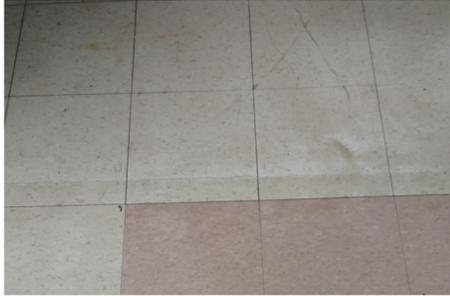
Recommendation – Confirm with AHJ that combustible storage cabinets are acceptable in exit access corridor.
6.	South Corridor		
		Floor – North End	<p>Poor condition. Cracks and differential settlement in VCT along assumed slab joint lines, scrapes, gouges, discoloring.</p> <p>Recommendation – Install new flooring after flashing concrete slab.</p>

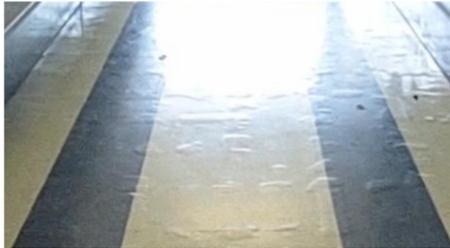
Floor – South End	<p>Poor condition. Bubbling under VCT, edge of flooring at exterior door threshold chipped.</p> <p>Recommendation – Replace flooring.</p>

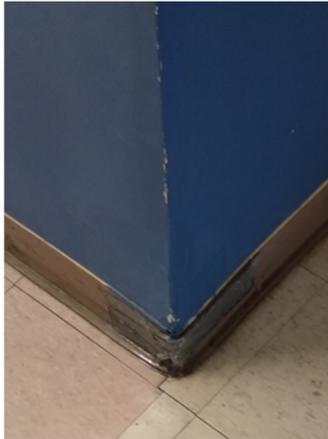
Walls/ Columns – North End	<p>Poor condition. External corners damaged, wall base damaged, paint scraped / missing.</p> <p>Recommendation – Patch and repaint walls, replace wall base.</p>

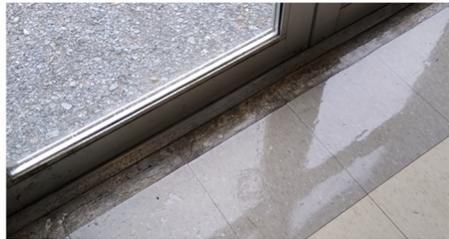
7.	East Corridor		
		Floor	Good condition. Rough edge at exterior door threshold. Recommendation – Intsall wider threshold.

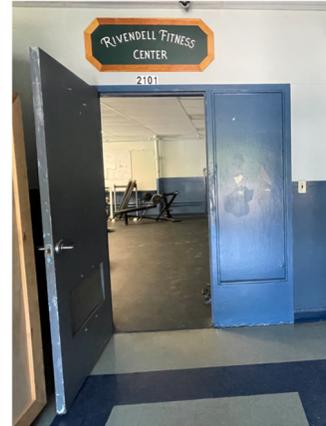
8.	Fitness Center 2101		
		Floor	Good condition.
		Walls/ Columns	Poor condition. Multiple areas of damage. Recommendation – Fixed damaged areas and repaint.
		Ceiling	Poor condition. Bulkhead and numerous ceiling tiles damaged. Recommendation – Repair bulkhead and replace damaged 2x4 ACT.
		Doors	Poor condition. Recommendation – Replace doors and frames.

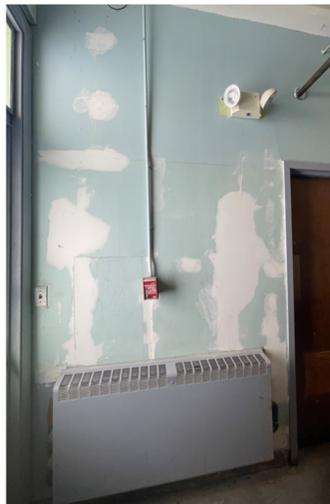
13.	Kitchen Storage 2105		Not assessed – unable to access area.
14.	Stair / Exit Corridor		This space appears to have numerous life safety code deficiencies. Any work in this area should be coordinated with the AHJ.
		Floor	Poor condition. Concrete is unfinished and has cracks. Recommendation – Seal cracks and install flooring.
		Walls/ Columns	<p>Poor condition. Walls have numerous unfinished patches, wall base missing. Recommendation – Repair and repaint wall, install wall base.</p>

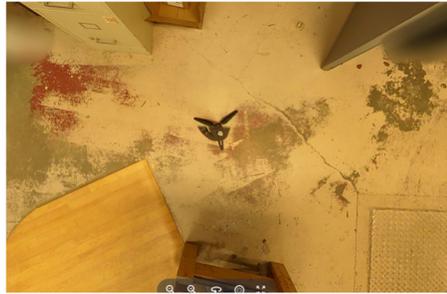
15.	Room 2106		Note that material is stacked below electrical panels and should be removed.
		Floor	Poor condition. Concrete floor has cracks and finish has worn off. Recommendation – Repair cracks and repaint.

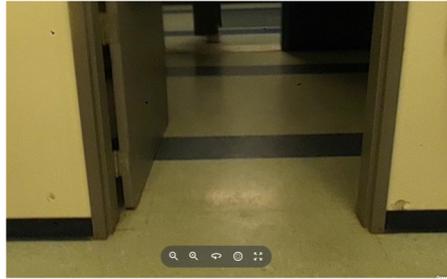
16.	Kitchen 2107		
		Floor	VCT fair condition. For sanitary purposes floor should have no/seamless joints, integral wall base, and floor drain. Recommendation – If kitchen is used for commercial food preparation, upgrade flooring to high-traffic seamless with integral base and install floor drain with slope to drain.
		Walls/ Columns	Fair condition with some damage. Recommendation – Repair and paint damaged areas.

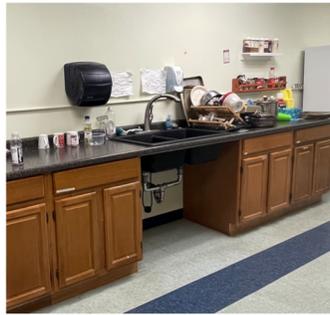
Ceiling	Fair condition, no immediate action required.
		Doors	Fair condition, no immediate action required.
		Borrowed Lites	N/A
		Millwork	Fair condition. Counter height not in compliance with ADA standards, sink drain lacks ADA required insulation. Recommendation – Install ADA compliant sink/counter with drain insulation.

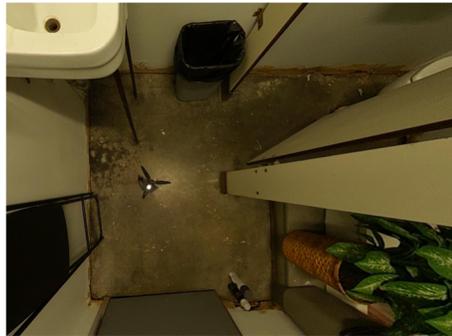
Walls/ Columns	Good condition.
		Ceiling	Good condition.
		Doors	Poor condition. Recommendation – Replace door and frame.
		Borrowed Lites	N/A
		Millwork	N/A
19.	Toilet Room 2109		
		Floor	Poor condition. Bare concrete. Recommendation – Install flooring.

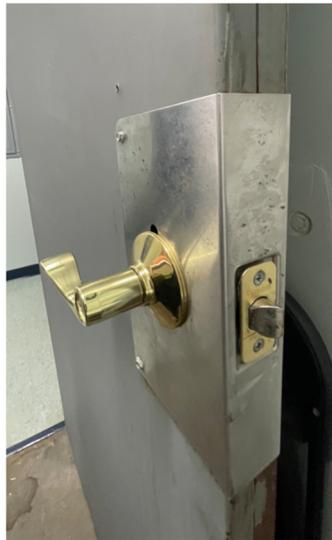
Walls/ Columns	Poor condition. No wall base, dings and dents. Recommendation – Patch and paint walls, install wall base.
		Ceiling	Good condition.
		Doors	Poor condition. Metal door has holes, damaged edges. Recommendation – Replace door.

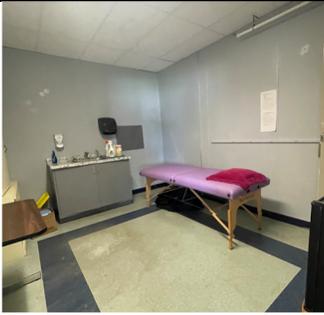
26.	Room 2116

Floor	<p>Poor condition. Portion of floor discolored and scraped.</p> <p>Recommendation – Replace VCT flooring.</p>
		Walls/ Columns	<p>Poor condition.</p> <p>Recommendation – Patch and repaint.</p>

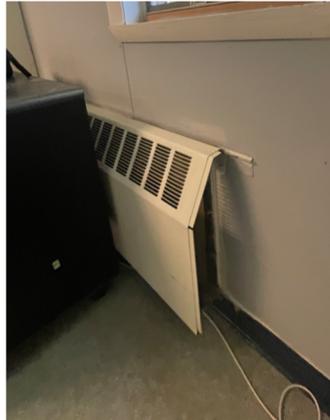
Ceiling	Poor condition. Recommendation – Replace 2x4 VCT tiles.
		Doors	Fair condition, no immediate action required.
		Borrowed Lites	N/A
		Millwork	N/A
27.	Former Coach Office 2117		
		Floor	Fair condition.
		Walls/ Columns	Fair condition.
		Ceiling	Fair condition.
		Doors	N/A
		Borrowed Lites	N/A
		Millwork	N/A
28.	Office 2118		
		Floor	Poor condition. Area near desk worn and joints of adjacent VCT tile discolored. Recommendation – Replace VCT tile.
		Walls/ Columns	Good condition. Finned tube convactor missing end panel. Recommendation – Replace end panel.

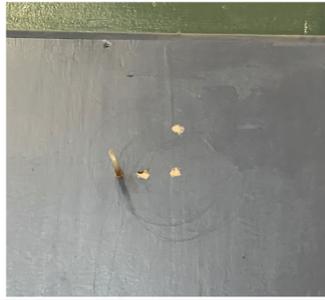
Ceiling	Fair condition, no immediate action required.
		Doors	Good condition.
		Borrowed Lites	Good condition.
		Millwork	N/A
29.	Gymnasium 2119		
		Floor	Good condition.
		Walls/ Columns	Good condition. Some minor damage.

<p>Recommendation – Minor repair and touch up painting.</p>

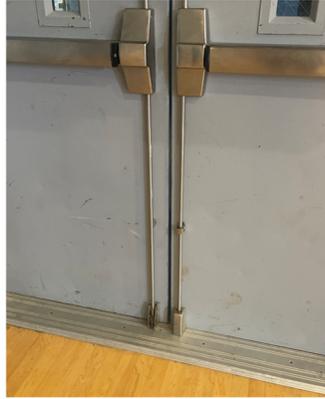
Ceiling	Exposed structure.
		Doors	<p>Fair condition. Some dings and scratches, missing parts on surface rods to east double doors.</p> <p>Recommendation – Repair and repaint doors and frames, repair surface rods.</p>

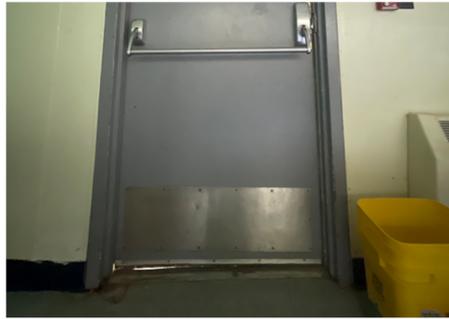
33.	Room 2123 (former Stage)		
		Floor	Good condition – Carpet at ramp. Poor condition – VCT. Many marks and stains. Portions of floor covered by material so cannot be assessed. Recommendation – Replace VCT.
		Walls/ Columns	Fair condition, no immediate action required.
		Ceiling	Fair condition. Some sag in 2x4 ACT.
		Doors	Good condition – Interior door. Fair condition – Exterior door. Large gap at bottom left. Recommendation – Install new weatherstripping and address threshold if necessary.

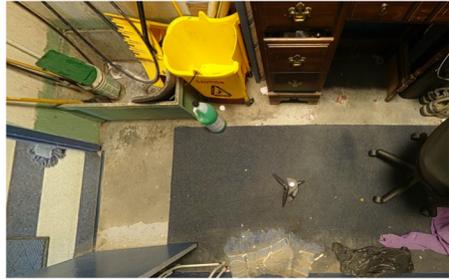
34.	Janitor’s Closet 2124		
		Floor	Fair condition. Most of floor is covered by walk-off mat and cannot be fully assessed. Visible portions are concrete that is sound, painted finish worn off. Recommendation – Repaint floor.

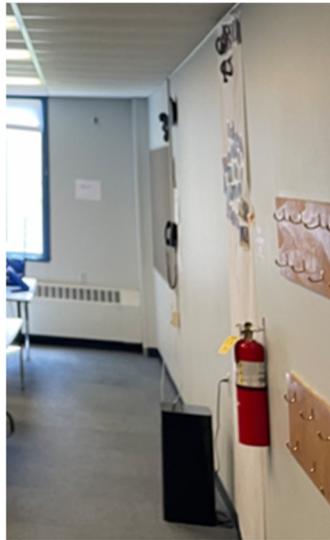
Walls/ Columns	Fair condition for visible portions of wall surfaces.
		Ceiling	Poor condition. ACT damaged. Utility space so not critical.
		Doors	Fair condition. Door edge scraped. Recommendation – Repaint door edge.
		Borrowed Lites	N/A
		Millwork	N/A
35.	Classroom 2125		
		Floor	Fair condition. Some carpet stains and runs. Recommendation – Clean carpet.
		Walls/ Columns	Good condition. Some dings and scrapes on blue wall. Surface mounted fire extinguisher exceeds ADA maximum allowed projection. Recommendation – Touch up damage and repaint blue wall. Place fire extinguisher out of path of travel or mount in semi-recessed cabinet.

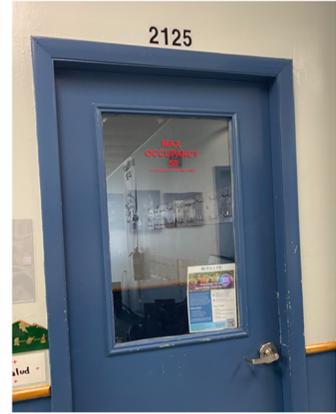
Ceiling	Good condition.
		Doors	Fair condition. Paint scrapes on door and frame. Recommendation – Repaint door and frame.

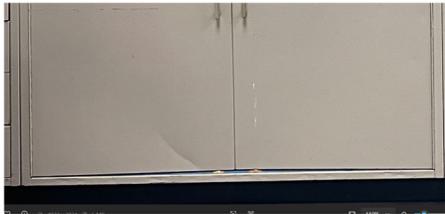
Borrowed Lites	N/A
		Millwork	<p>Fair condition. Door and drawer faces have dents, scrapes, door misalign. Recommendation – Replace cabinetry.</p>

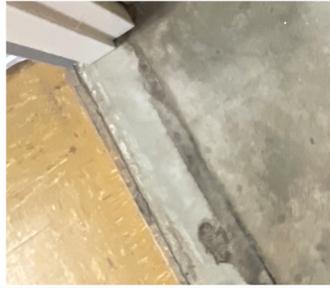
Fair condition – Exterior door. Recommendation – Repaint interior door and frame.
		Borrowed Lites	N/A
		Millwork	Fair condition, no immediate action required.
38.	District Office 2128, 2134		
		Floor	Fair condition. Numerous scrapes.
		Walls/ Columns	Good condition.
		Ceiling	Good condition.
		Doors	Good condition. Some chips and scrapes on exterior of 2134, damaged threshold to storage room. Recommendation – Repaint exterior face of door 2134, replace threshold to storage room.

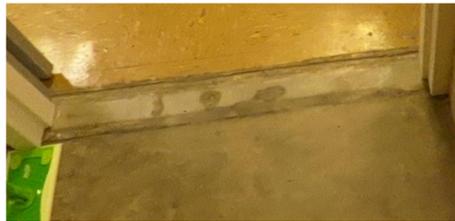
Borrowed Lites	N/A
		Millwork	N/A
39.	Storage for District Office 2128, 2134		
		Floor	Fair condition. Sealed concrete floor. Damaged threshold. Recommendation – Replace threshold to storage room.

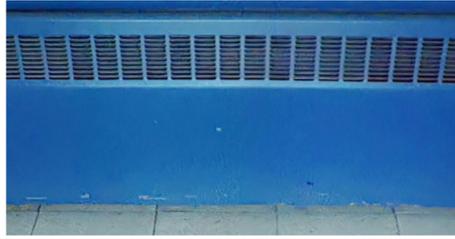
Millwork	Good condition. Exceeds maximum ADA counter height, sink is not accessible, path not accessible.
40.	Connector		
		Floor	Good condition. Most of the floor is covered by walk-off carpet and is not fully assessed.
		Walls/ Columns	Good condition. Window sills have chips, finned tube convector has scrapes. Recommendation – Repaint sills and convector.

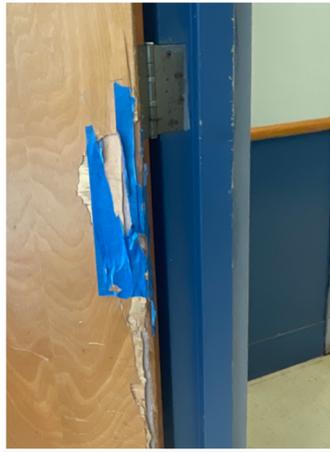
Ceiling	Good condition.
		Doors	Good condition – North door and exterior door. Poor condition – South door. Recommendation – Replace wood south door, paint frame.

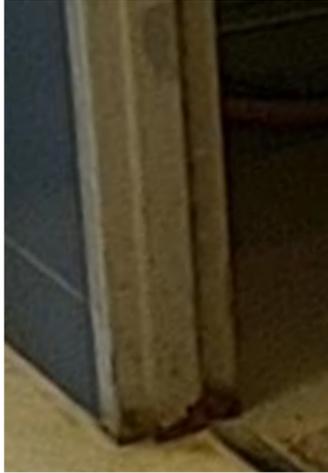
Ceiling	Ceiling obscured by equipment and is not able to be assessed.
		Doors	<p>Fair condition – Interior door. Frame rusted at bottom.</p>

<p>Poor condition – Exterior door. Recommendation – Patch and repaint interior door frame, replace exterior door.</p>
		Borrowed Lites	N/A
		Millwork	N/A
42.	Offices 2130, 2032, 2036, 2038		
		Floor	<p>Fair condition. 2130 has wear pattern at desk. 2132 has mismatched VCT and wear pattern at desk. Recommendation – Replace worn and mismatched VCT, may require replacement of all VCT in room if product no longer available.</p>

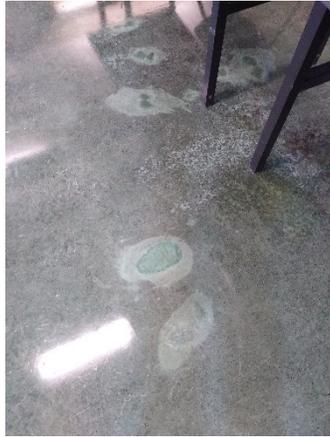
Doors	Good condition.
		Borrowed Lites	N/A
		Millwork	N/A
43.	Multi-Purpose 2131		
		Floor	Fair condition. Some discoloration, surface finish scrapes, chips. No immediate action required.

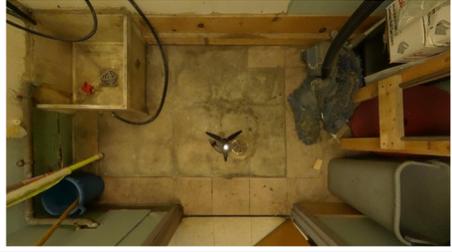
Ceiling	Poor condition. Chipped, cut, stained 2x4 ACT. Chipped, stained grid. Recommendation – Replace ACT and grid.
		Doors	Poor condition. Wear patterns, scratches, discoloration. Recommendation – Replace doors.
		Borrowed Lites	N/A
		Millwork	N/A
45.	Janitor’s Closet 2135		
		Floor	Very poor condition. Portion of VCT missing, remaining VCT is damaged. Recommendation – Replace flooring.

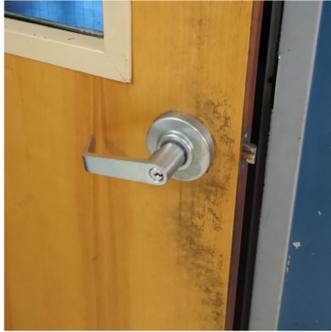
Walls/ Columns	<p>Fair condition. Dings, scratches, scuffs. Windows difficult to open. Shades in poor condition. Recommendation – Patch and paint walls, determine if window operation can be improved, replace shades.</p>
		Ceiling	<p>Poor condition. 2x4 ACT chips, stains. Recommendation – Replace ACT and grid.</p>
		Doors	<p>Poor condition – Entry doors. Worn finishes, chips, scrapes, loose hardware. Recommendation – Replace doors and hardware.</p>

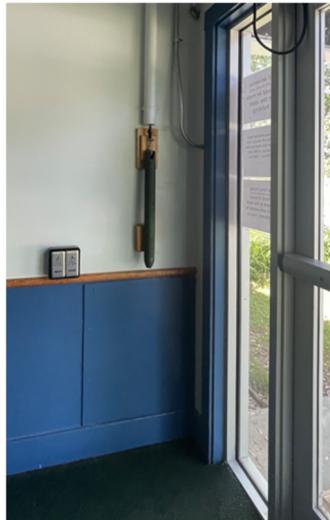
Doors	Fair condition. Operable hardware missing. Recommendation – Install latching leverset or push/pull.
		Borrowed Lites	N/A
		Millwork	N/A
52.	Public Entry – Vestibule & Lobby		
		Floor	Good condition – Vestibule. Poor condition – Lobby. VCT work and large gaps between tiles. Large portion of floor obscured by walk-off carpet and is not fully assessed. Recommendation – Replace lobby VCT.
		Walls/ Columns	Good condition – Vestibule. Some paint discoloration and chips at “wainscot”, unknown device on south wall.

Fair condition – Lobby. Recommendation – Repaint discolored areas, properly conceal device on south wall.
		Ceiling	Good condition – Vestibule. Fair condition – Lobby.
		Doors	Good condition. Aluminum entry doors weatherstripping has gaps. Recommendation – Replace weatherstripping.
		Borrowed Lites	Good condition – door sidelites.
		Millwork	Fair condition – wood wainscot.

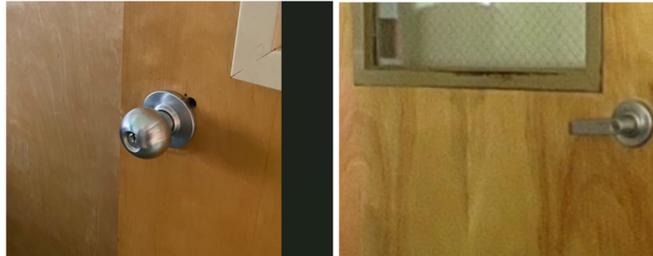
Doors	Fair condition. Office 2148 entry door operating hardware does not conceal holes for previous hardware. Office 2150 entry door lite frame and bottom of door frame have rust. Recommendation – Replace knobs with levers having rosette sized to conceal holes if door is not replaced. Prep and paint rusted elements.

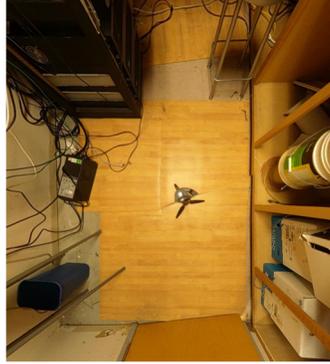
Borrowed Lites	Good condition.
		Millwork	N/A
54.	Computer Room 2152		
		Floor	Poor condition. Random sizes of sheet flooring loose laid on VCT. Recommendation – Install static dissipative flooring.

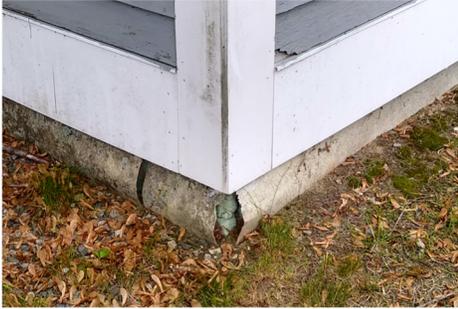
1.	General: Site elements are not included in the scope of work of this review.		
2.	Walls		
		Foundation	Fair condition. Southern portion of building foundation insulation cover has broken / bowed sections. Recommendation – Repair / replace damaged areas.

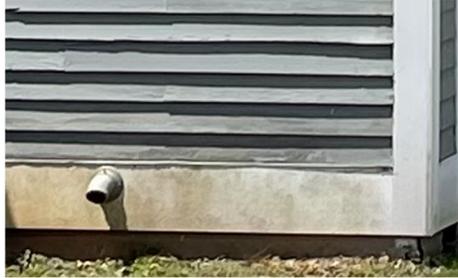
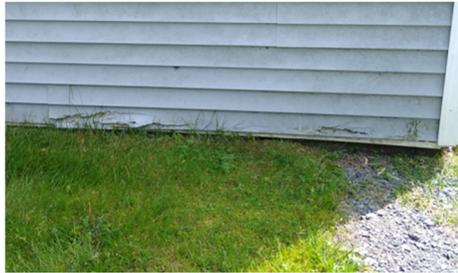
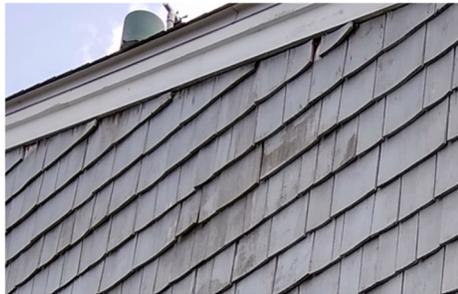
Siding	Poor condition – Southern portion. Wood clapboards have numerous areas of rot. Trim boards under exterior doors have areas of rot. Gable end shakes have areas of cupping and deterioration. Trim boards at bottom of wall show discoloration. All siding and trim should be painted.

Recommendation – Replace wood siding and replace trim under doors. Clean and repaint any wood elements to remain.

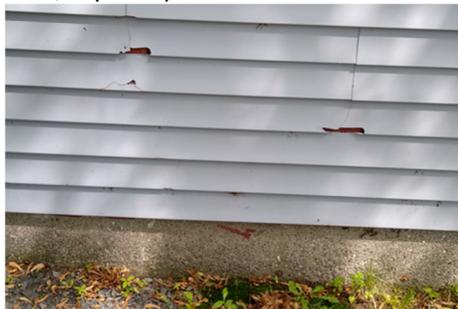
Good condition – North portion. Various locations have cracked / broken vinyl clapboards and broken vinyl trim pieces. Damage and makeshift corner pieces at panels above vinyl clapboards.

Recommendation – Replace broken vinyl clapboards and trim, replace panels.

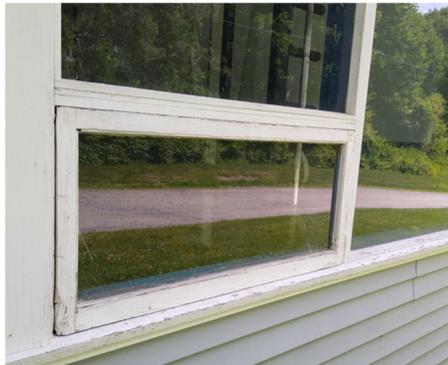
Overall fair condition – South portion. Wood hung windows difficult to open, some screens damaged. Fair condition vinyl, poor condition wood – North portion. Wood windows deteriorated / rotted. Seal is broken on some thermal panes, some screen frames show signs of rust.

Recommendation – Replace wood windows, replace thermal panes with broken seals, replace rusty screens.

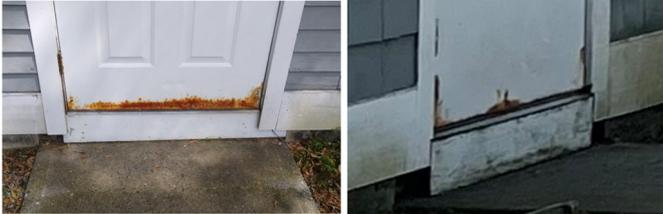
<p>Fair condition – Hollow metal doors. South portion of building has several HM doors with rust at bottom of door.</p> <p>Fair condition – Overhead door. Door has dents.</p> <p>Recommendation – Replace rusted doors, replace dented section of overhead door.</p>

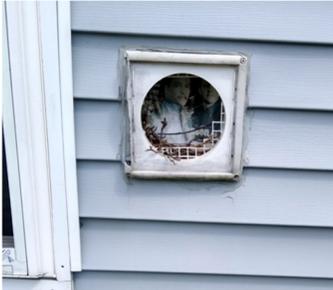
Louvers	<p>Good condition. Two exhaust vents on west side of north portion of building in very poor condition.</p> <p>Recommendation – Replace vents or remove if not in use.</p>

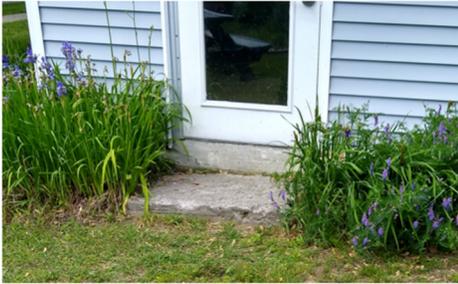
3.	Elements [e.g. Columns]	Hose Bib	<p>Poor condition. Hose bib surround broken at north portion west façade.</p> <p>Recommendation – Replace vinyl trim at hose bib.</p>
		Concrete Pads at Exterior Doors	<p>Poor condition. Cracks and rust at concrete pad at main entry. Crooked concrete pad at exit from Room 2136. Concrete pad eroded at north entry. No concrete pad at stair exit door.</p> <p>Recommendation – Install new concrete pads at exterior doors to meet ADA requirements.</p>

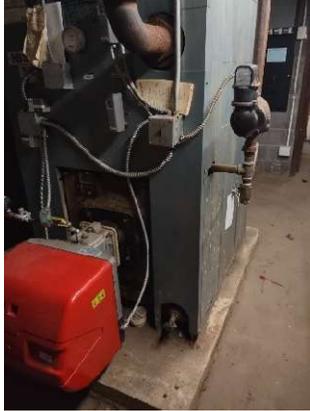
Basement boiler #1 with an oil service burner and boiler. This existing burner/boiler has 3 zones, was combustion tested in 2019, was installed in accordance with code, is well maintained but is at the of its service life. LN Consulting recommends that this equipment be upgraded.

Basement boiler #1 at the end of its service life.

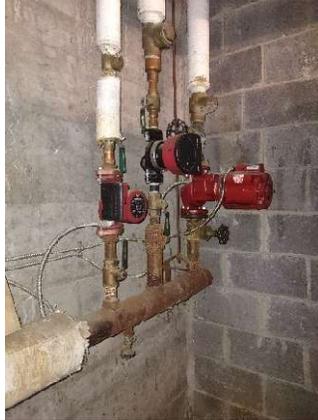
Newer circulation pumps.

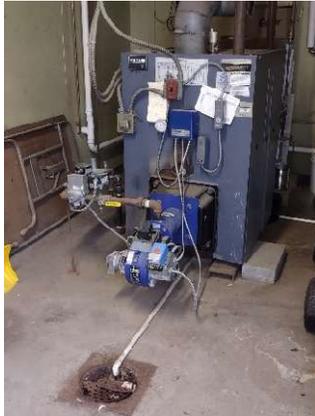
Room 133 boiler #2 with a propane service burner and boiler. This existing burner/boiler has 3 zones, was installed in accordance with code, is well maintained, and 15 years into its 30 year service life.

Room 133 Propane fired boiler #2 – 15 years into 30 year service life.

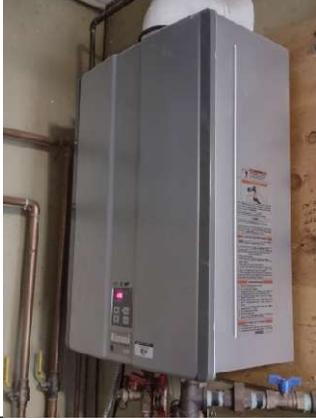
Room 133 boiler #2 Room - Newer hot water heater.

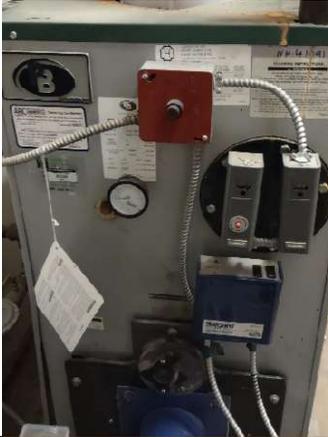
AHU Room boiler #3 with an oil service burner and boiler. This existing burner/boiler has 3 zones, was installed in accordance with code, is well maintained, and 15 years into its 30 year service life.

AHU Room boiler #3 – 15 years into a 30 year service life.

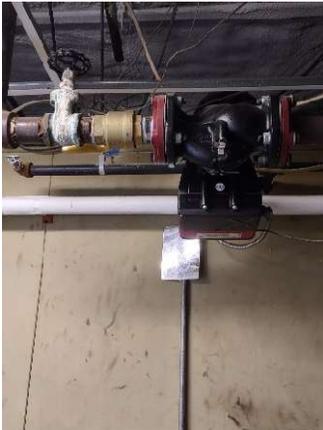
Newer circulation pump.

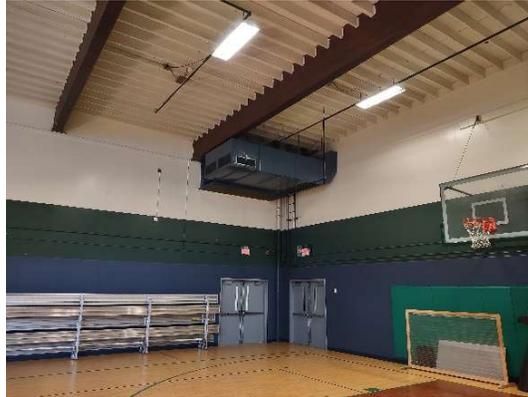
AHU in gym – older unit at the end of its service life.

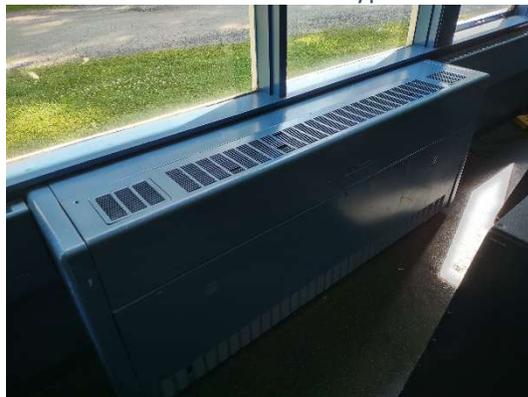
Terminal unit in classroom – typical.

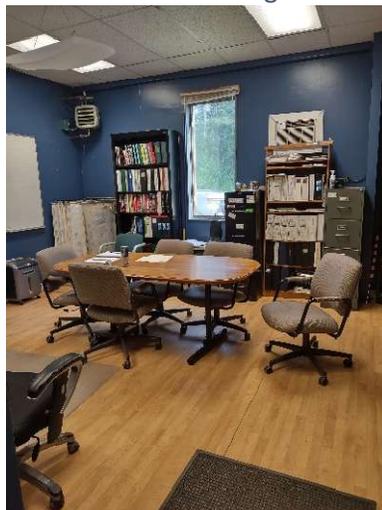
Unit heater and through wall AC in office area.

Secondary areas have aging through wall and window mounted air conditioning units that should be replaced.

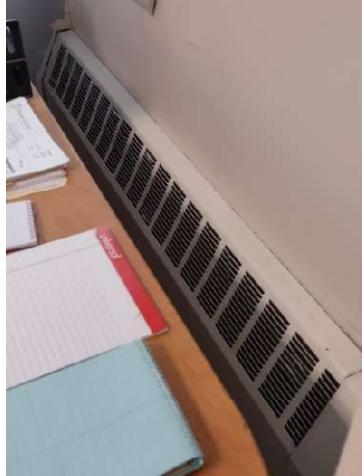
Radiant baseboard – typical.

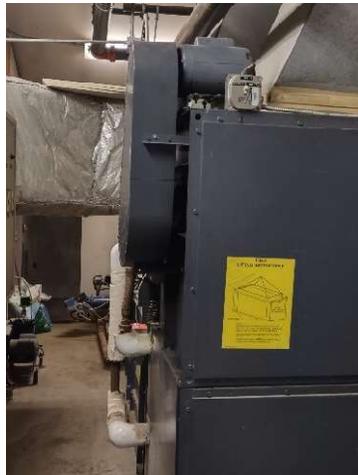
AHU room equipment

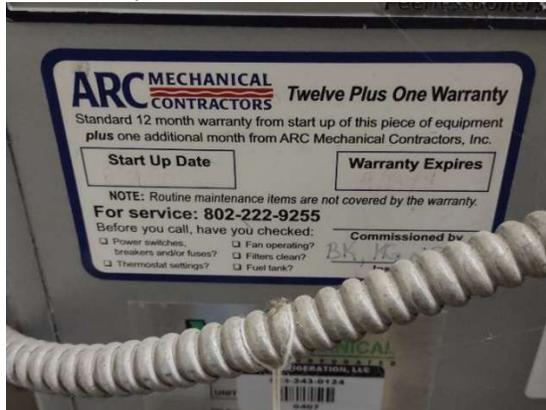
AHU nameplate.

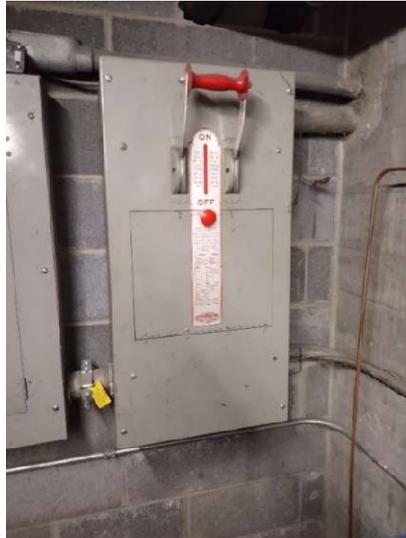
The main service equipment is in the basement. Functional but past its service life.

- The electrical service and some distribution equipment is obsolete and should be replaced as part of any facility upgrade.
- All lighting should be upgraded to LED lighting. This should include emergency lighting for exterior exit paths. Exterior floodlights have LED bulbs but the fixture should be replaced.

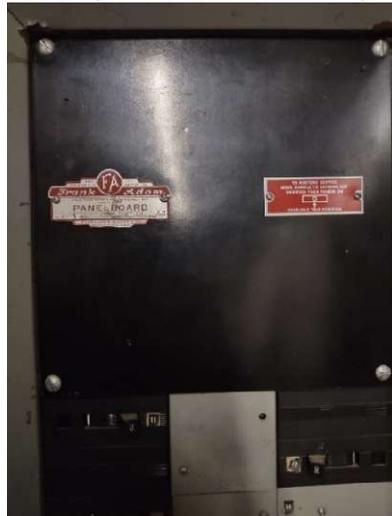
225 amp, 120/240 volt, three phase service panelboard.

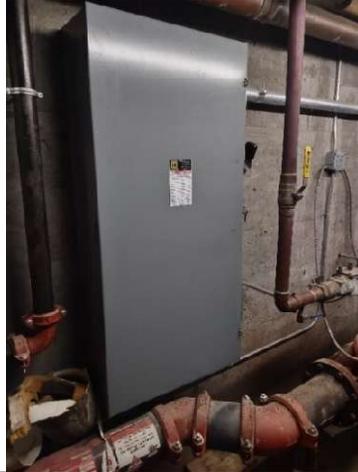
Newer 600A safety switch in very good condition.

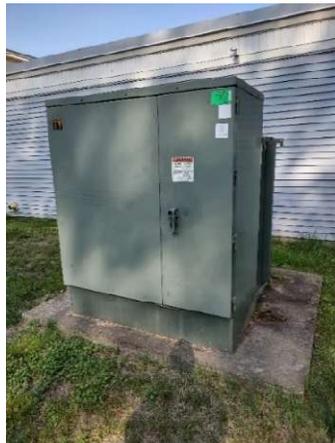
Pad mounted service transformer at the back of the school.

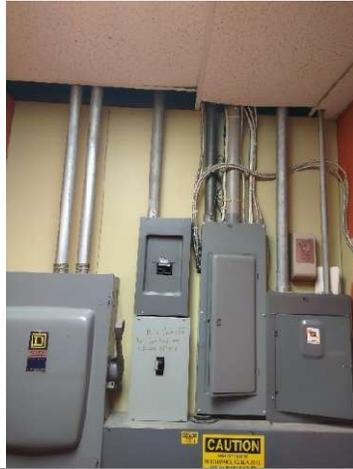
The 1st floor electrical service equipment is in Room 134 - Electrical. Functional but some components are past their service lives.

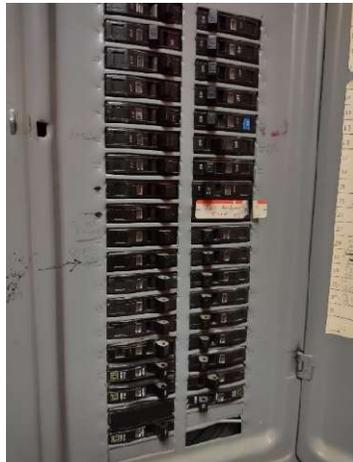
Functional but aging panel.

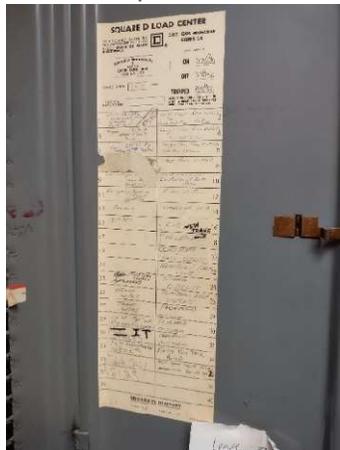
Functional panelboard shows signs of aging.

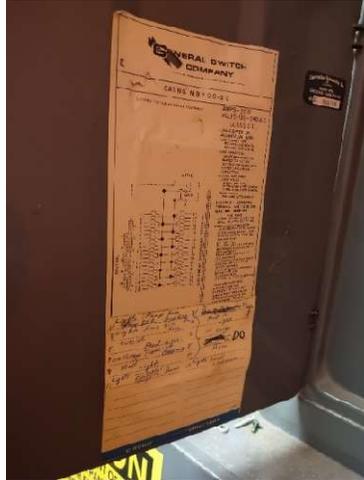
Sub panel original to the facility.

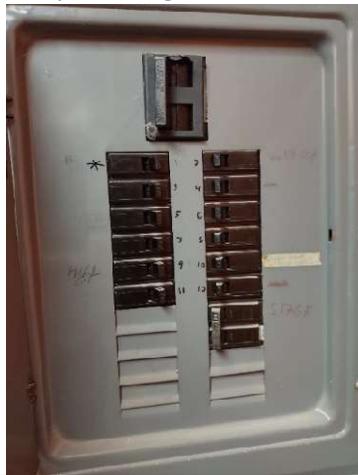
Sub panel original to the facility. Shows signs of age.

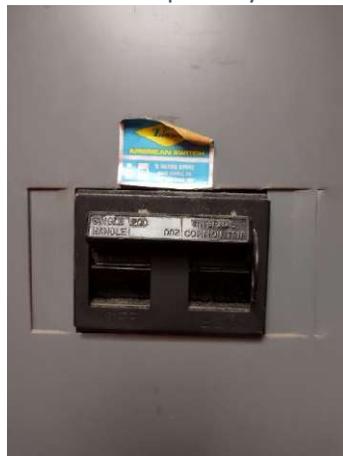
Older 200 amp safety switch.

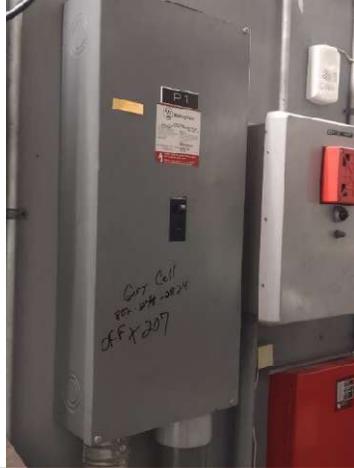
Electrical service disconnect switch to AHUs for gym.

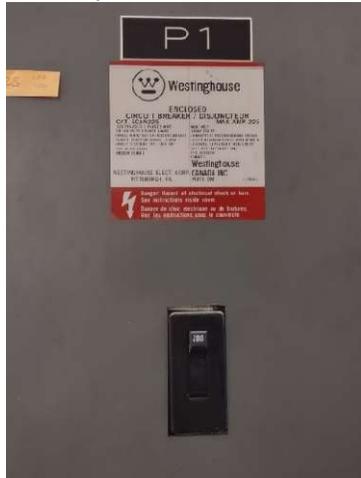
200 amp, 120/240 volt, main breaker – AHU room.

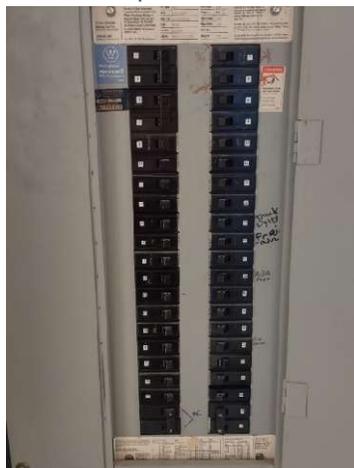
Functional panelboard shows signs of age.

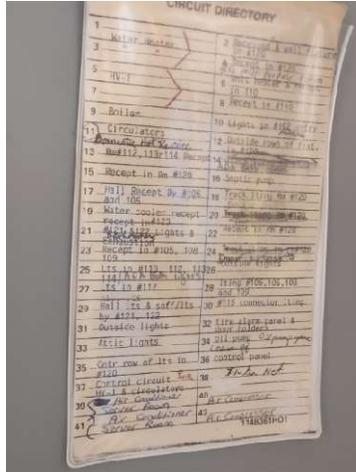
Panel schedule for AHU room.

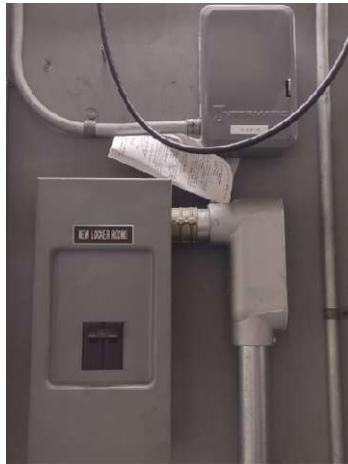
Older disconnect switch.

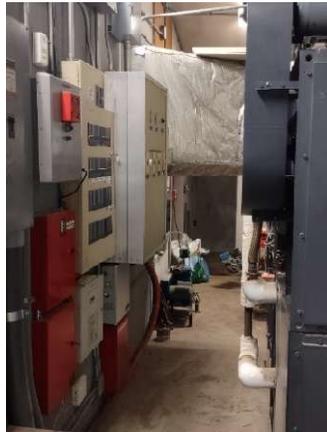
View of AHU room with electrical service panels for gym, HVAC, and FP.

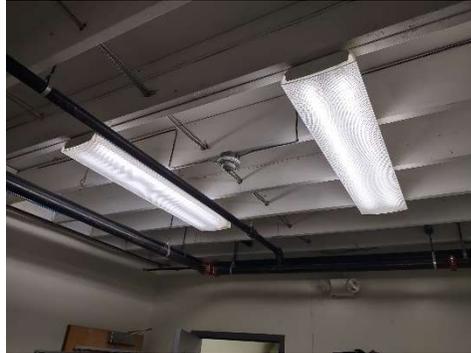
Typical traditional lighting. These tend to provide more glare since they do not “disperse” the light but rather simply shine down. The fixtures appear to still be incandescent and fluorescent type.

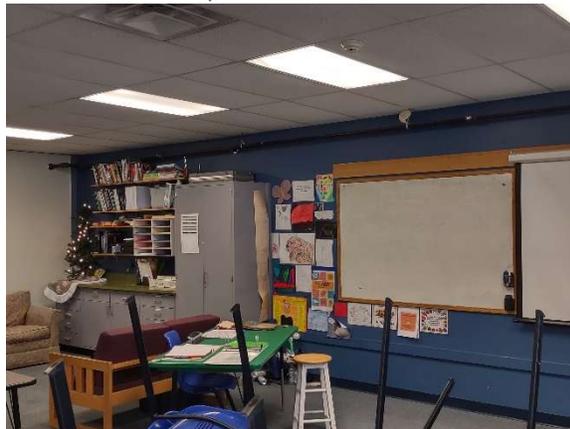
T-8s should be replaced with LED.

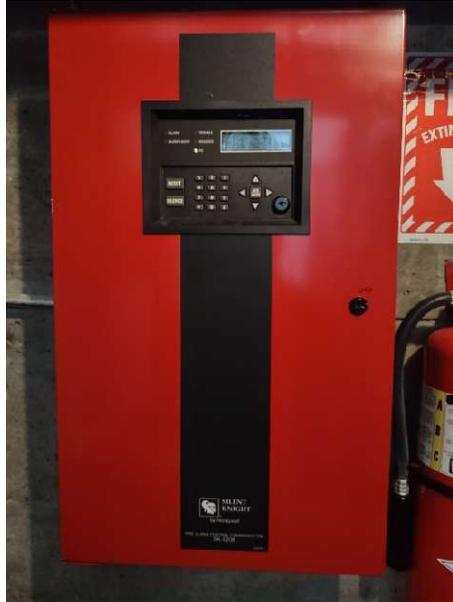
The main fire alarm panel. There were no violation notes on the front cover.

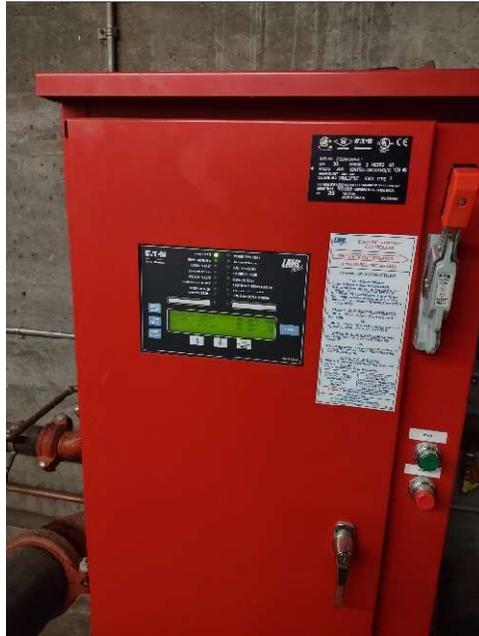
Fire pump controller – recently installed and well maintained.

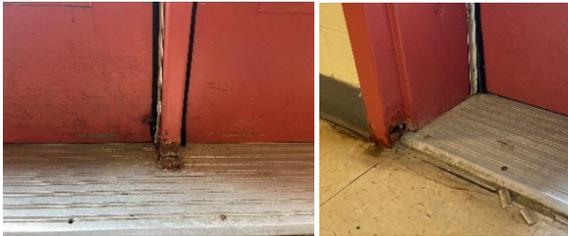
1.	General: Room numbers are per the numbering system within the building.		
2.	North corridor – East (outside kitchen)		
		Floor	Fair condition. Cracked portions of VCT near entrance. Recommendation – Replace cracked VCT.
		Walls/ Columns	Fair condition, no immediate action required.
		Ceiling	Fair condition. Ceiling tiles outside gym entrance door shows signs of water leak. Recommendation – Replace damaged ceiling tiles.
		Doors	Poor condition. Recommendation – replace exterior storefront doors.

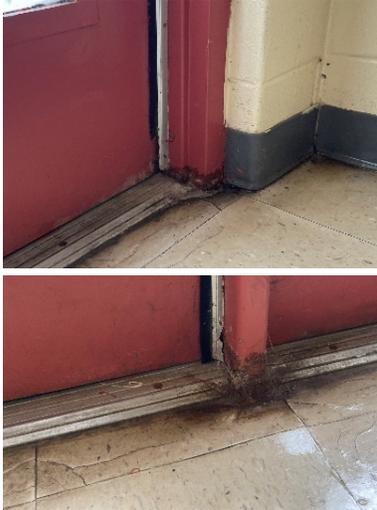
Borrowed Lites	N/A
		Millwork	N/A
3.	North Corridor - West		
		Floor	Fair condition. Cracked portions of VCT near entrance. Recommendation – Replace damaged floor tiles.
		Walls/ Columns	Fair condition, no immediate action required.
		Ceiling	Fair condition. Minimal ceiling tiles show signs of water leak. Recommendation – Replace damaged ceiling tiles.
		Doors	Poor condition.

<p>Recommendation – Replace exterior doors and frames.</p>

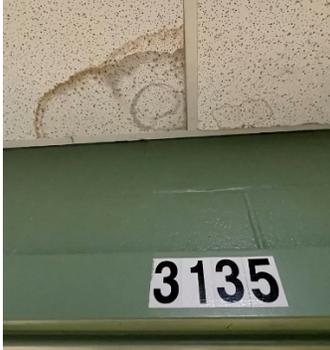
Borrowed Lites	N/A
		Millwork	N/A
4.	Corridor at Southwest Exit		
		Floor	Good condition.
		Walls/ Columns	Good condition.
		Ceiling	<p>Poor condition. Water staining outside room 3135.</p> <p>Recommendation – Replace damaged tiles.</p>

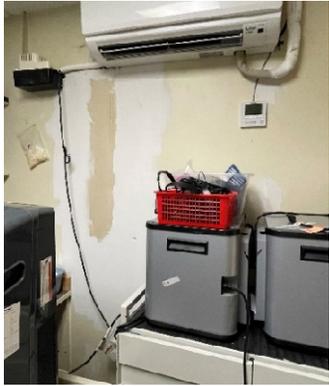
Doors	Good condition.
		Borrowed Lites	N/A
		Millwork	N/A
10.	Conference Room 3113		
		Floor	Fair condition. Wall base is in poor condition peeling away and deteriorating. Recommendation – Replace vinyl base.
		Walls/ Columns	Good condition.
		Ceiling	Good condition.
		Doors	Good condition.
		Borrowed Lites	N/A
		Millwork	N/A
11.	Server Room 3115		
		Floor	Poor condition. VCT shows wear, fading. Recommendation – Replace VCT; determine if static dissipative flooring is required.
		Walls/ Columns	Poor condition. Recommendation – Patch and paint several areas.

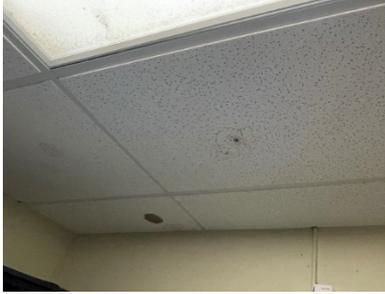
Ceiling	Fair condition. ACT stained at multiple locations, light fixtures have debris. Recommendation – Replace tile, clean light fixtures.

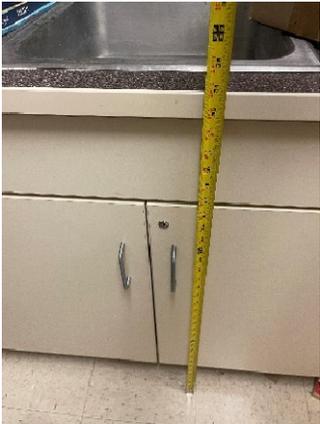
Doors	Good condition.
		Borrowed Lites	N/A
		Millwork	Shelves protruding beyond 4" allowed by ADA regulations. Recommendation – Address ADA cane detection requirements.
12.	Room 3117		
		Floor	Fair condition, no immediate action required.
		Walls/ Columns	Fair condition. Mainly concealed by shelving so only visible portion assessed.
		Ceiling	Fair condition. ACT has one tile with water damage. Recommendation – Verify there is no active leak and replace damaged tile.
		Doors	Good condition.
		Borrowed Lites	N/A
		Millwork	Fair condition. Materials in fair condition but the cabinet height is not in compliance. Base cabinets at 34.5" with non-accessible sink. Recommendation – Replace cabinets and sink with ADA compliant units.

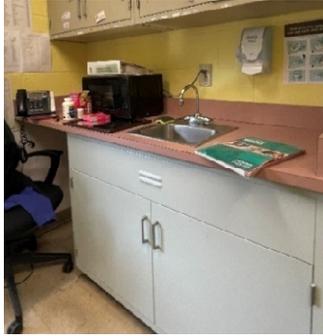
<p>additional door for students to reach the nurses office other than through the adjacent restroom space.</p> <p>Recommendation – Provide access to Nurse 3121 through space other than adjacent restroom.</p>
		Borrowed Lites	Good condition.
		Millwork	<p>Poor Condition. Nurse’s Station counter height not in compliance with ADA standards. No ADA access to the sink.</p> <p>Recommendation – Install new ADA open cabinet below sink and 34” counter above base cabinets. Install new door to the right (leading to Office 3135) of the cabinets.</p>

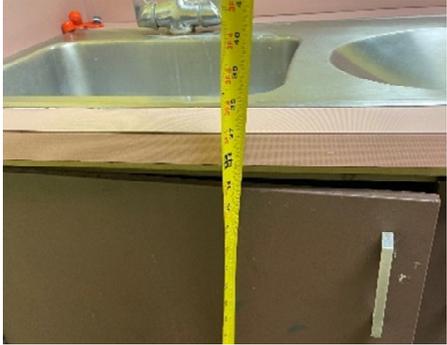
16.	Bathroom at Nurse 3121		
		Floor	Good condition.
		Walls/ Columns	Good condition.
		Ceiling	Good condition.
		Doors	Good condition.
		Borrowed Lites	N/A
		Millwork	<p>Poor condition. Counters not in compliance and in poor condition.</p> <p>Recommendation – Install new ADA sink at 34” height.</p>

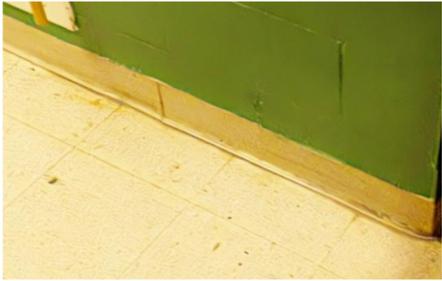
Walls/ Columns	<p>Good condition. Wall base is discolored. Recommendation – Replace wall base.</p>

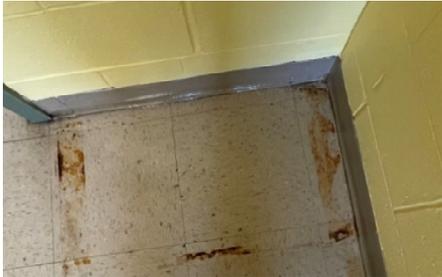
18.	Office 3123		
		Floor	<p>Fair / Poor condition. Majority of VCT is in fair condition, however, there are isolated areas where furniture locations have left damage and discoloration.</p> <p>Recommend – Replace stained and damaged tiles.</p>

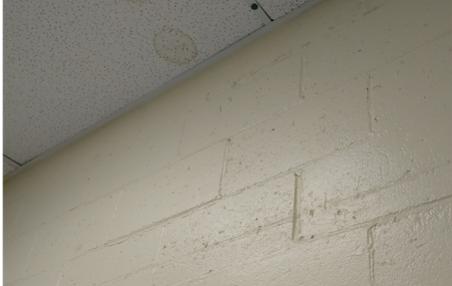
21.	Rooms 3126, 3130, & 3132		Note Room 3132 not reviewed as space was occupied; assuming similar conditions as adjacent classrooms.
		Floor	Poor condition. Gaps between VCT tiles and cracked corners. Recommendation – Replace VT tiles throughout space.
		Walls/ Columns	Fair condition – CMU; no immediate action required. Some rough areas.

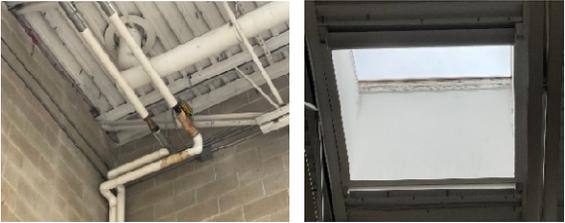
Ceiling	<p>Fair condition. Skylights have visible signs of water penetration. Water leaking at pipes at ceiling.</p> <p>Recommendation – Investigate skylight leaks for repairs, repair leaks at pipes.</p>

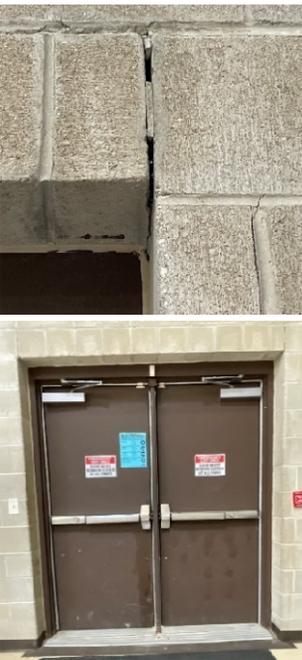
Doors	<p>Fair condition. Dings and dents at all doors, water damage / rust at base of hollow metal doors. Caulking joint above door deteriorating.</p> <p>Recommendation – Repair / replace mortar and soft joints above exterior doors. Repair damage to doors and frame or replace.</p>

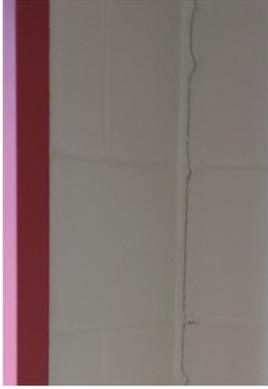
Recommendation – Replace damaged tiles.
		Walls/ Columns	<p>Fair condition – CMU. Crack at corner near exterior door.</p>

<p>Poor condition – Wall base and GWB finish. Recommendation – Replace wall base, patch and paint GWB, create soft joint at CMU crack and paint to match wall.</p>
		Ceiling	<p>Fair condition. Some ACT stained. Recommendation – Replace stained tiles.</p>
		Doors	<p>Poor condition. HM frames fair condition, door seals missing under exterior door. Recommendation – Replace door seals.</p>
		Borrowed Lites	Fair condition, no immediate action required.
		Millwork	<p>No clear floor area ADA access at sink. Wall base as backsplash behind sink in poor condition. Recommend replacement of sink cabinet to meet ADA requirements. Replacement of backsplash.</p>
