FACILITIES CONDITION ASSESSMENT

Rivendell Interstate School District

Rivendell Academy East & West Wings | Samuel Morey Elementary | Westshire Elementary

September 25, 2025

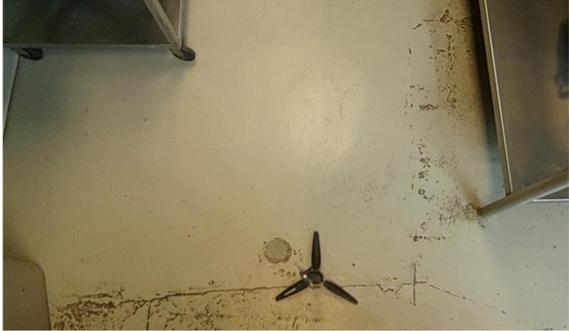
Recommendation – Replace sink cabinet to meet ADA requirements. Replace backsplash.
32.	Kitchen 3151		
		Floor	<p>Poor condition. Paint finish worn away in many locations, cracks in concrete.</p> <p>Recommendation – Repair cracks, install new seamless flooring and integral wall base suitable for kitchen sanitation requirements.</p>

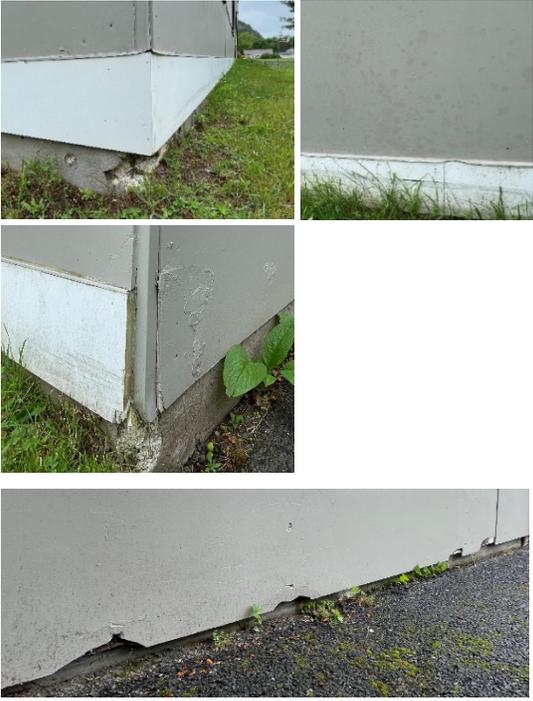
1.	General: Site elements are not included in the scope of work of this review.		
2.	Walls		
		Foundation	<p>Fair condition. Synthetic stucco over insulation board generally in fair condition; corner conditions throughout the building show significant deterioration.</p> <p>Recommendation – Repair corner conditions, patch, repair refinish to match existing.</p>

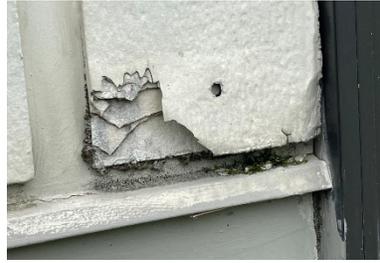
Isolated areas of siding discoloration for various reasons.

Recommendation – Repaint all discolored areas. Patch, repair refinish to match existing. Approximately 10% of façade.

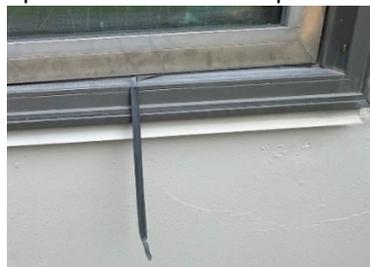
Additional areas of siding damage at windows specifically. Refer to above siding section for recommendations.

Approximately 90% of windows.

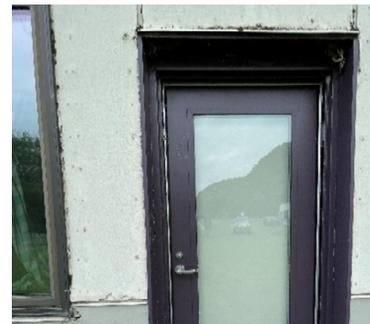
Additional areas of siding damage at doors specifically. Refer to above siding section for recommendations.

Approximately 80% of doors.

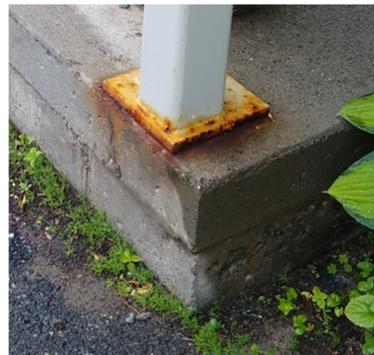
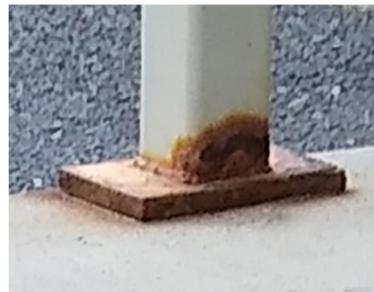
Rusted post base plate and bottom of posts (5 posts).

Recommendation – Replace posts and base plates.

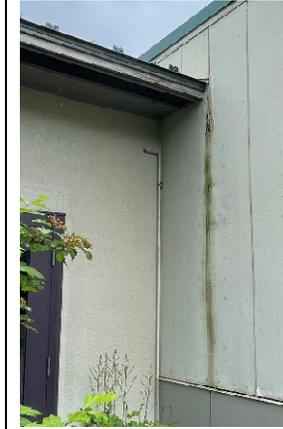
Fair condition. Low Slope Roof single-ply EPDM membrane at gym installed c.1999 so may be approaching end of service life. Pitched Roof standing seam metal installed c.2019. Water shedding from pitched roof on south side above Media Room is deteriorating siding below. Recommendation – Install rain diverter or gutter to protect siding.

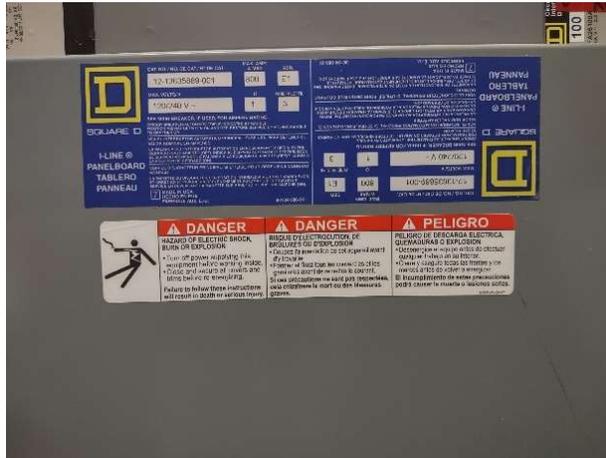
Older panelboard with fire emergency circuit.

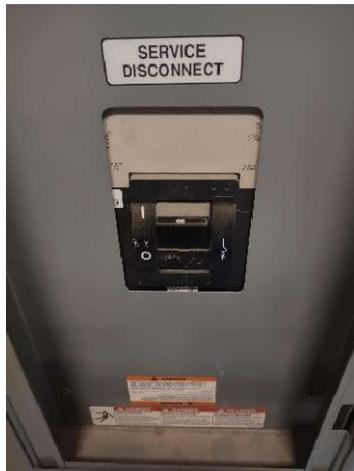
Old main circuit breaker.

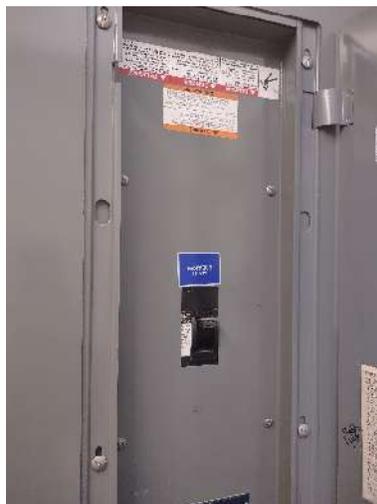
Older main breaker.

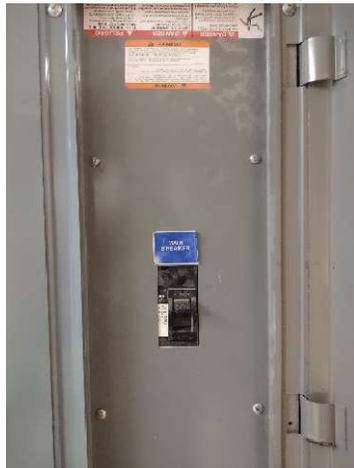
Main breaker showing signs of age.

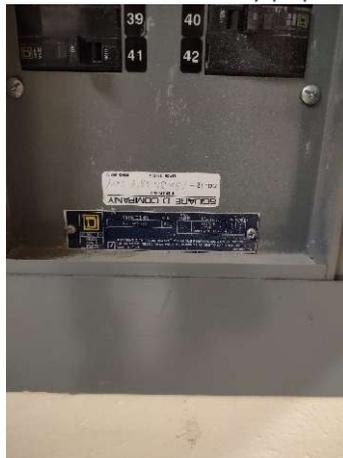
Older breakers in fully populated panel.

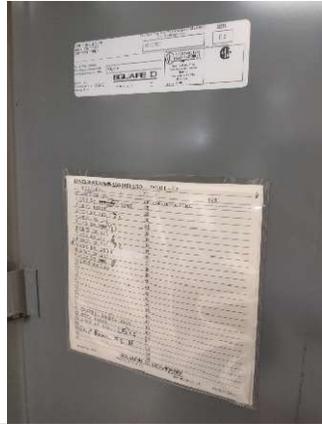
Panelboard near end of service life.

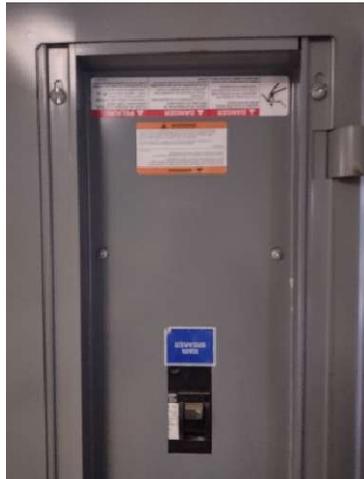
Older main breaker.

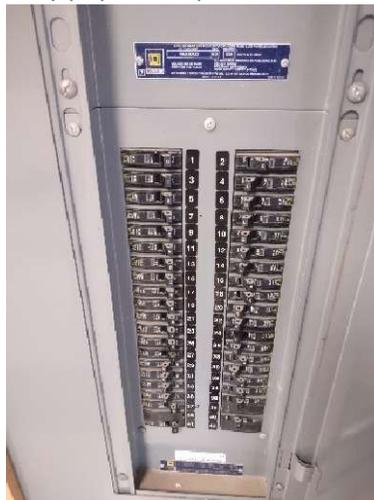
Fully populated panel with older breakers.

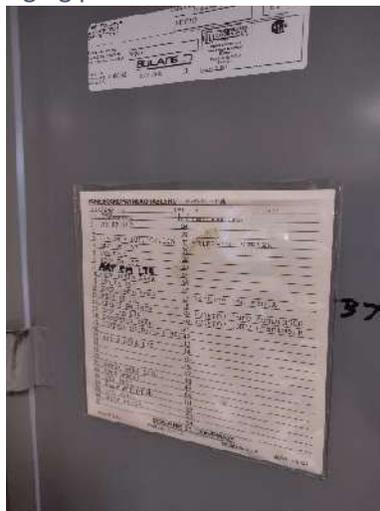
Aging panelboard.

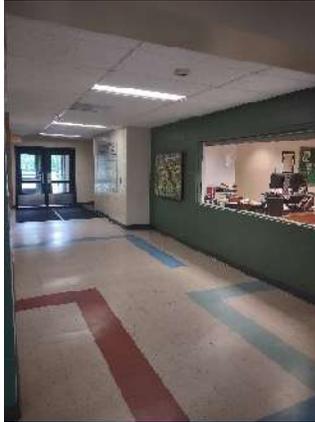
Typical traditional lighting. The fixtures appear to still be incandescent and fluorescent type.

The main recommendation that is not a safety issue is the replacement of the existing lighting with LED type. In conjunction with this, the controls would be upgraded to provide occupancy sensor control and dimming. The simplest way to accomplish this may be to provide new light fixtures with integral wireless controls. This would significantly reduce the amount of recircuiting required. There may be some incentives to upgrade.

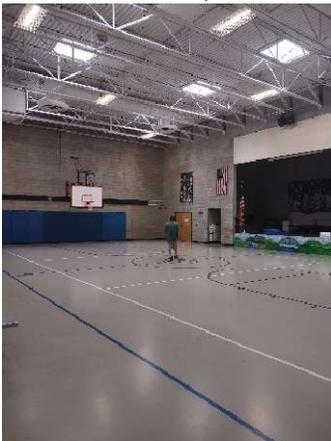
T-8s should be replaced with LED.

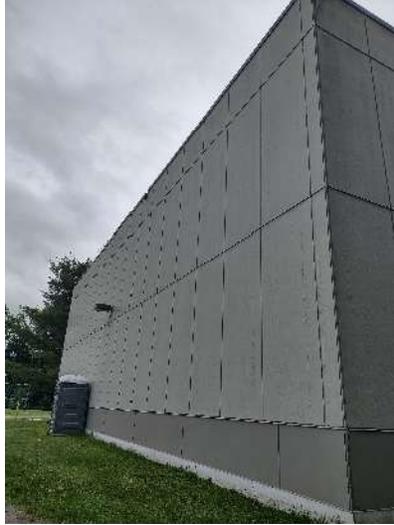
Exterior flood lights to be upgraded.

- Some electrical distribution equipment is obsolete and should be replaced as part of any facility upgrade.
- All lighting should be upgraded to LED lighting. This should include emergency lighting for exterior exit paths. Exterior floodlights have LED bulbs but the fixture should be replaced.

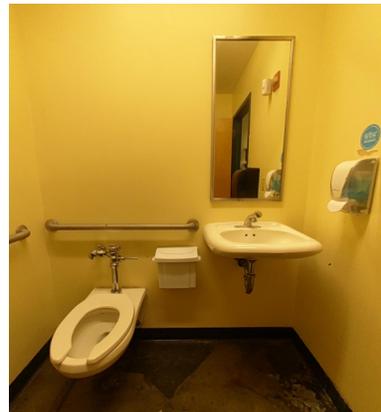
<p>Paper towel dispenser exceeds 4" protrusion limit.</p>

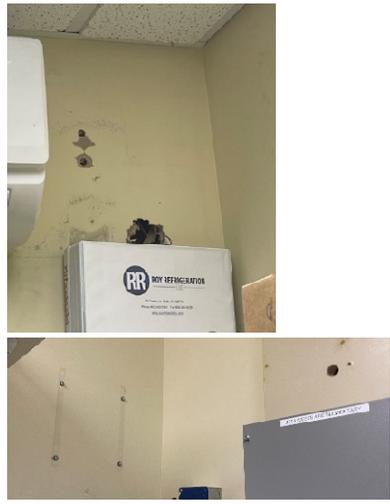
Ceiling	Good condition.
		Doors	Good condition.
		Borrowed Lites	N/A
		Millwork	N/A
11.	Server 4106		
		Floor	Poor condition. Concrete floor has a large crack extending the width of the door at entry. Recommendation – Repair crack and seal concrete.
		Walls/ Columns	Fair condition some holes.

Recommendation - Patch holes, repaint wall.
		Ceiling	Good condition. There is a roof hatch ladder going in good condition. Hatch above has visible light coming through does not appear to be sealing properly. Recommendation – Review and repair or replace roof hatch.

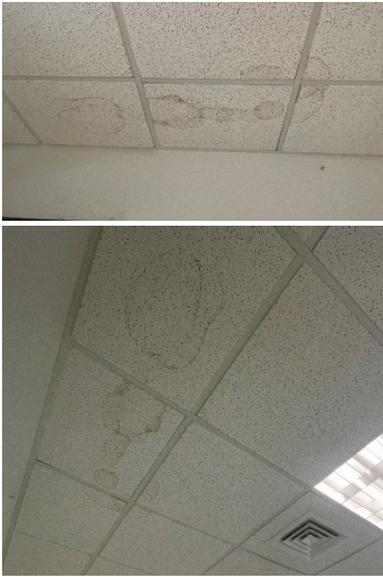
Ceiling	<p>Fair condition. Water Damage at a couple ceiling tile near diffuser Recommendation – Replace stained ceiling tiles.</p>

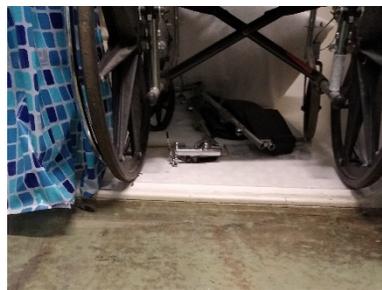
Millwork	Fair condition however does not meet ADA requirements - 39" sink height. Recommendation – Install sink at ADA height. Fair condition - Shower portion. Recommendation reseal around shower.
--	--	----------	------------------------------------------------------------------------------------------------------------------------------------------------------------------------------------------------------

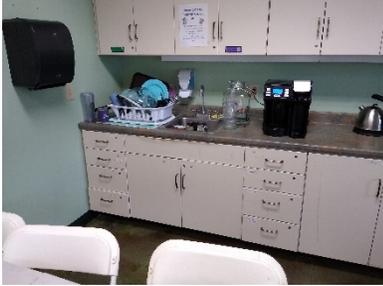
<p>Millwork in Fair condition however does not meet ADA requirements - 38" sink counter laminate but no clear ADA access below. Recommendation – Install ADA access sink cabinet with proper counter height. Overhead storage adjacent to entry door. Recommendation – Remove or move shelving up to provide min. 6'-8" head clearance.</p>

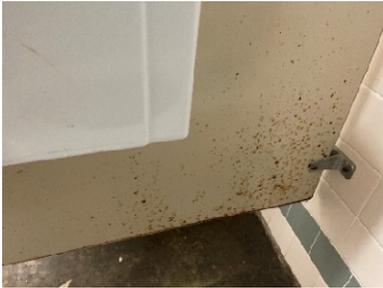
Borrowed Lites	N/A
		Millwork	Poor condition. Rusted out base of partitions.

Recommendation – Replace partitions.
30.	Room 4129 Boys Restroom		Poor condition. Rusted out base of partitions.

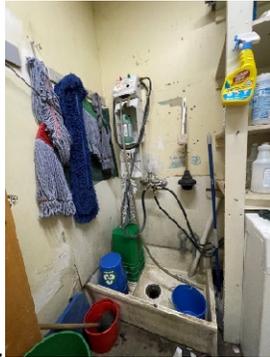
32.	Janitor Closet 4134		
		Floor	Poor condition concrete floor. Owner to review to determine if suitable for janitorial closet.

Recommendation – Renovate space with new flooring, sink, GWB.
		Walls/ Columns	Scrapes and gouges around sink area, rough edges at sink backsplash. Recommendation – Repair and repaint wall.
		Ceiling	Fair condition, no immediate action required.
		Doors	Fair condition, no immediate action required.
		Borrowed Lites	N/A
		Millwork	Fair condition. Suitable given use of space.

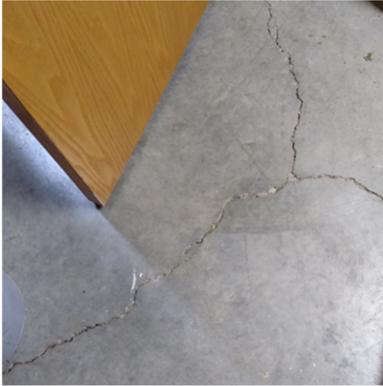
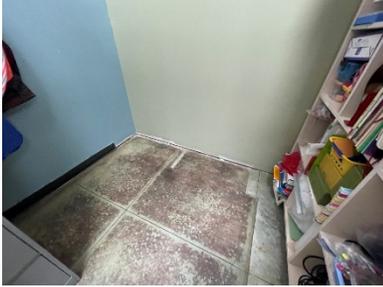
34.	Mechanical Room 4136		
		Floor	<p>Floor obscured by stored material so only able to assess portion near entry door which has significant crack.</p> <p>Recommendation – Repair crack.</p>

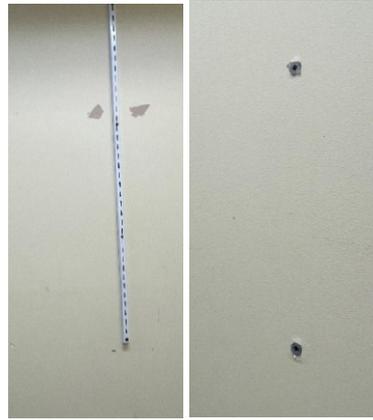
Walls/ Columns	Walls obscured by stored material, unable to assess.
		Ceiling	Exposed structure.
		Door	<p>Poor condition, door missing panic bar. Missing Exit Sign.</p> <p>Recommendation – Install exit sign above door and required panic hardware devices.</p>
		Borrowed Lites	N/A
		Millwork	N/A
35.	Storage 4141		
		Floor	Good condition.
		Walls/ Columns	<p>Fair Condition. Holes and damage.</p> <p>Recommendation – Patch and paint.</p>

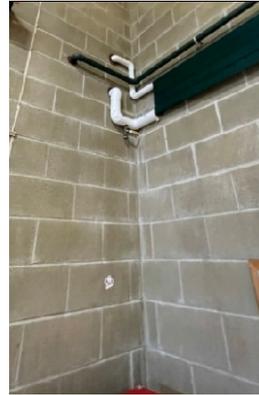
37.	Gym Room 4145		
		Floor	Fair condition, no immediate action required.
		Walls/ Columns	Fair condition. Scuffs, scratches, marks typical for use of space.

Recommendation – Spot clean marked areas.

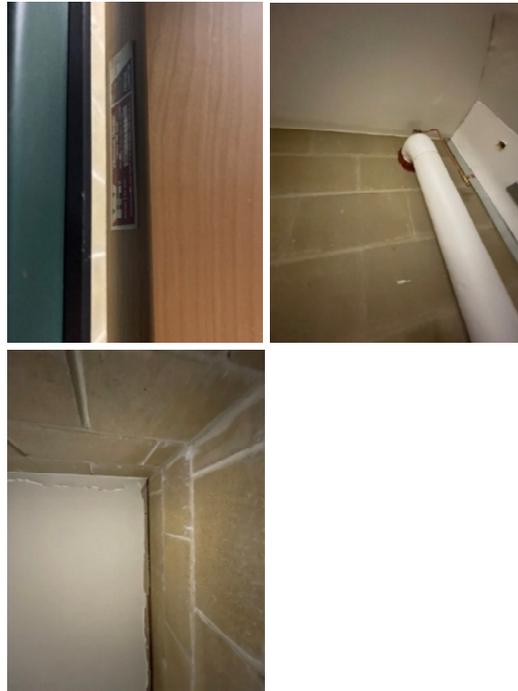
<p>Space is in good condition overall; however, door is rated but only portions of the wall are sealed to meet the required 2-hour rating.</p>

Recommendation – Verify the seal is complete around the perimeter of the mezzanine mechanical space. If not complete, then apply proper seal.

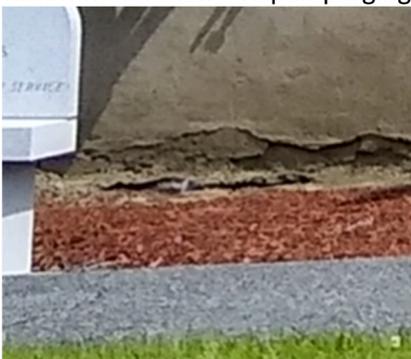
1.	General: Site elements are not included in the scope of work of this review.		
2.	Walls		
		Foundation	
			<p>Concrete foundation in poor condition. Foundation parging at south façade deteriorating where it meets the ground and to the right of the entry door. Recommendation – Repair parging.</p>

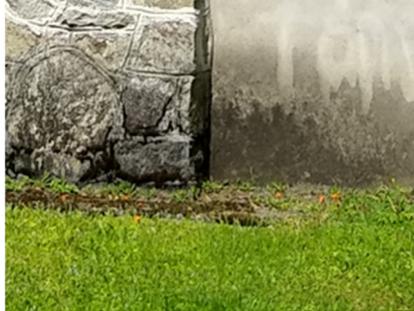
Stone foundation and window infill panels at east façade are discolored where they meet the ground. Recommendation – Clean materials and assess for damage.

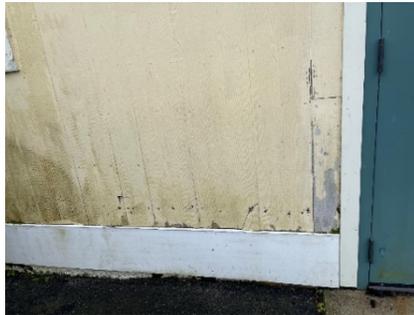
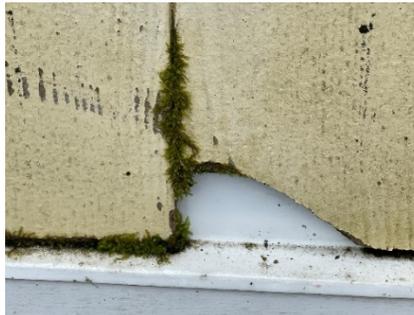
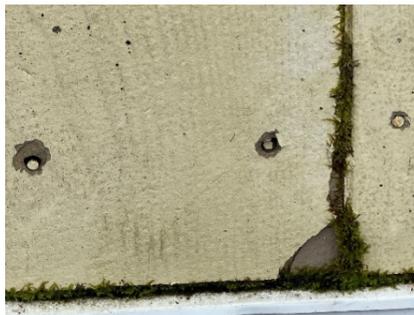
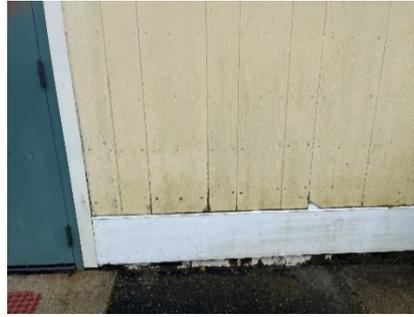
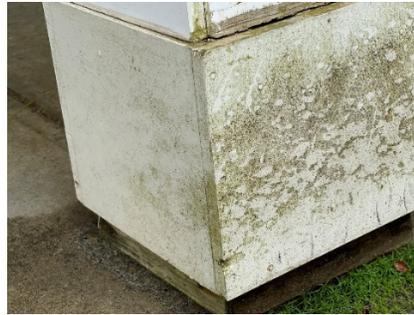
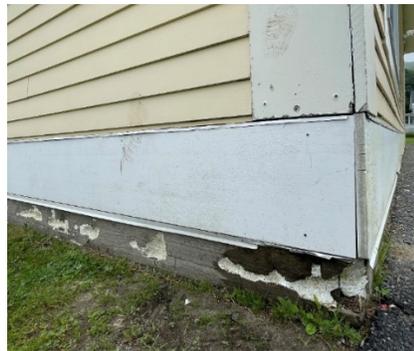
Poor condition. See below photos for a wide variety of siding issues rendering the need for replacement. Recommendation – Replace siding and all associated trim. Confirm no water damage behind siding.

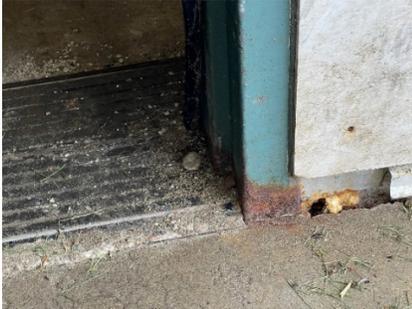
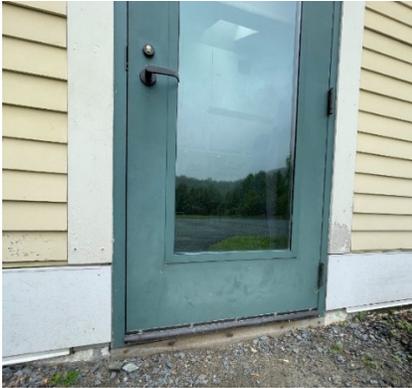
Doors	<p>Poor condition. Damaged base of door and frame, rusted, worn, and faded. Recommendation – Repair doors and replace door / frame where necessary.</p>

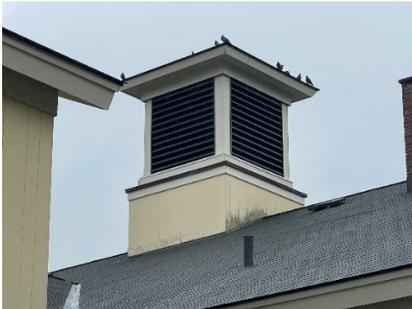
Louvers	N/A
		Soffits	Fair condition.
		Fascia	Discoloration and damaged trim at west façade. Recommendation – Clean, repair/replace, repaint.
3.	Elements [e.g., Columns]		<p>Siding Damage at base of Roof cupola. Cannot confirm if there is roof damage. Recommendation – Consult a roofing contractor to determine the probable cause of the leaks and to develop a plan to remediate them.</p>

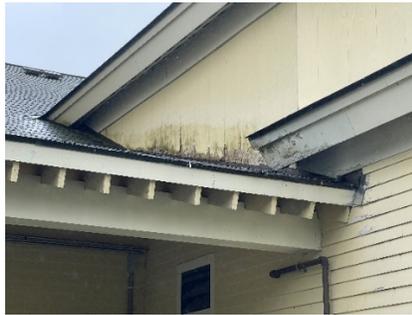
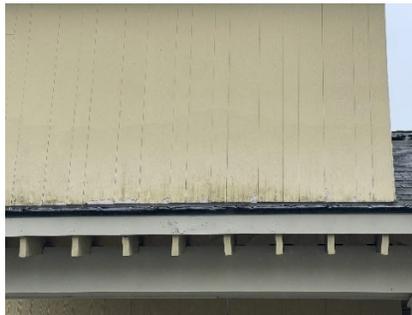
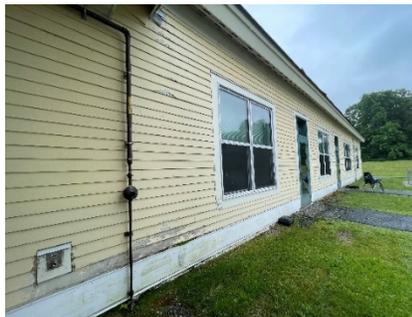
Poor condition, particularly at roof to wall intersection. Large area where the gabled roof meets the higher wall there are signs of significant water damage. The roof and wall damage tracks to the ground.

Recommendation – Consult a roofing contractor to determine the scope of work for the roof and best method to remediate the wall intersection problem.

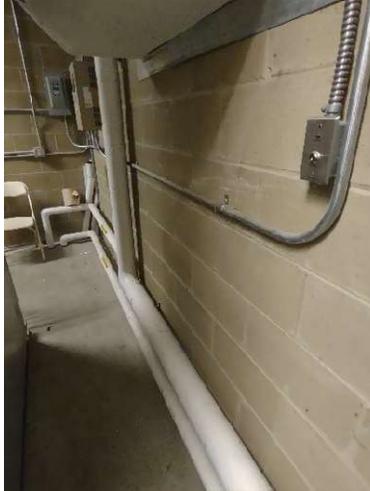
AHU Room piping arrangement.

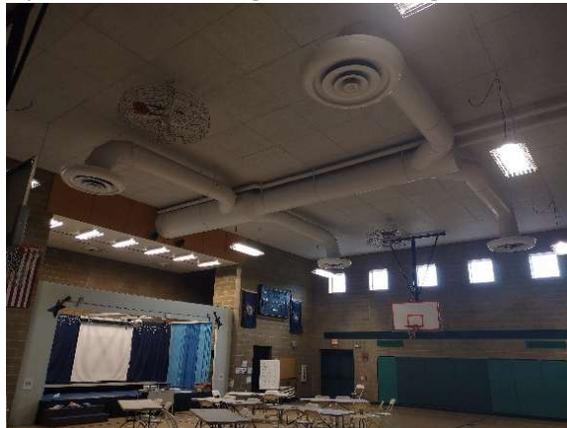
Gym ductwork arrangement and large fans.

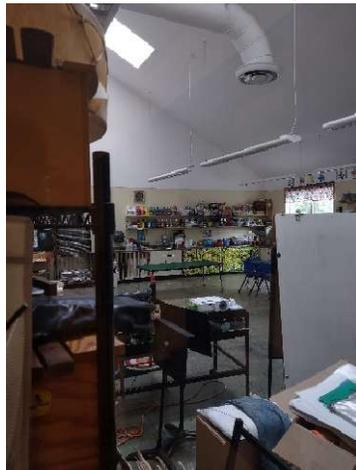
Ductwork diffuser arrangement in classroom – typical

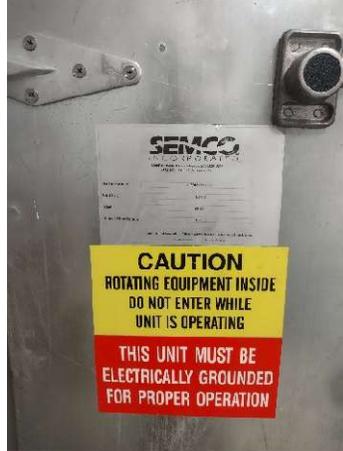
AHU Room above boiler room – product data

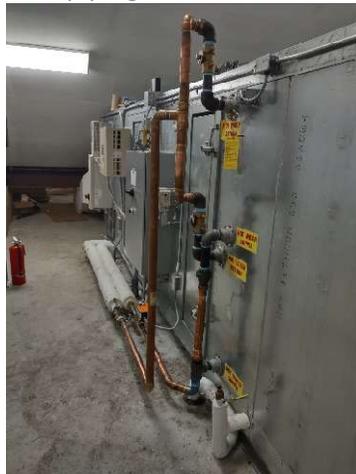
AHU piping connections and controls

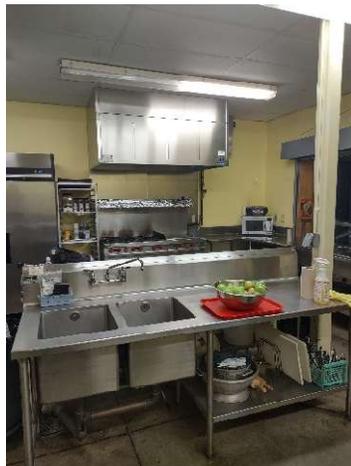
Grill hood in kitchen.

- Remove abandoned circulation zone pump.
- Remove abandoned condenser units outside in the back of facility.
- Repair and replacement of heating system piping insulation. Inspect heating system piping.
- Clean split duct cooling system for offices.
- Paint mechanical rooms and repair through wall penetrations
- Replace kitchen hood.

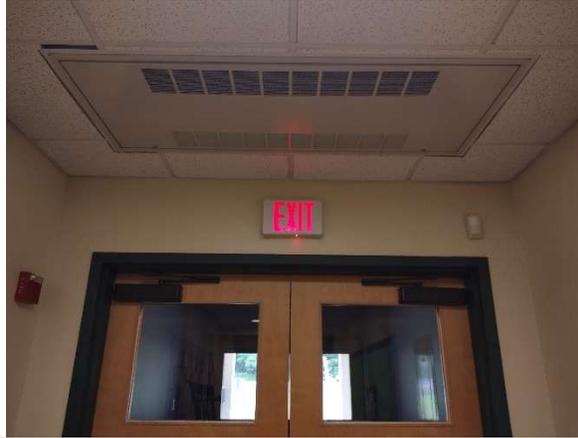
Heaters at entrances – typical.

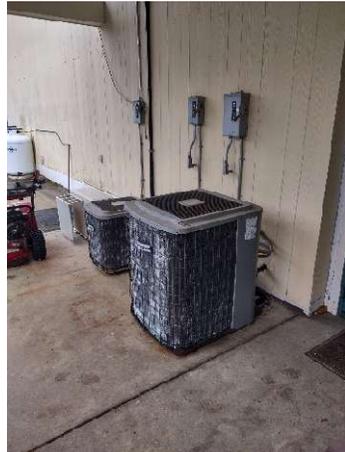
Older outdoor condenser units.

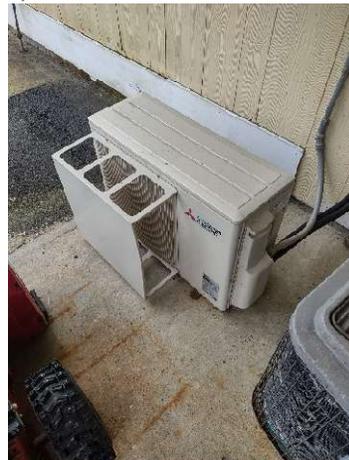
Split duct condenser unit.

- Replace heating system circulation pumps and VFDs.
- Replace split duct cooling systems.
- Replace window mounted AC units.

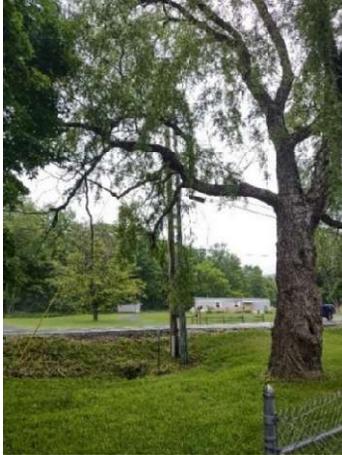
Pole mounted transformer electrical service feed underground to electric vault.

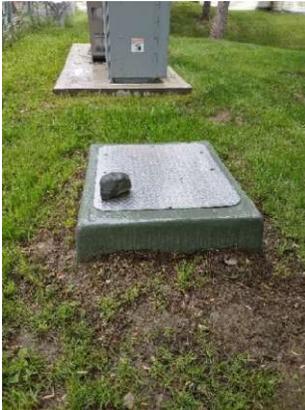
Electrical service vault manhole, generator, and ATS pad.

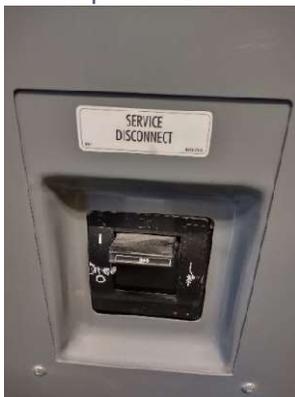
800 amp Main Breaker

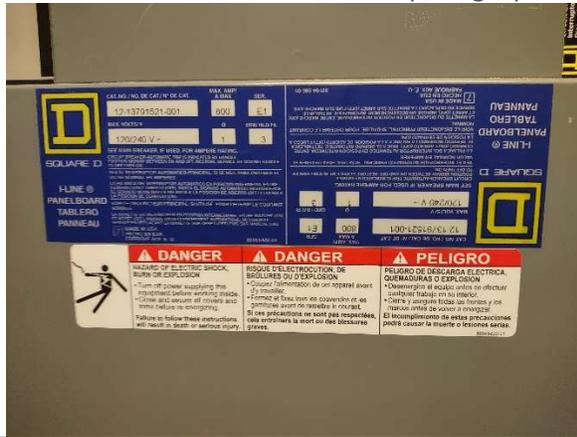
Service Main Panelboard. 800 amp, single phase.

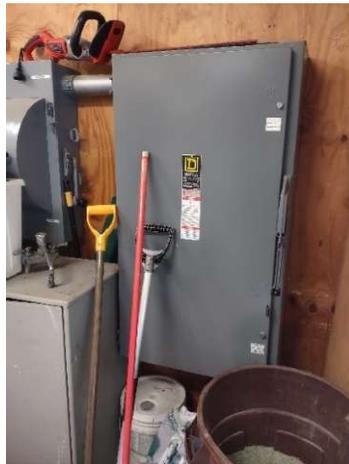
400 amp disconnect-double trouble safety switch for a generator. Switch is off.

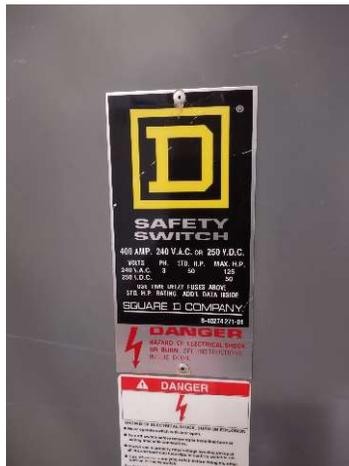
Electrical service to boiler room.

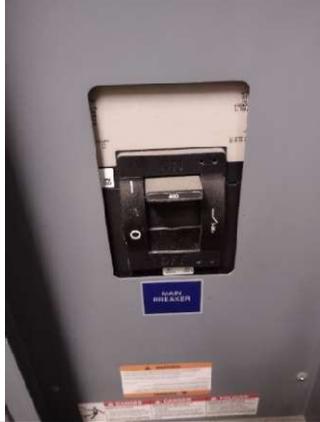
400 amp breaker for boiler room.

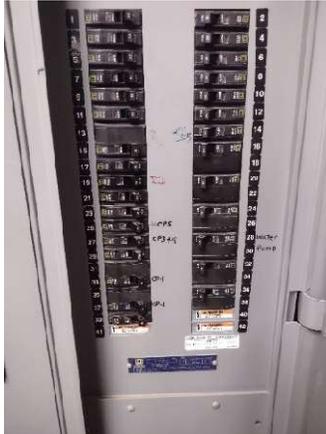
Panelboard for boiler room.

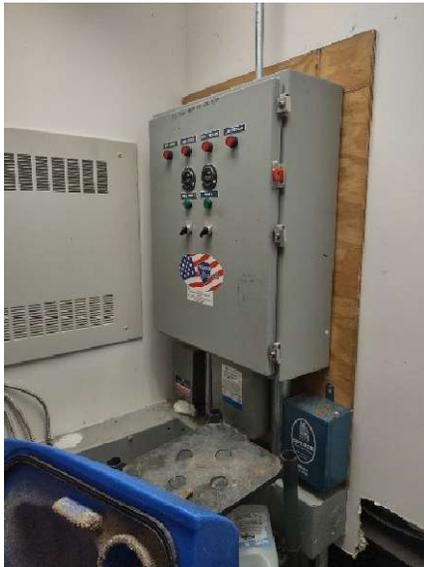
Control panel for well pumps.

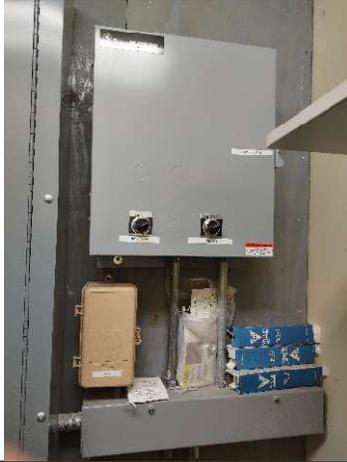
Automatic switches for pole and building lighting circuits.

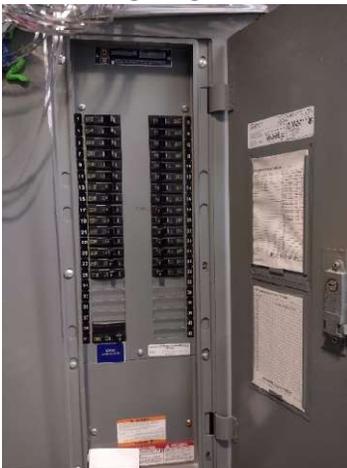
Panel for lighting and outlets – typical.

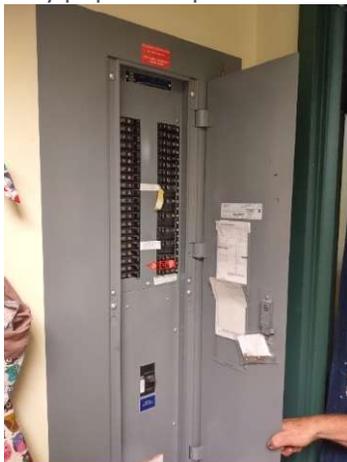
Fully populated panel with emergency fire circuit.

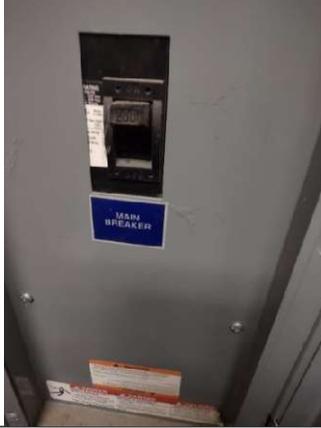
200 amp breaker for kitchen.

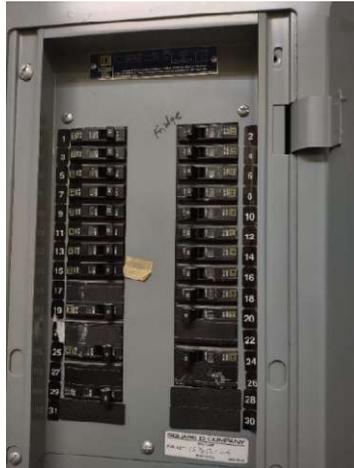
Panelboard for kitchen.

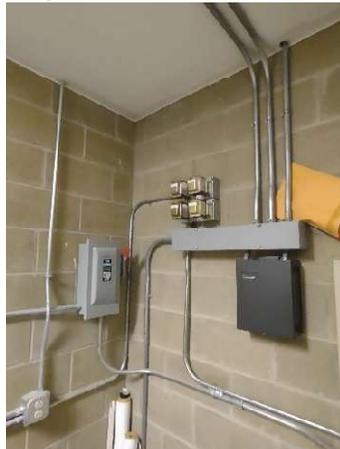
Stage AHU disconnect and wiring in conduit arrangement.

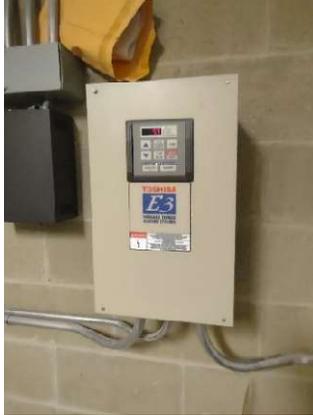
Stage AHU controls.

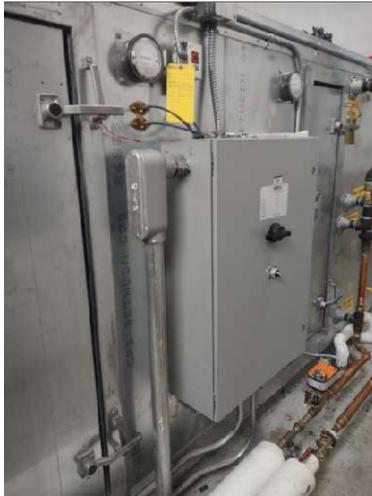
AHU Room above boiler room – auto shut off switch.

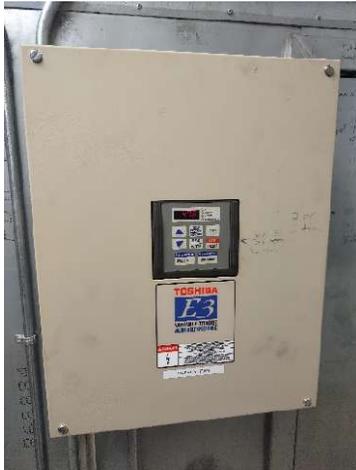
AHU controls in upper boiler room AHU space.

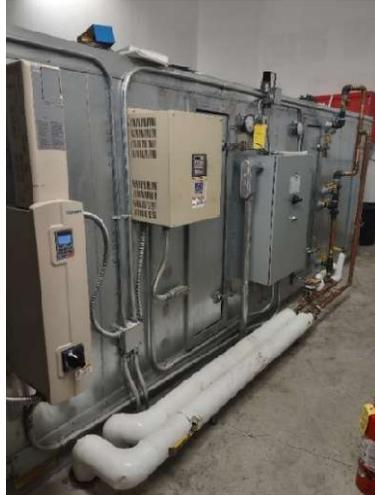
Upper AHU Room - Power, VFD, and piping arrangement

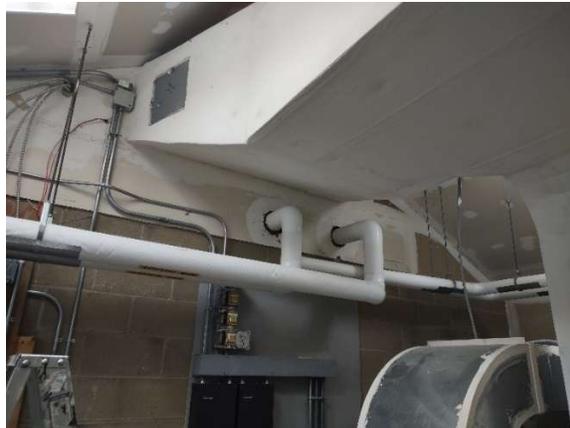
Damper control wiring.

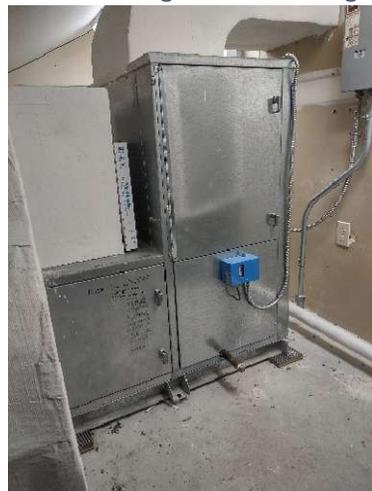
Control wiring for AHU arrangement.

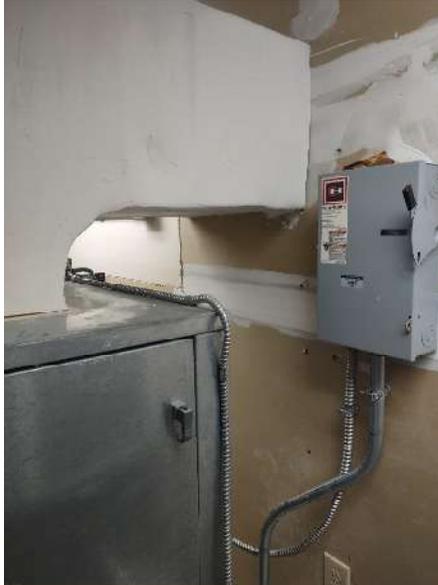
AHU disconnect switch.

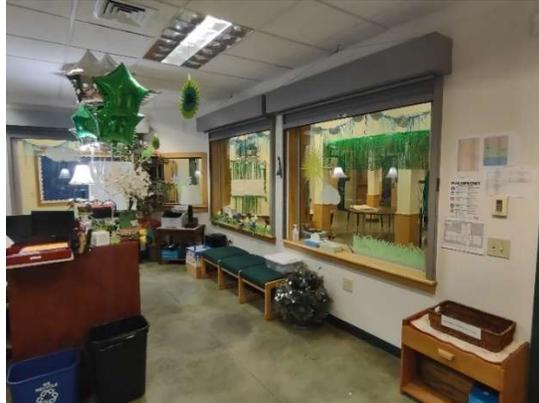
Typical traditional lighting. The fixtures appear to still be incandescent and fluorescent type.

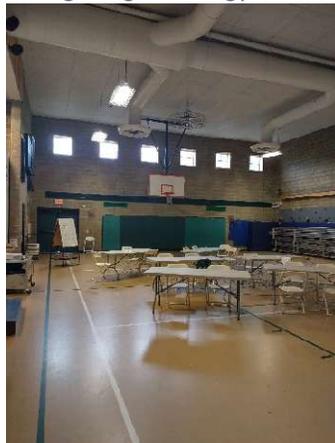
T-8 lighting in the gym.

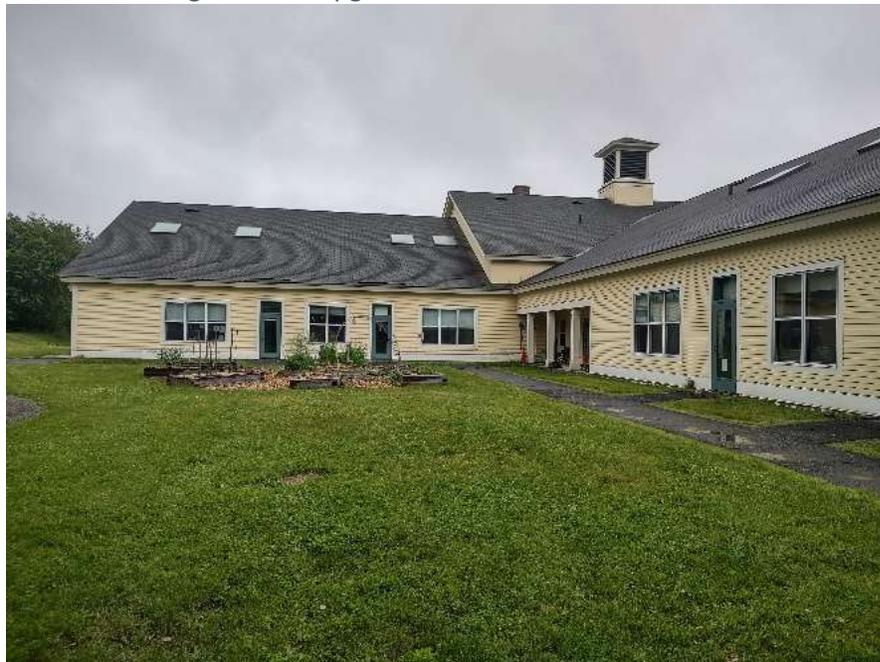
Exterior flood lights to be upgraded.

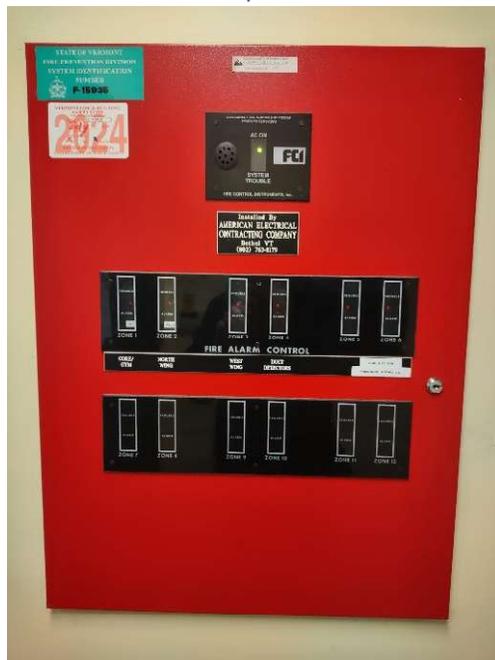
The main fire alarm panel. There were no violation notes on the front cover.

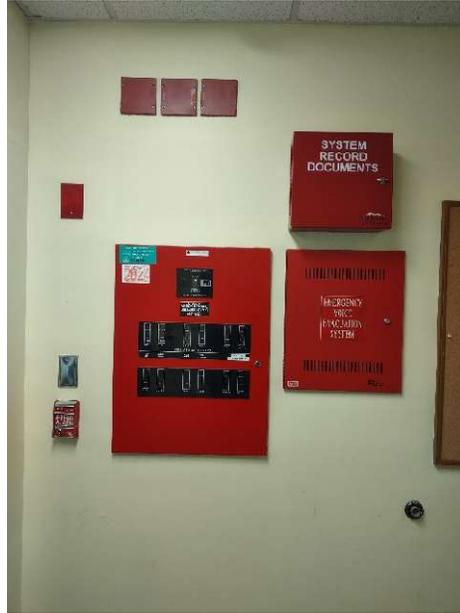
FACP – sub panel – typical
