MOLD INSPECTION REPORT

Inspection Report
401 North 4th Street, Lake Wales, Florida 33853

Proj: Edward W Bok Academy

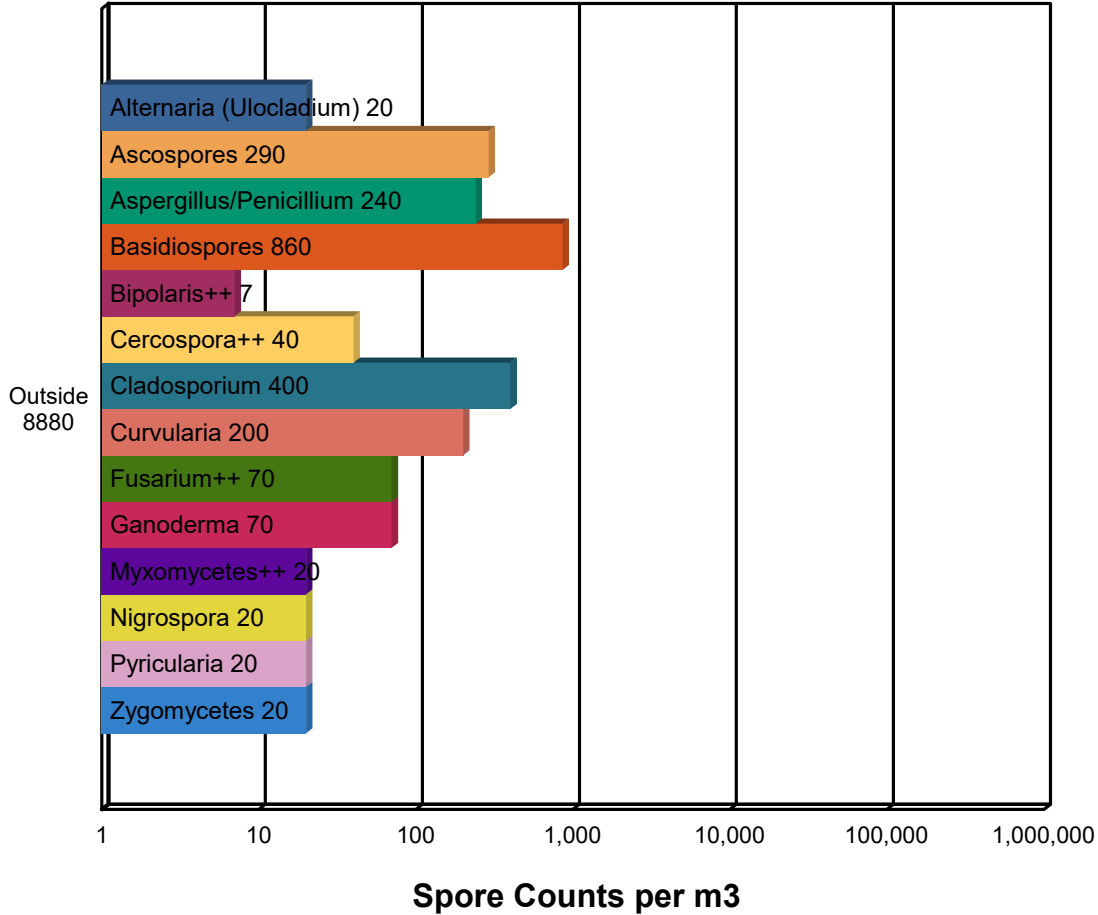
Spore Trap Report: Total Counts

* The chart is displayed using a logarithmic scale. Bar size is not directly proportional to the number of spores.

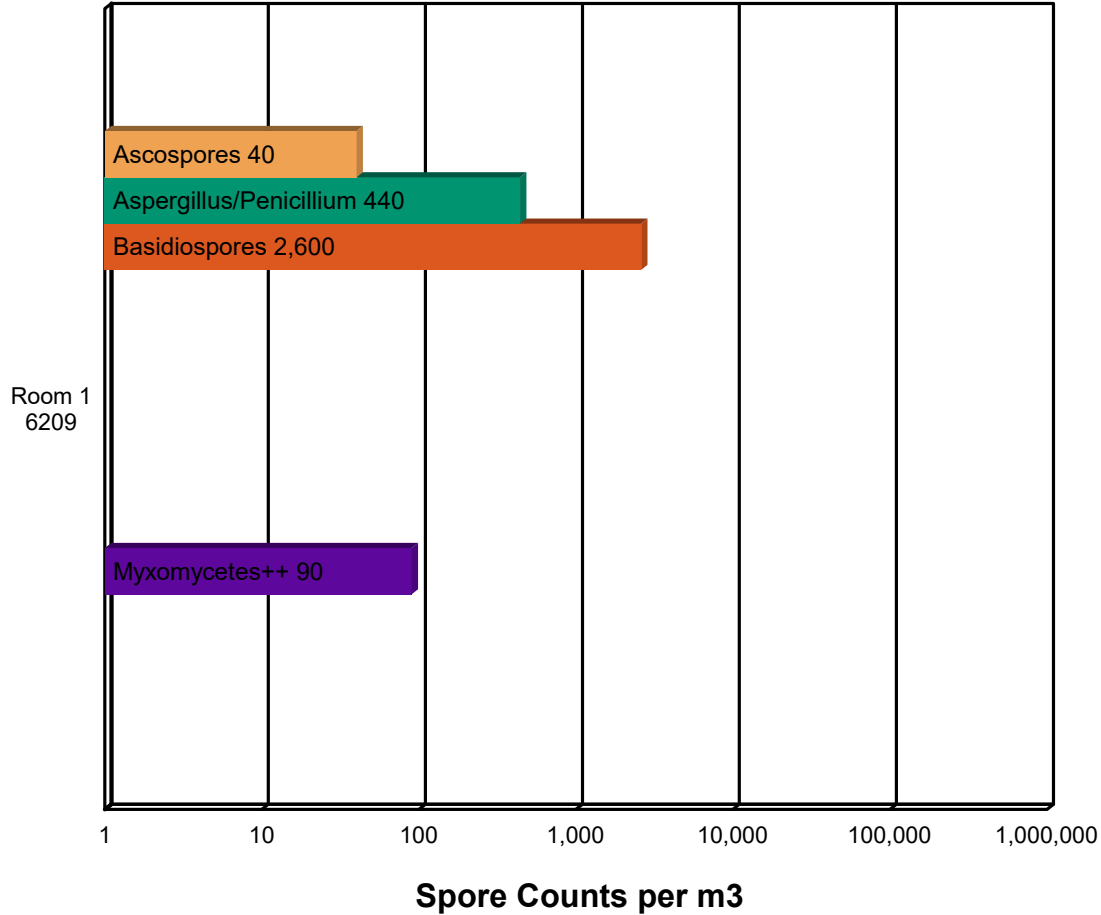
Spore Trap Report: Total Counts

Alternaria (Ulocladium)	Ascospores	Aspergillus/Penicillium
Basidiospores	Bipolaris++	Cercospora++
Cladosporium	Curvularia	Fusarium++
Ganoderma	Myxomycetes++	Nigrospora
Pyricularia	Zygomycetes

* The chart is displayed using a logarithmic scale. Bar size is not directly proportional to the number of spores.

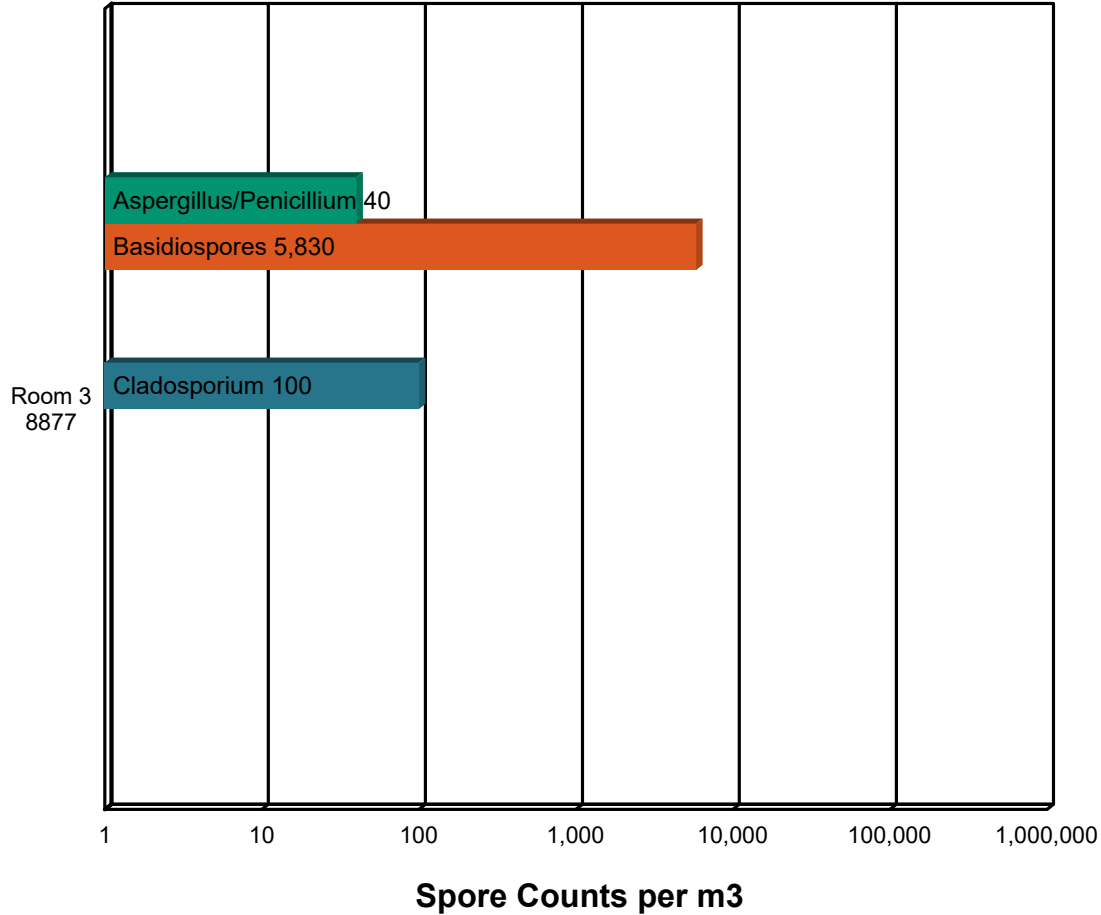
Spore Trap Report: Total Counts

Alternaria (Ulocladium)	Ascospores	Aspergillus/Penicillium
Basidiospores	Bipolaris++	Cercospora++
Cladosporium	Curvularia	Fusarium++
Ganoderma	Myxomycetes++	Nigrospora
Pyricularia	Zygomycetes

* The chart is displayed using a logarithmic scale. Bar size is not directly proportional to the number of spores.

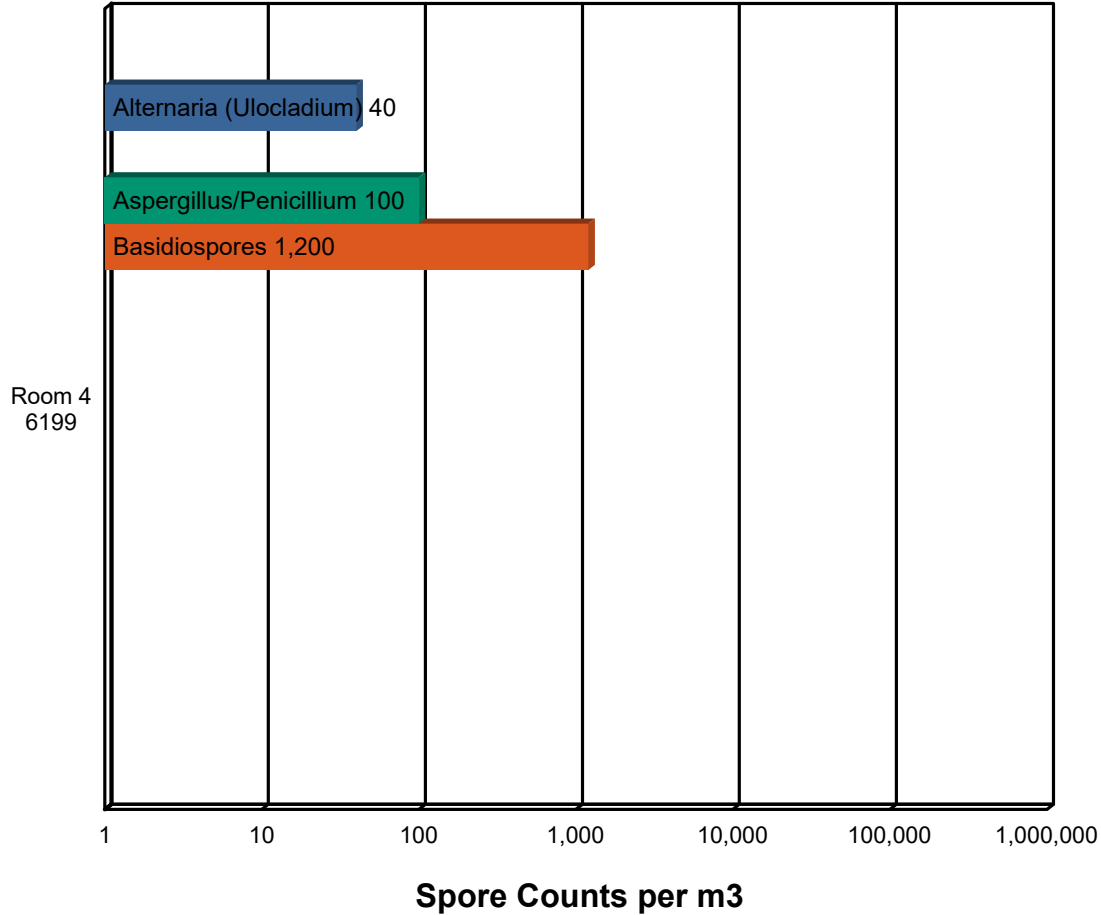
Spore Trap Report: Total Counts

Alternaria (Ulocladium)	Ascospores	Aspergillus/Penicillium
Basidiospores	Bipolaris++	Cercospora++
Cladosporium	Curvularia	Fusarium++
Ganoderma	Myxomycetes++	Nigrospora
Pyricularia	Zygomycetes

* The chart is displayed using a logarithmic scale. Bar size is not directly proportional to the number of spores.

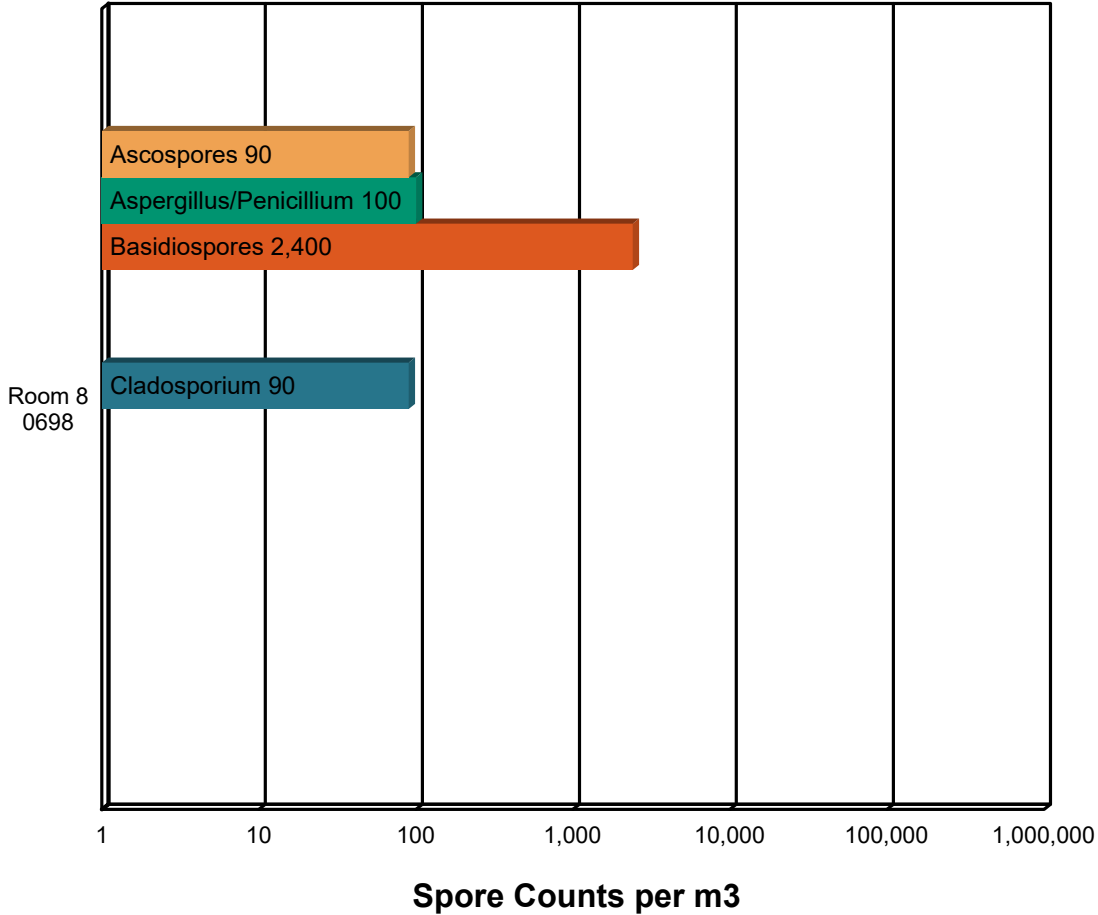
Spore Trap Report: Total Counts

Alternaria (Ulocladium)	Ascospores	Aspergillus/Penicillium
Basidiospores	Bipolaris++	Cercospora++
Cladosporium	Curvularia	Fusarium++
Ganoderma	Myxomycetes++	Nigrospora
Pyricularia	Zygomycetes

* The chart is displayed using a logarithmic scale. Bar size is not directly proportional to the number of spores.

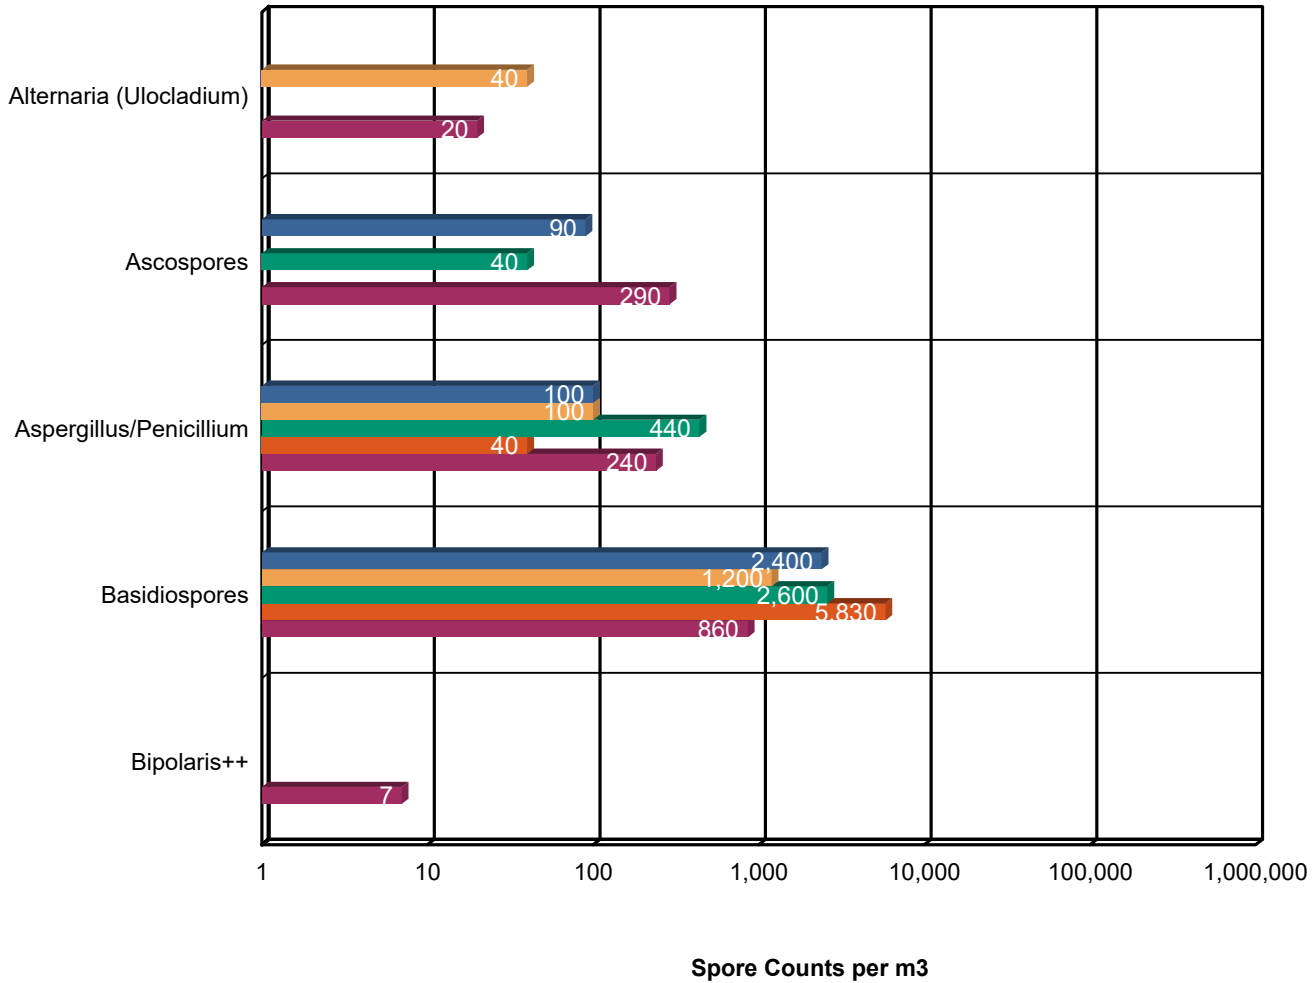
Background Comparison Chart

* The chart is displayed using a logarithmic scale. The bar size is not directly proportional to the number of spores.

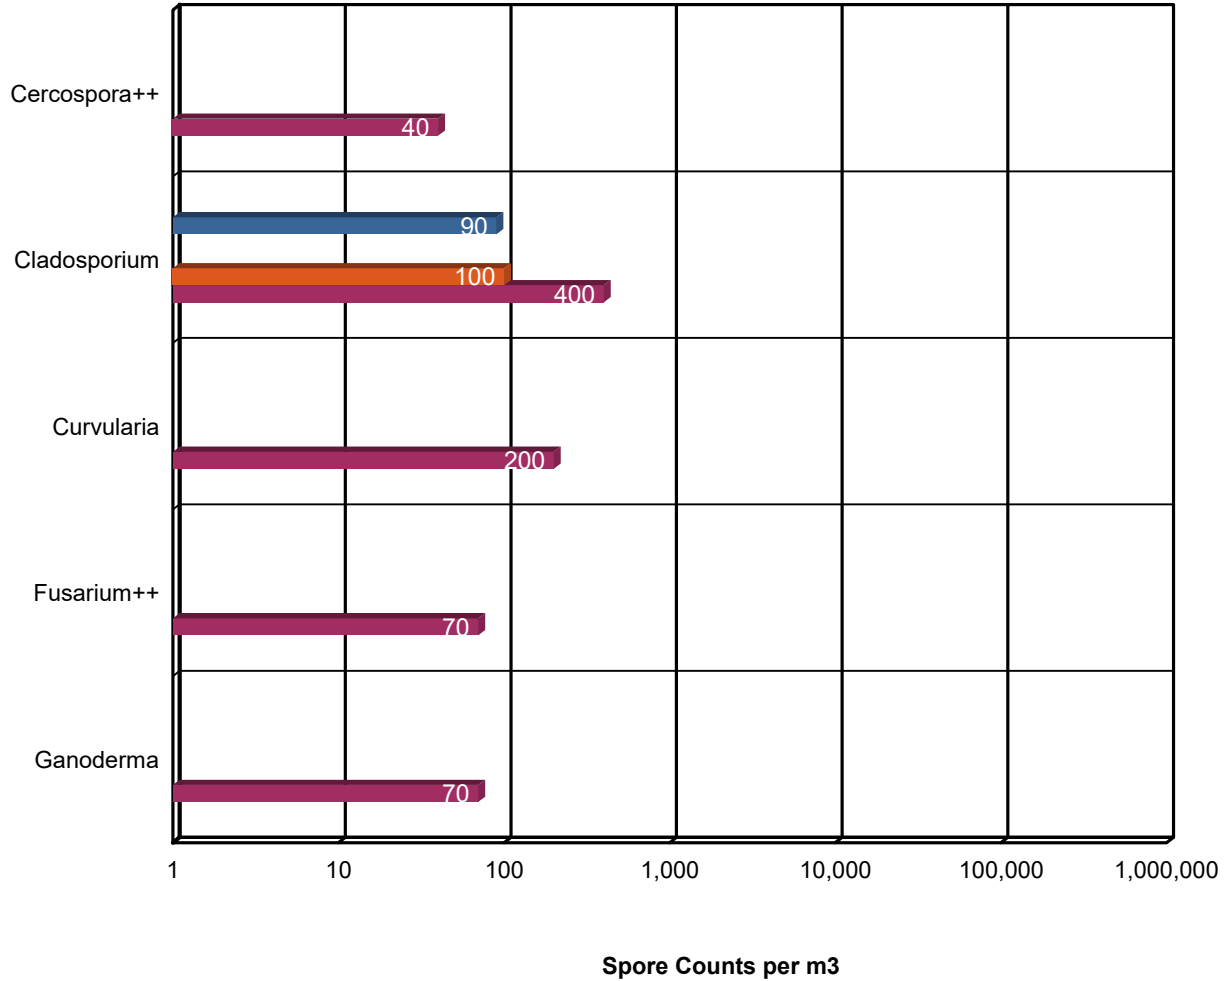
Background Comparison Chart

* The chart is displayed using a logarithmic scale. The bar size is not directly proportional to the number of spores.

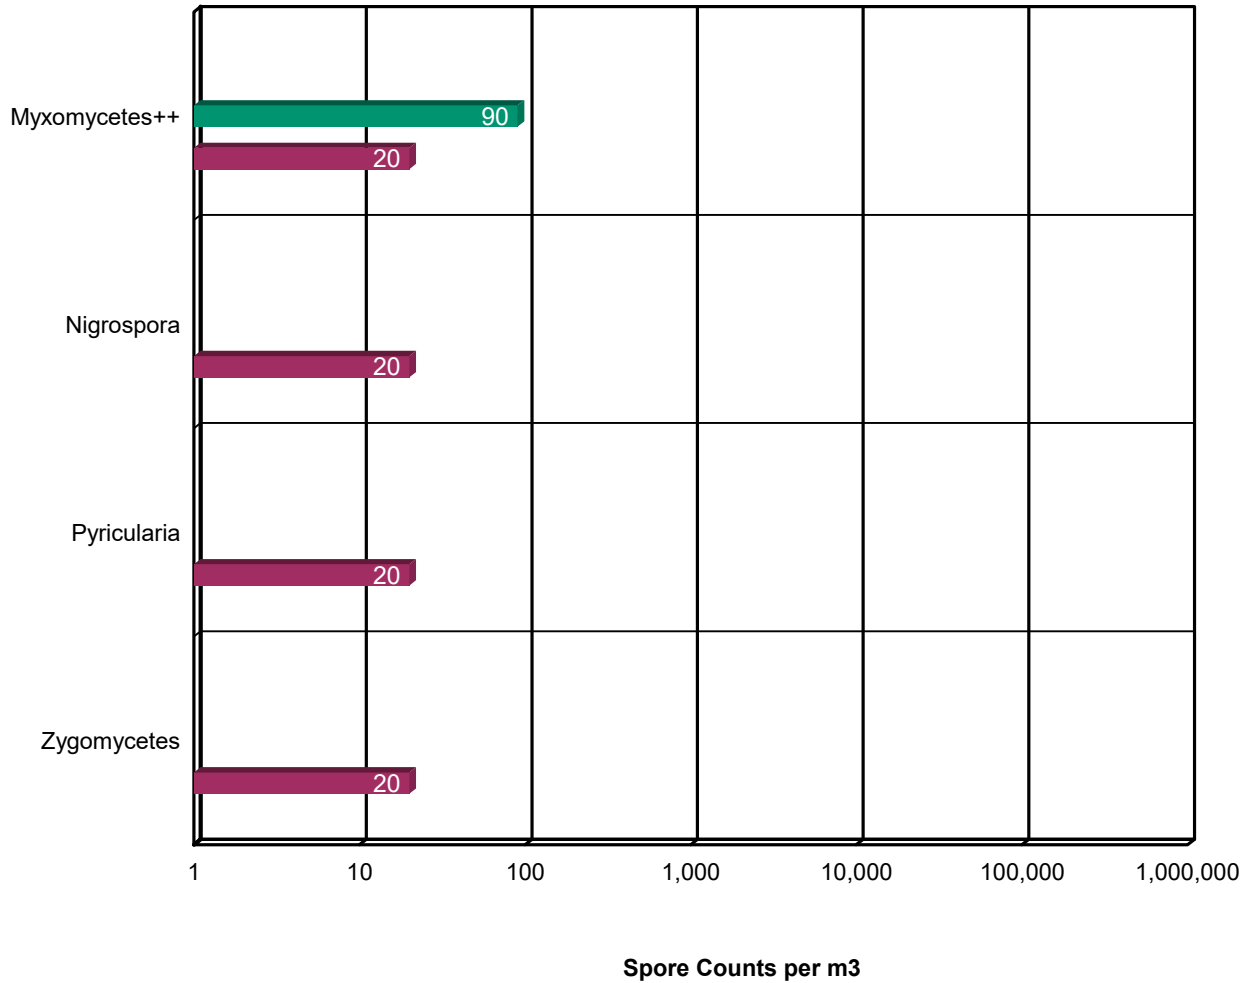
Background Comparison Chart

* The chart is displayed using a logarithmic scale. The bar size is not directly proportional to the number of spores.
