# Midland Public Schools

## Facilities Assessment

March 16, 2026

## Executive Summary + Table of Contents

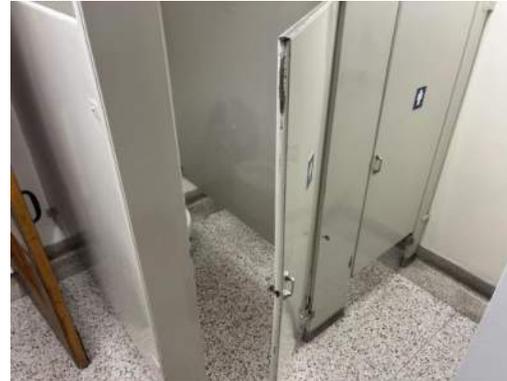
Existing Toilet Partition

Accessories	Missing vertical grab bars and non compliant stalls observed.			x		\$0			\$0

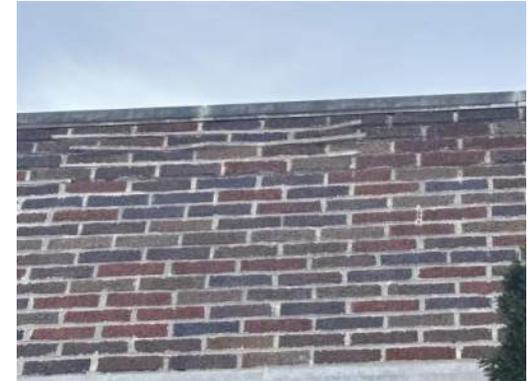
Existing Exterior Brick

Carpenter Pre-Primary Center is the oldest facility in the district and exhibits architectural systems that are largely original and identified for near-term replacement throughout the assessment. The building envelope includes aging masonry walls and are starting to no longer provide adequate thermal performance, or weather resistance. Roofing systems are documented as being at or beyond typical service life, with replacement identified in the near-term timeframe due to condition. Interior layouts limit some flexibility, and offer poor adjacencies – particular in reference to toilet rooms, art, Spanish and cafeteria space. Interior finishes—including ceilings, flooring, and wall systems—have been updated as needed to provide additional classroom spaces, however all the upgrades are cosmetic in nature. Numerous ADA deficiencies are noted across the building, including restroom accessibility, door clearances, and egress routes. Collectively, the architectural findings indicate that addressing deficiencies would require extensive, building-wide intervention rather than isolated repairs.

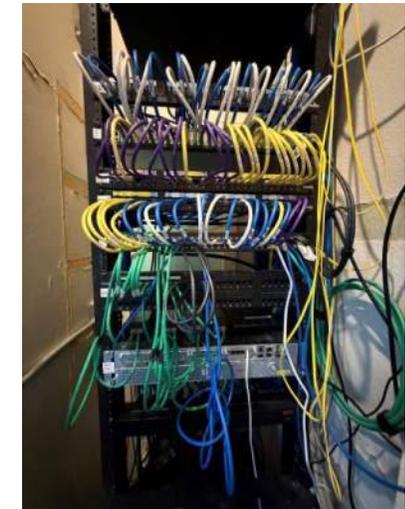
Existing IT

Network Switches	Ruckus ICX 7150-48(F)(PF)		x			\$4		\$5	
Wireless Access Points	Ruckus (primarily R720) EOL 2028	x				\$54,750	\$57,488		
Classroom Audio System	Lightspeed 955 (per classroom)		x						
Classroom Video System	Direct HDMI to Epson Projector & manual pull down screen (per classroom)		x			\$234,210		\$299,789	
Media Center AV System	Currently similar to classroom setup (projector and Lightspeed)		x			\$53,230		\$68,134	
Maker Space AV System	Crestron, not functioning	x							
Gym AV System	Audio System, Projection screen		x			\$12,775		\$16,352	
Add telecomm rooms to generator standby	Part of generator addition, add standby system and include telecomm rooms	x				\$0	\$0		
<b>13.0 Electrical Assessment SUBTOTAL</b>						<b>\$1,811,092</b>	<b>\$310,735</b>	<b>\$593,160</b>	<b>\$1,556,587</b>

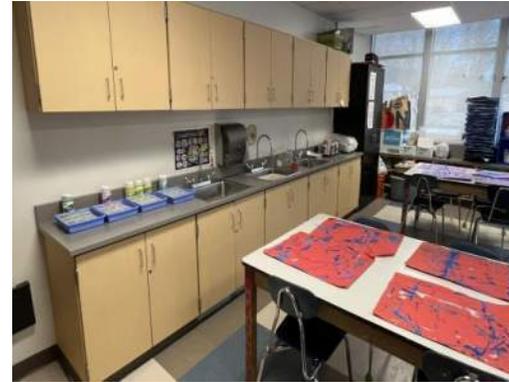
Existing Classroom

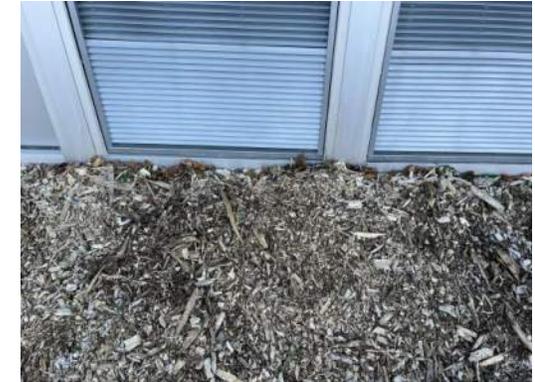
Existing Window/Grade

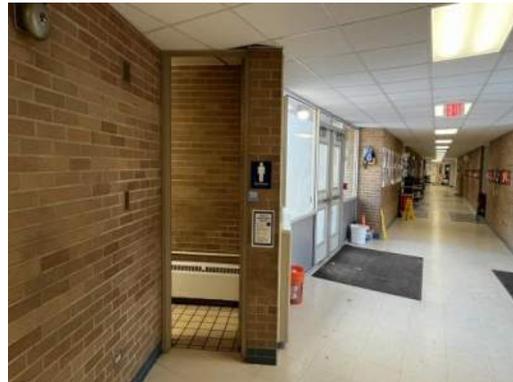
Existing Toilet Room Entry/Lack of ADA

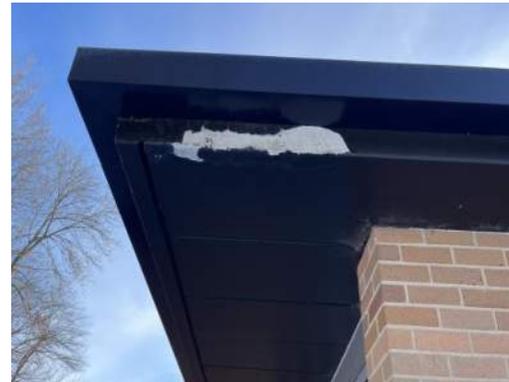
Existing Soffit at Roof Edge

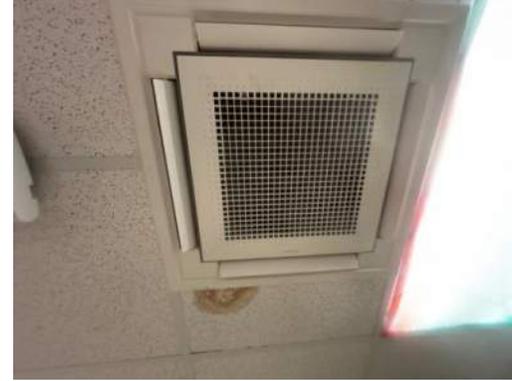
Existing Mini Split

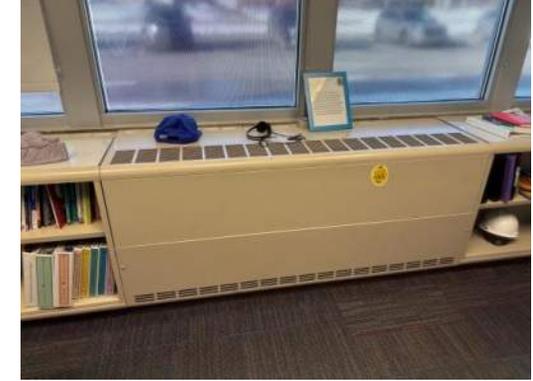
Existing Unit Ventilator

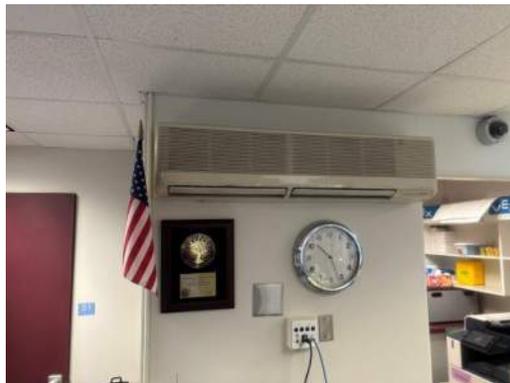
Existing Fan Coil

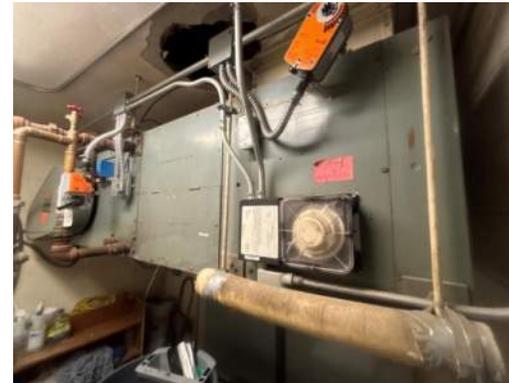
Existing Indoor AHU

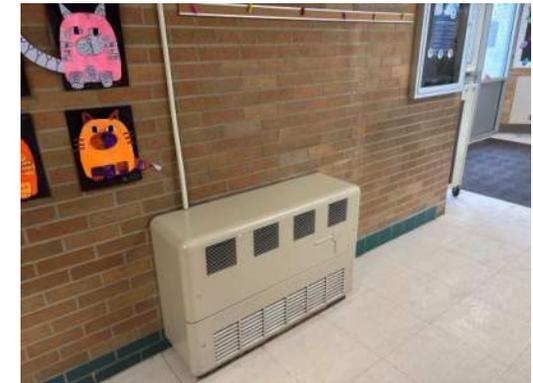
Existing Cabinet Unit Heater

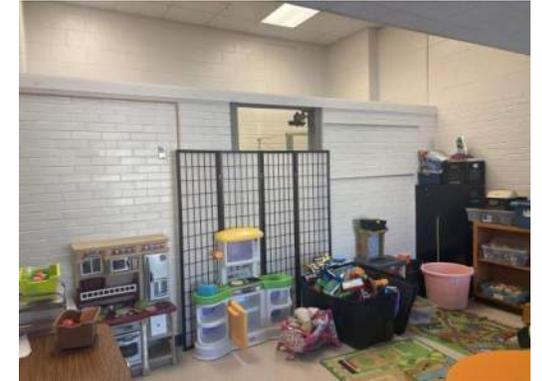
Existing Classroom

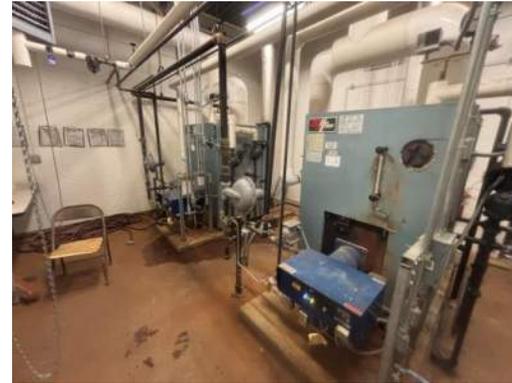
Existing Steam Boiler Plant

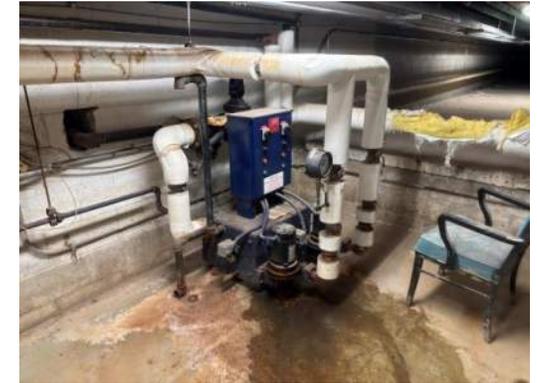
Existing Condensate Receiver

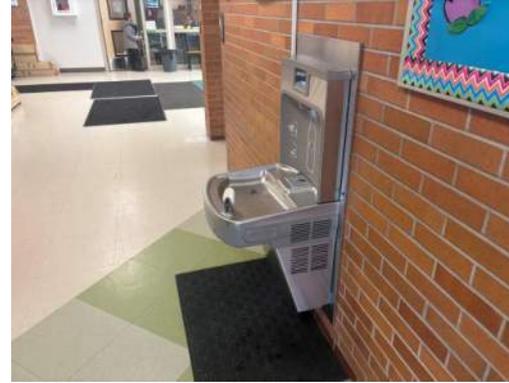
Existing Drinking Fountain  
Extending into Corridor

Interior Building Signage (general)	Observed adequate.				x	\$0			
Corridor Clearances	Observed adequate.				x	\$0			
Corridor Path of Travel Obstructions (drinking fountains/lockers/wingwalls)	There are several drinking fountains that protrude into path of travel for the visually impaired. Recommend adding wing walls with future renovations.			x		\$54,750			\$81,030
Doors & Hardware (knobs/levers/panic hardware/closers (general))	Observed. in compliance				x	\$0			
Pull/Push Side Clearances	Many classrooms don't meet today's code for side clearance. Recommend budgeting for improvements with future renovations. This is an expensive undertaking involving widening masonry openings, Recessing openings so door swings do not obstruct corridors, structural elements, new doors, frames, and hardware.			x		\$1,364,199			\$2,019,015

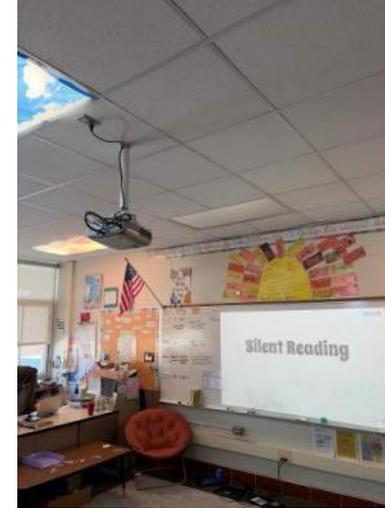
Existing Technology

Network Switches	Ruckus ICX 7150-48(F)(PF)		x			\$53,228		\$68,132	
Wireless Access Points	Ruckus (primarily R720) EOL 2028	x				\$54,768	\$57,506		
Classroom Audio System	Lightspeed 955 (per classroom)		x						
Classroom Video System	Direct HDMI to Epson Projector & manual pull down screen (per classroom)		x			\$234,210		\$299,789	
Maker Space AV System	2017 Crestron AV system not functioning	x				\$53,230	\$55,892		
Media Center AV System	2017: Currently similar to classroom setup (projector and Lightspeed) with additional standalone monitors			x		\$53,230			\$78,780
Gym AV System	No AV system in gym from 2017 bond	x				\$12,775	\$13,414		
Add telecomm rooms to generator standby	Part of generator addition, add standby system and include telecomm rooms	x				\$0	\$0		
<b>13.0 Electrical Assessment SUBTOTAL</b>						<b>\$2,390,276</b>	<b>\$761,210</b>	<b>\$367,921</b>	<b>\$2,039,256</b>

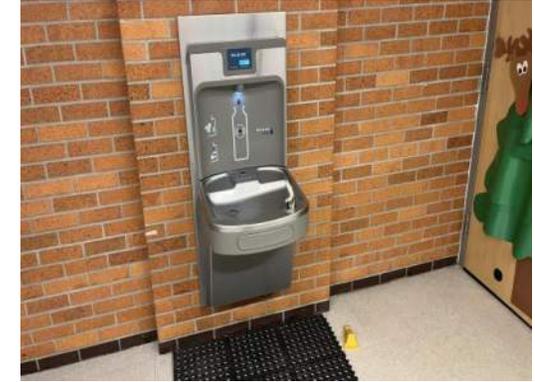
Existing Drinking Fountain  
Extending into Corridor

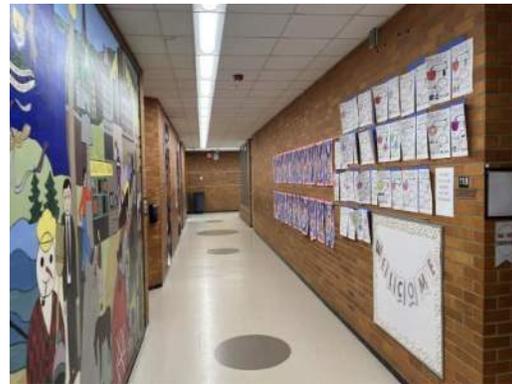
Existing Corridor

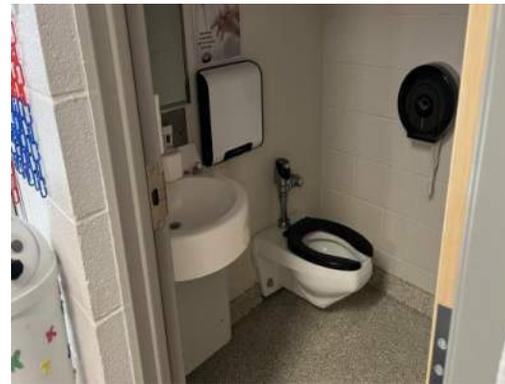
Existing Individual Toilet Room

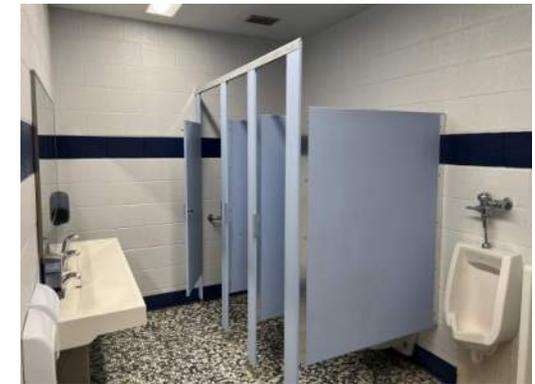
Existing Group Toilet Room

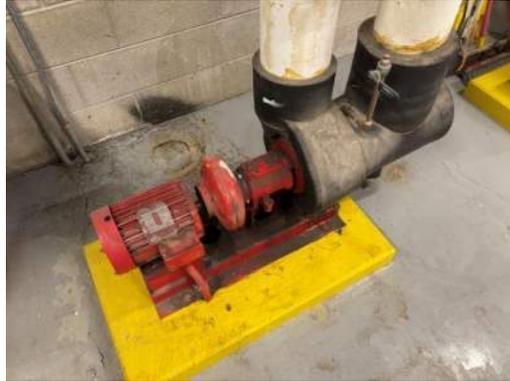
Existing CHW Pumps

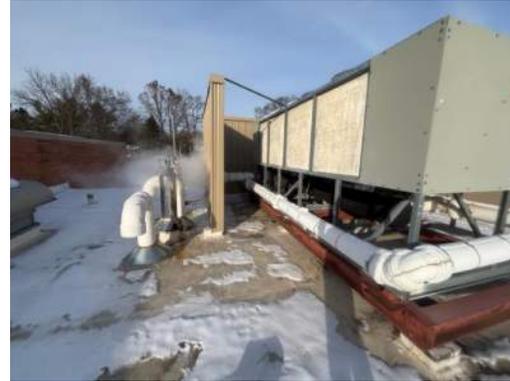
Existing Air-Cooled Chiller

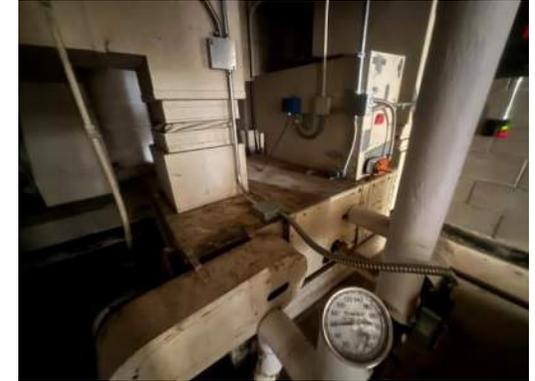
Existing AHU

Air Handling Units	Several original air handling units are still installed and operational in the building, installed in 1969/1970. These units are in poor condition and replacement is recommended, they are well beyond their expected life of 25-30 years. Units are single-zone, which is particularly problematic for the unit that serves the front offices. Approximate unit sizes as originally designed are (4500 CFM) (4800 CFM) (4800 CFM) (1400 CFM) (800 CFM). New VAV boxes for zone control at the front office would be recommend, approximately (4) boxes associated with the (1400 CFM) unit.	X				\$627,350	\$658,718		
Air Handling Units	New air handling units serving gym/cafeteria addition installed in 2017 during recent bond work are in good condition. Zone temperature control is limited due to single zone units serving multiple spaces (stage, kitchen, cafeteria). (3000 CFM) (6000 CFM).				X	\$0

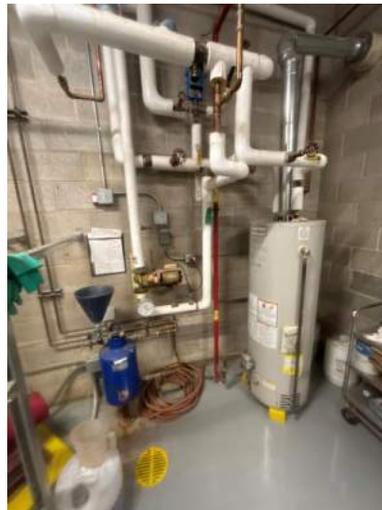
Existing Water Heater

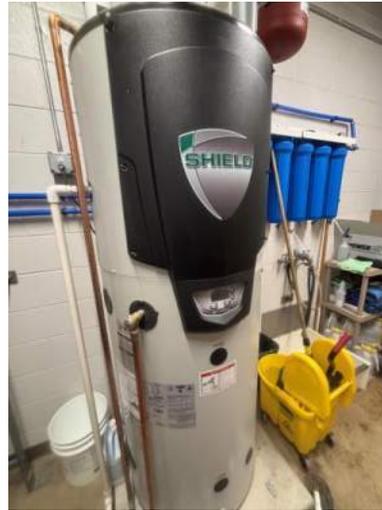
Existing Water Heater

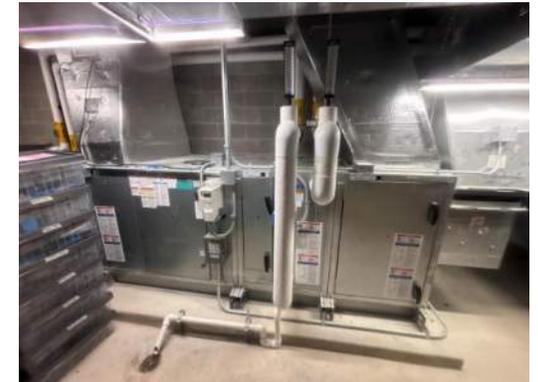
Existing AHU

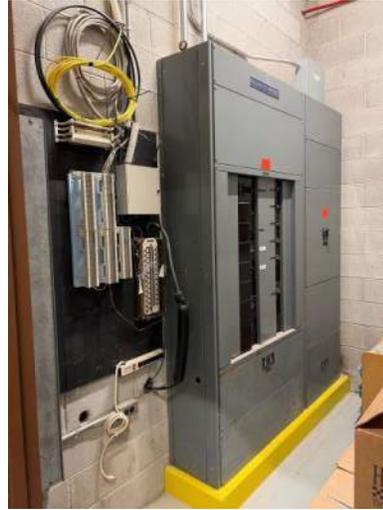
Existing Electrical Gear

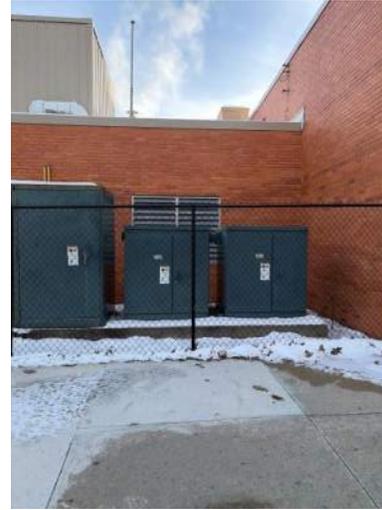
Existing Transformer

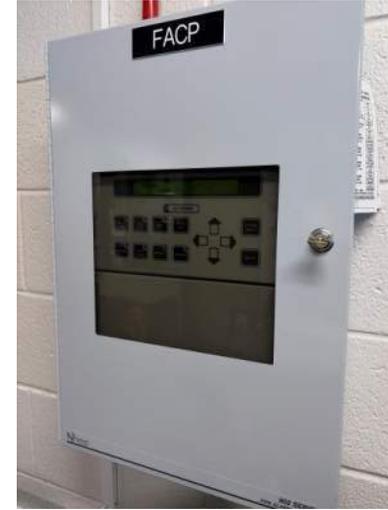
Existing Fire Alarm

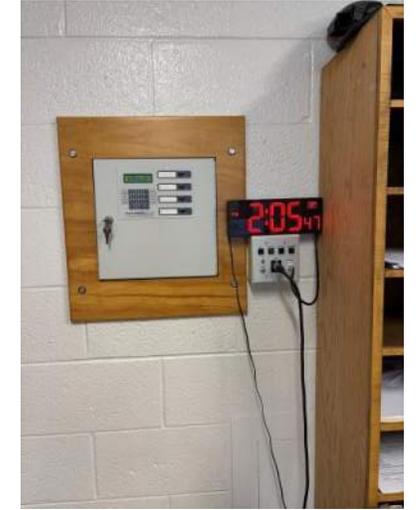
Existing Clock System

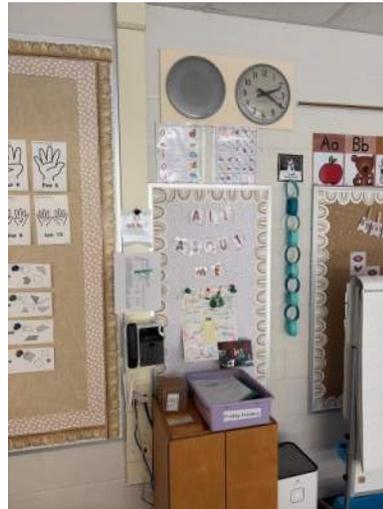
Existing Clock

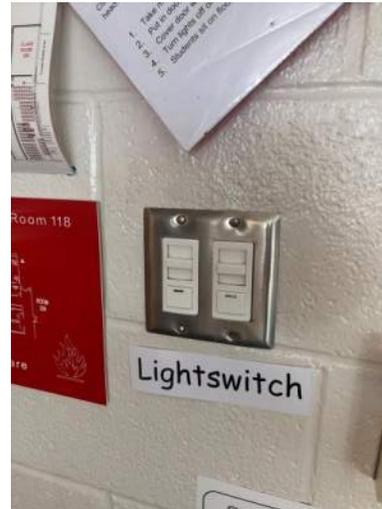
Existing Lighting Control

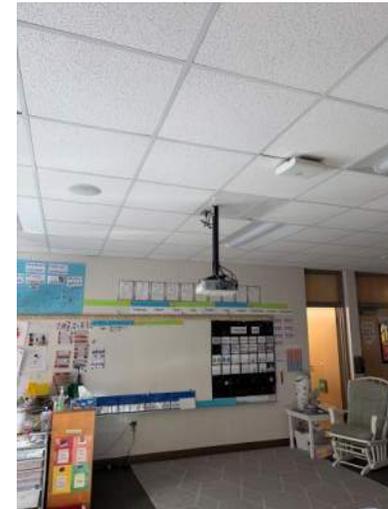
Existing Technology

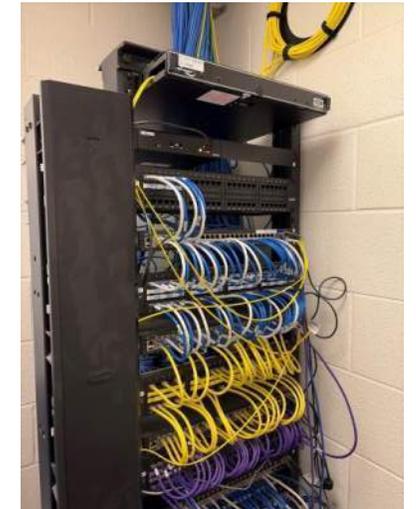
Existing IT

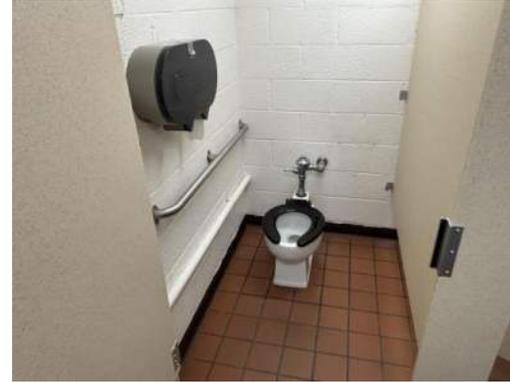
Existing Toilet Room/Finishes

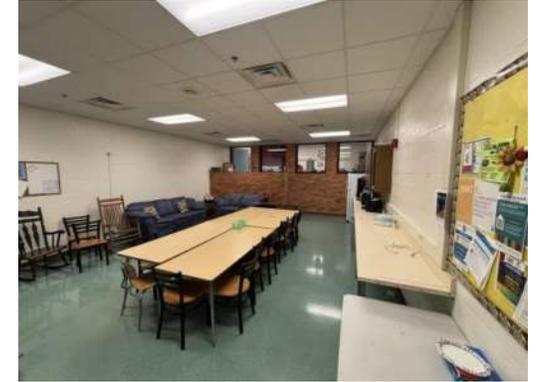
Existing Staff Lounge

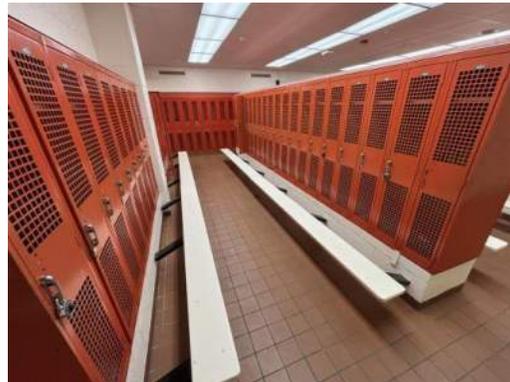
Existing Locker Rooms

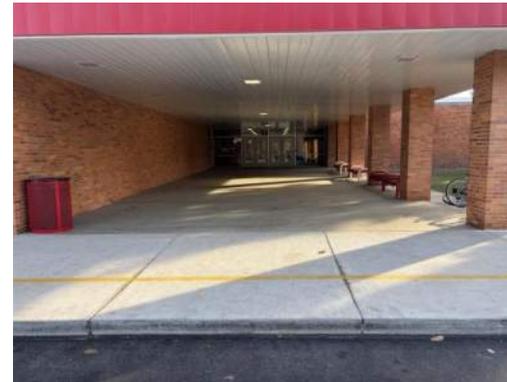
Existing Entry

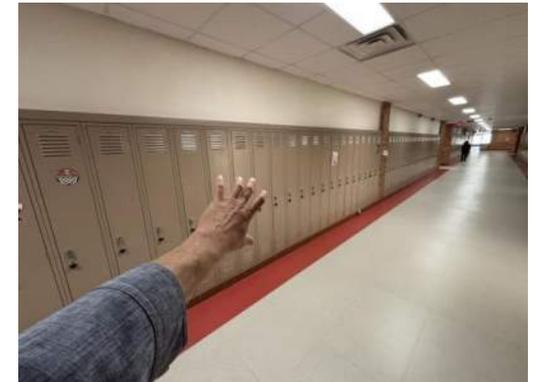
Existing Lockers

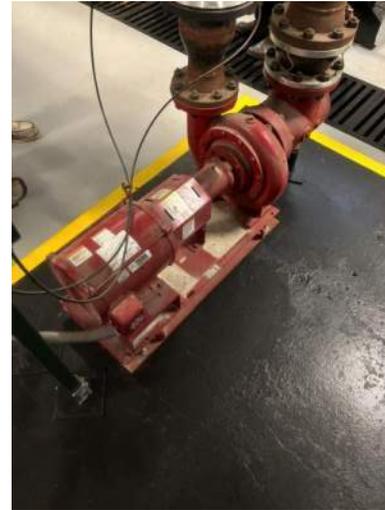
Existing HHW Pumps

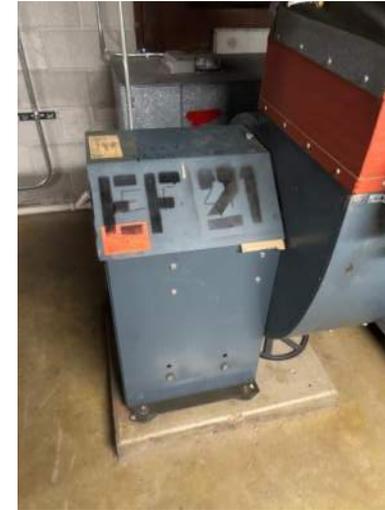
Existing Exhaust Fan

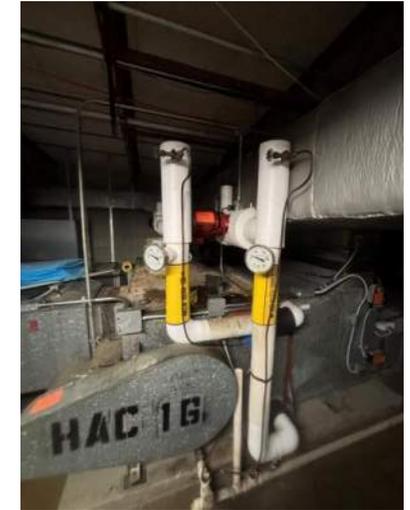
Existing HVAC Equipment

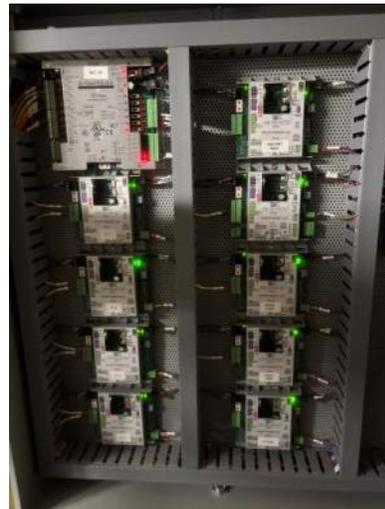
Existing Controls

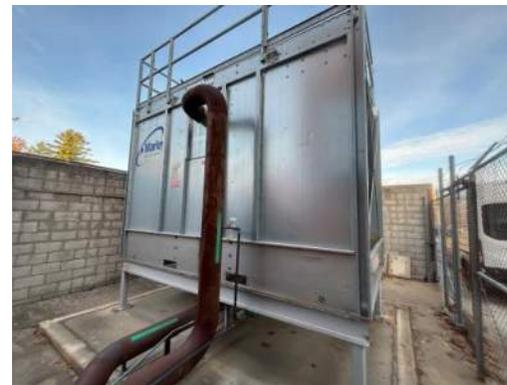
Existing Cooling Tower

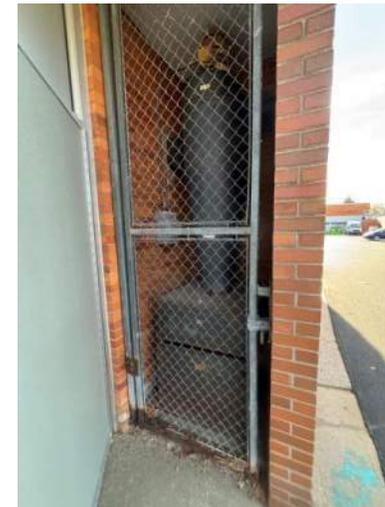
Existing Dust Collector

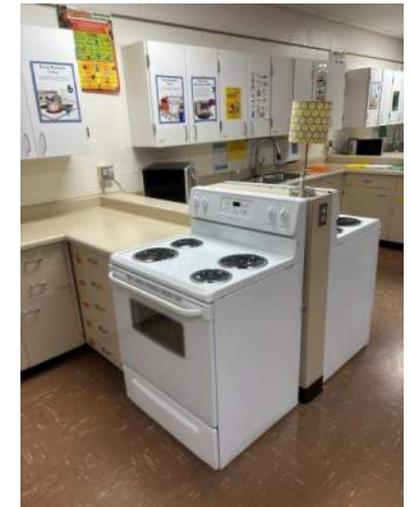
Existing Life Skills Kitchenettes

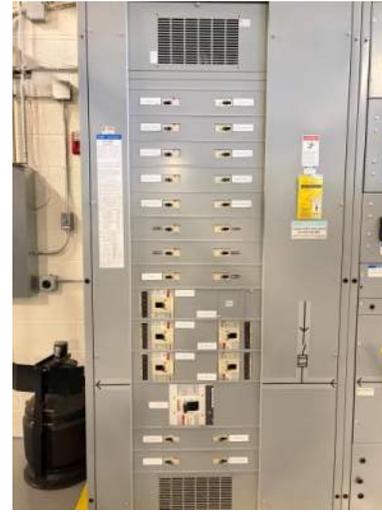
Existing Electrical Gear

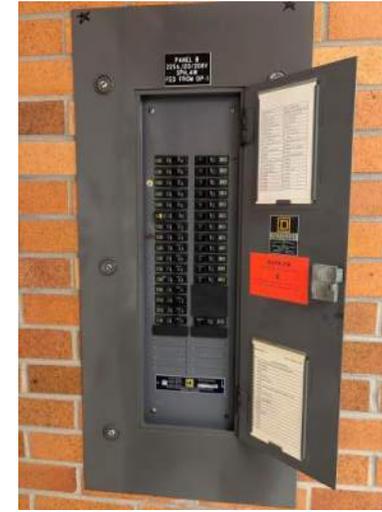
Existing Panel Board

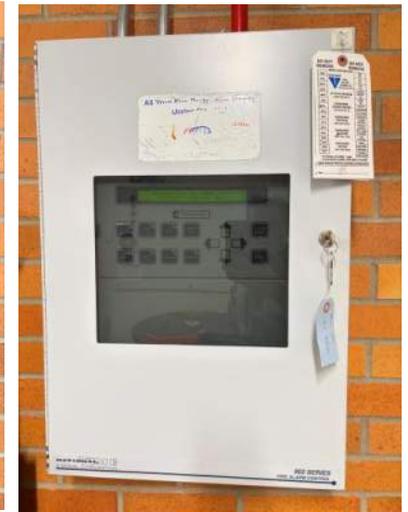
Existing Fire Alarm

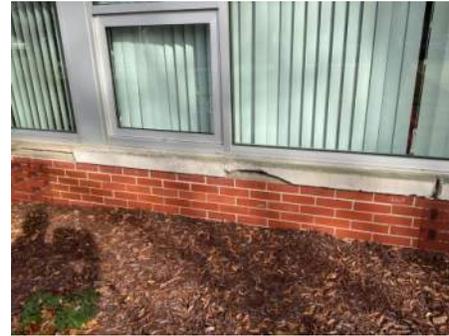
Existing Cracking Window Sill

Glass Block	Glass block windows poor condition. End of life cycle. Flashing above Glassblock deteriorated/end of life cycle. Openings 1.5' x 5.5'	x				\$12,319	\$12,935		
Aluminum Windows	windows are in good condition with double panes. Mid life cycle				x	\$0			
Wood/Wood Clad Windows	Poor condition. Failing hardware. No security. Recommend Replacement	x				\$146,000	\$153,300		
Exposed Steel Lintels	Failing finishes. Rust. Original building lintels at end of life cycle.	x				\$106,459	\$111,782

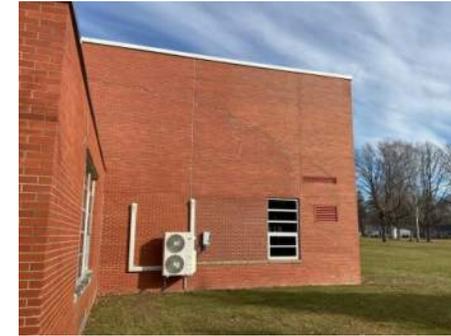
Existing Cracking Brick Facade

General Comment 1	There are several areas in need of tuckpointing repairs and full brick replacement. Note: replacing exterior masonry brick may not be the solution to preserve the building relative to potential unforeseen underlying issues.	x				\$0	\$0		
General Comment 2	There are several areas of deteriorating brick needing replacement	x				\$0	\$0		
General Comment 3	Areas of deteriorating concrete sills/caps need replacement	x				\$0	\$0		
General Comment 4	There are several areas where brick weeps have been covered by landscap material or soil. There are no weeps above openings	x				\$0	\$0		
General Comment 5	There are 2 masonry chimneys/stacks with extensive cracking. End of Life Cycle	x

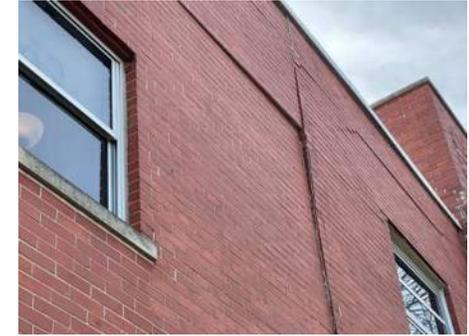
Existing Deflecting Brick Facade

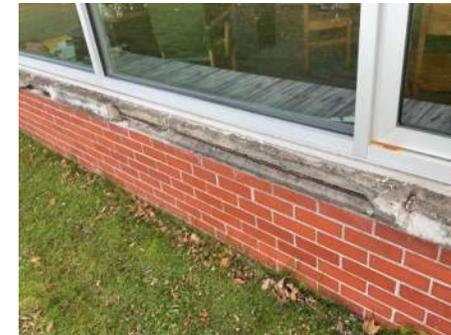
Existing Cracking Window Sill

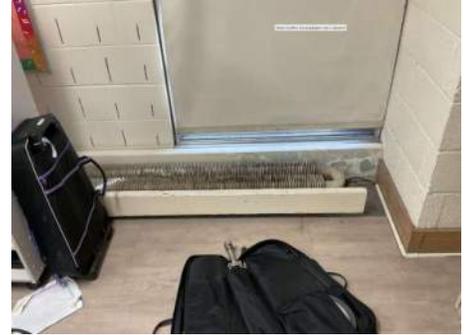
Existing Exterior Wall in Band Room

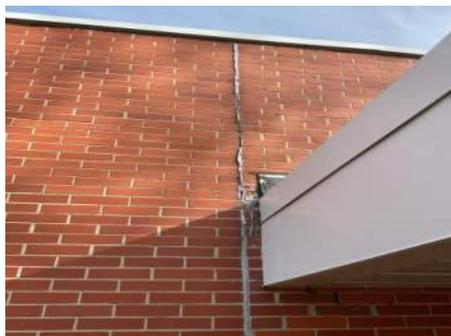
Existing Brick Repairs

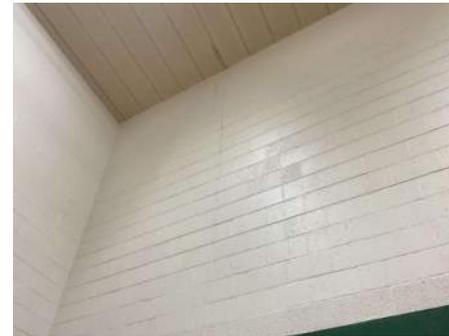
Existing CMU cracking in Gym

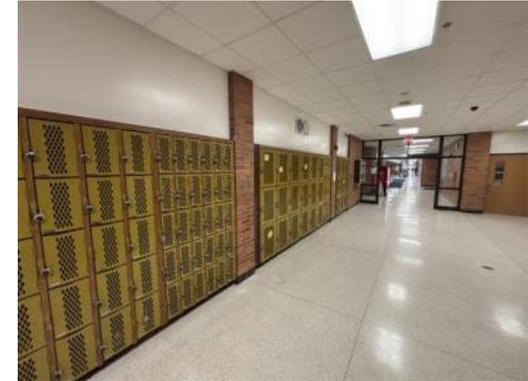
Existing Band Lockers

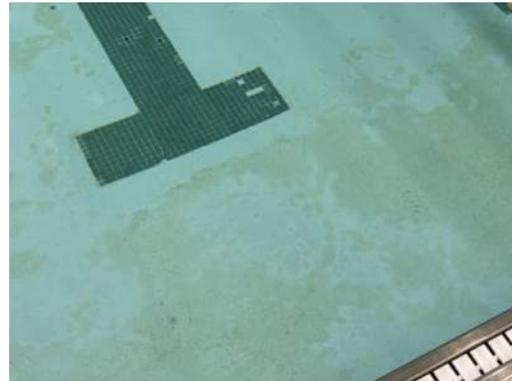
Existing Pool Surface

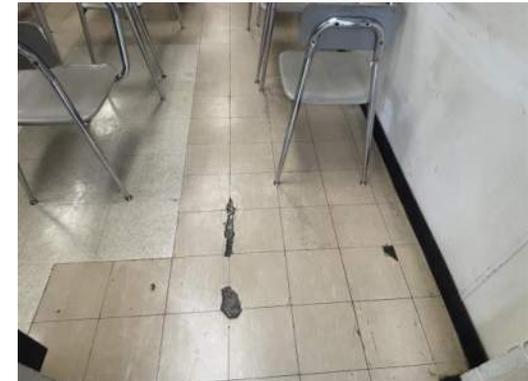
Existing Flooring in Auto Shop Class

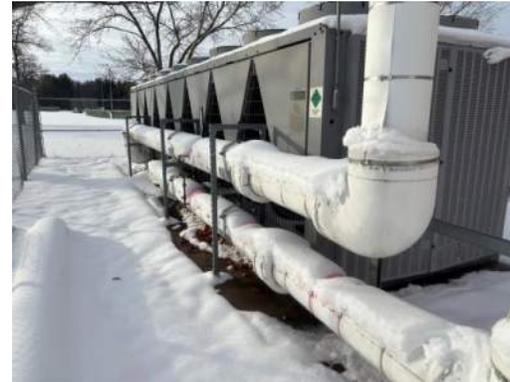
Existing Chiller

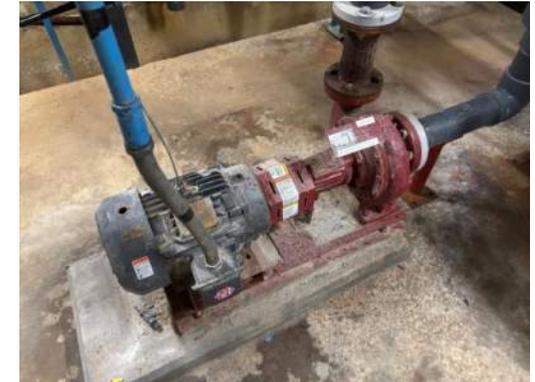
Existing Hydronic Pumps

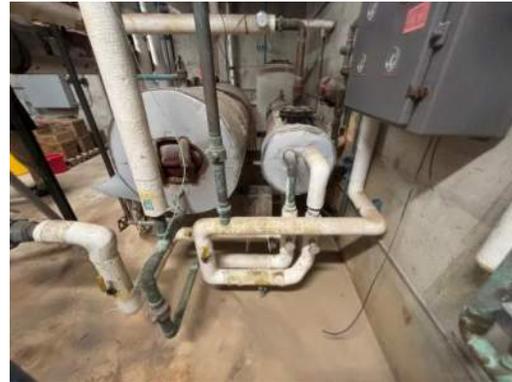
Existing Heat Exchanger

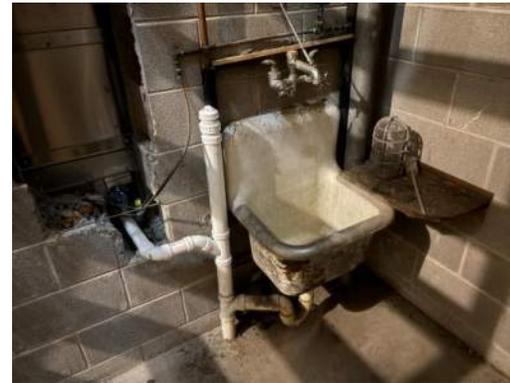
Existing Plumbing Fixture

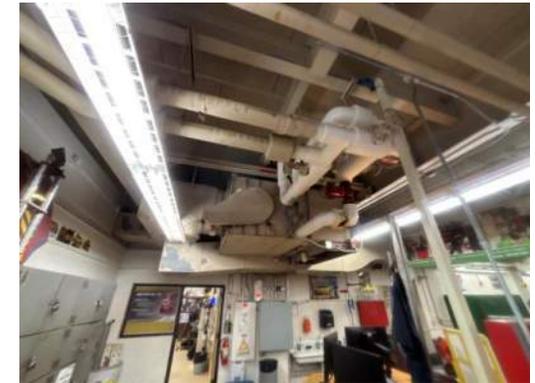
Existing Autoshop AHU

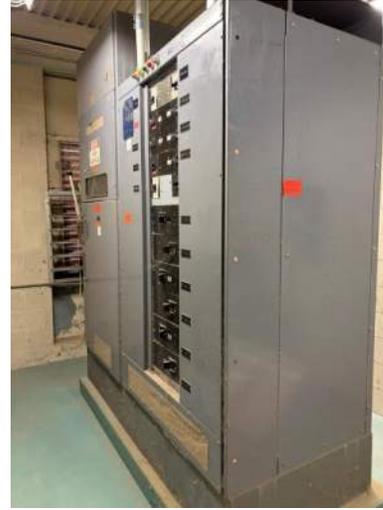
Existing Electrical Gear

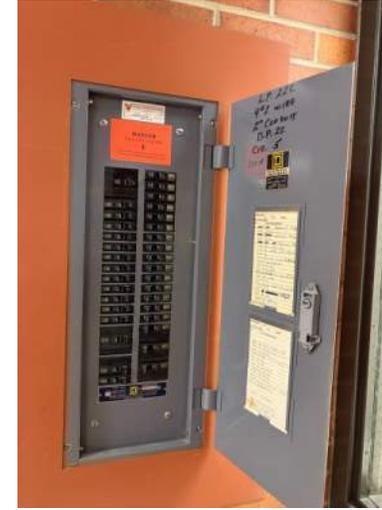
Existing Panel Board

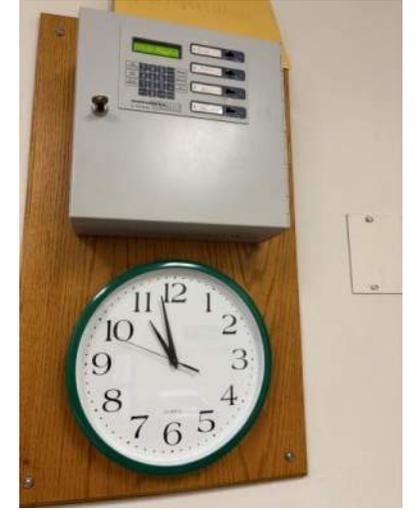
Existing Clock System

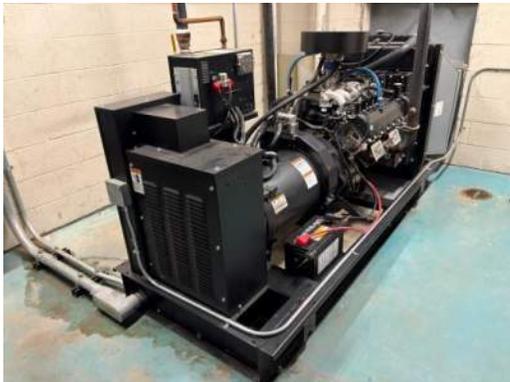
Existing Generator

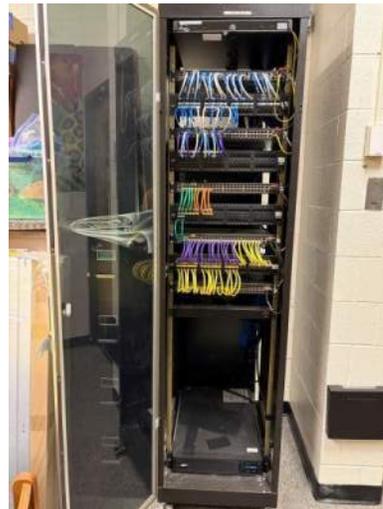
Existing IT

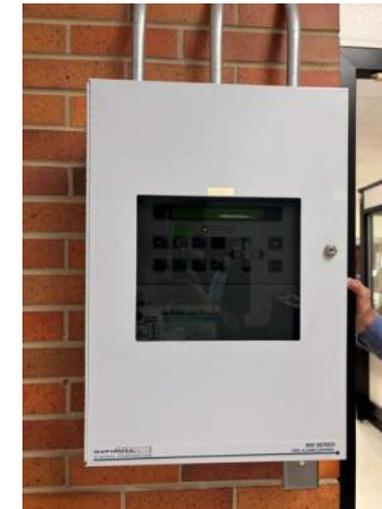
Existing Fire Alarm

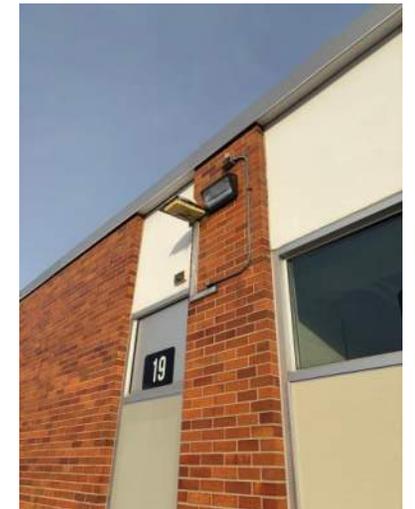
Existing Exterior Wall Pack

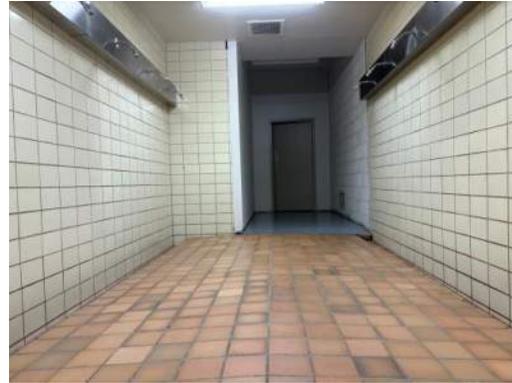
Existing Locker Room Shower

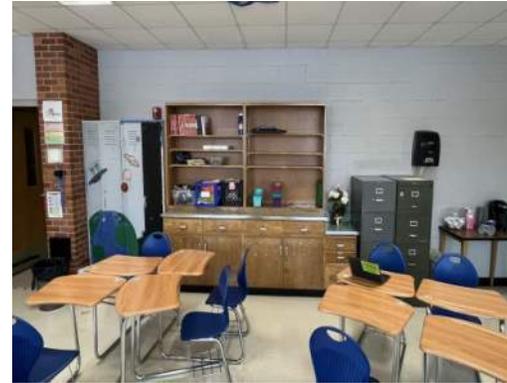
Existing Classroom and Storage

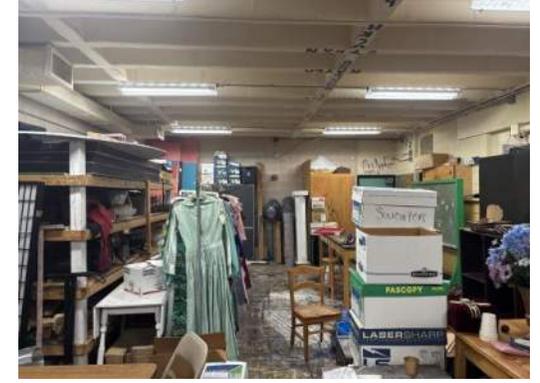
Existing Storage

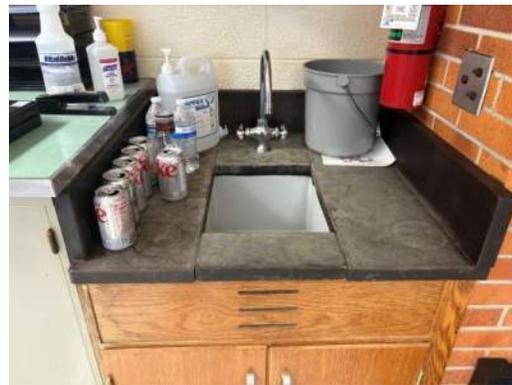
Existing Casework and Sink

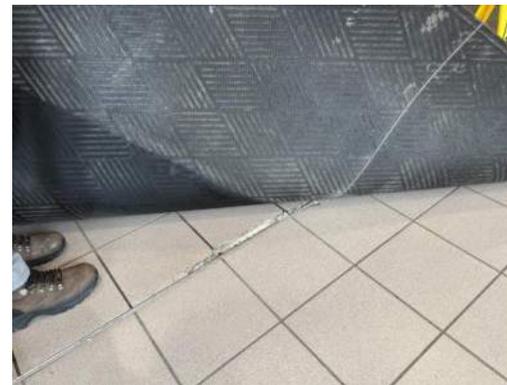
Existing Floor at Entry

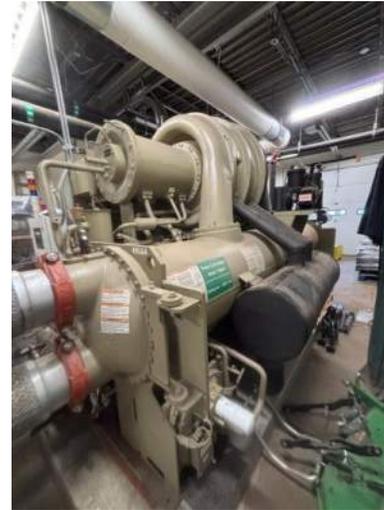
Existing Chiller

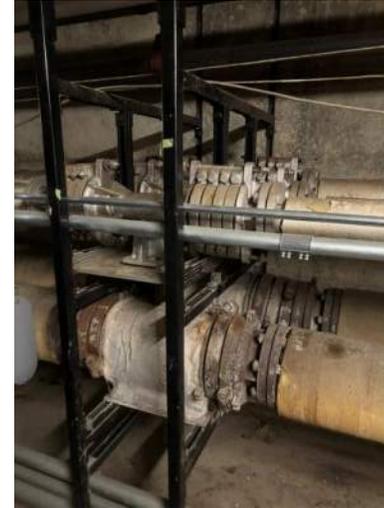
Existing Piping

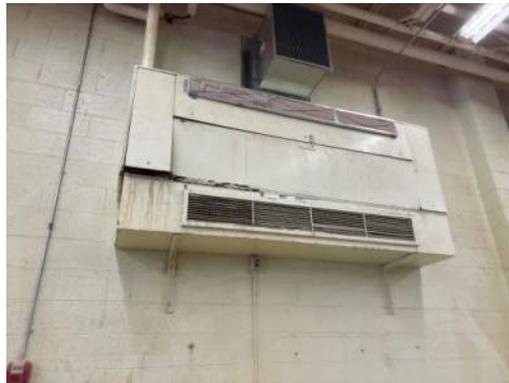
Existing Woodshop Ventilation

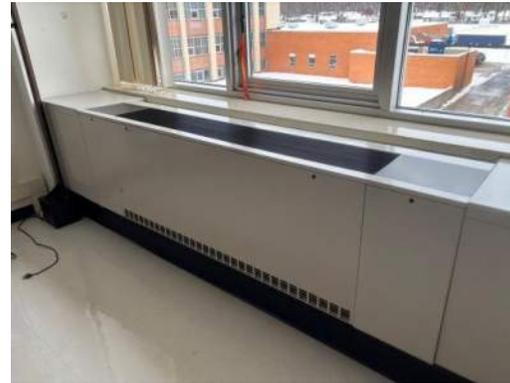
Existing Unit Ventilator

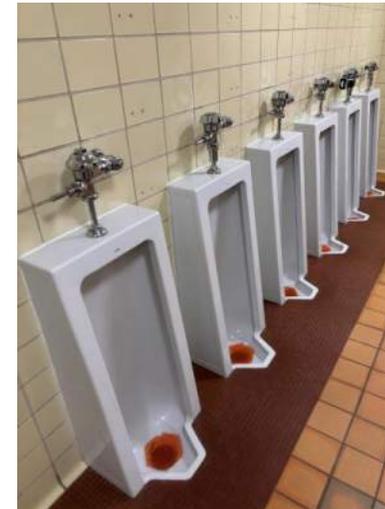
Existing Plumbing Fixtures

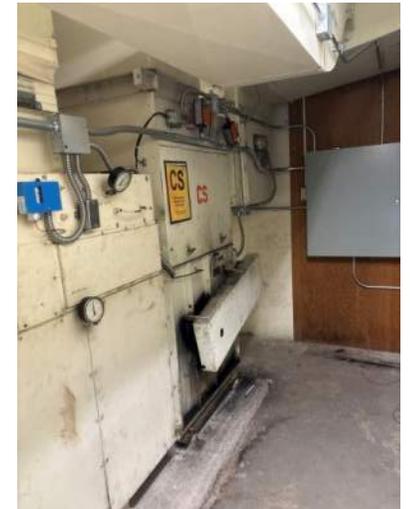
Existing AHUs

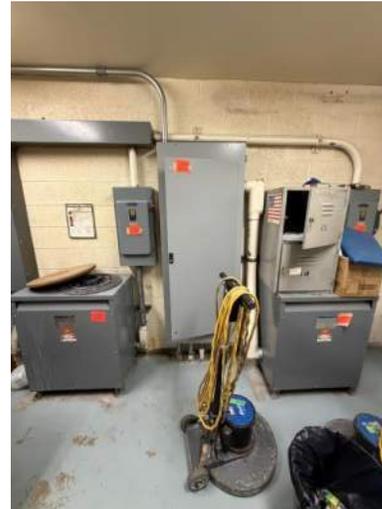
Existing Transformers

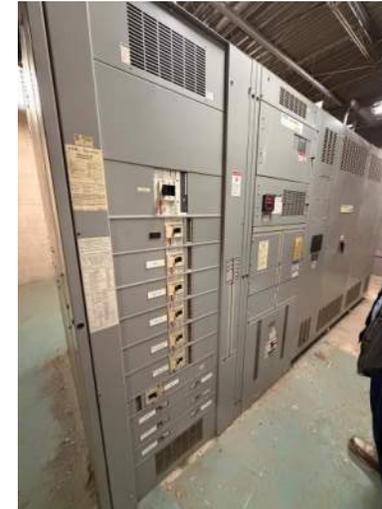
Existing Electrical Gear

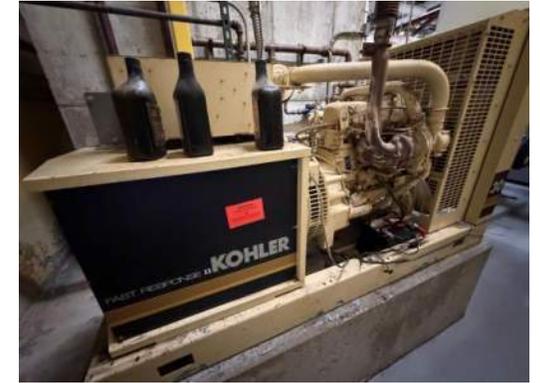
Existing Generator

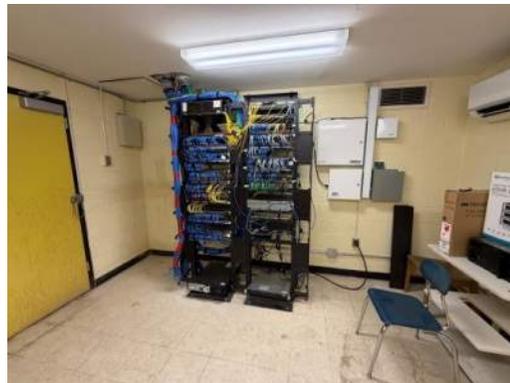
Existing IT

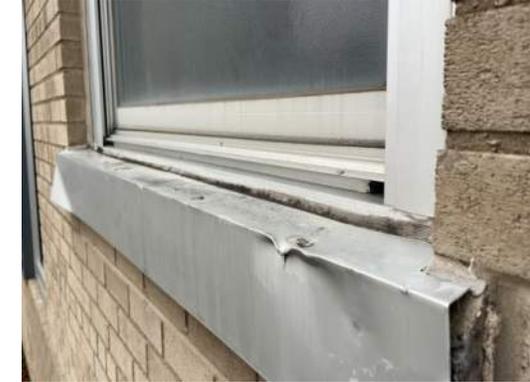
Existing Sills

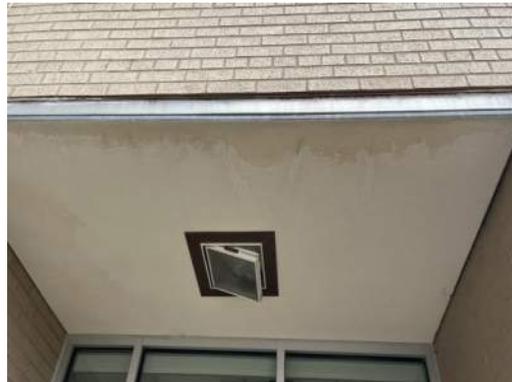
Existing Exterior Brick, Lintels,  
and Lighting

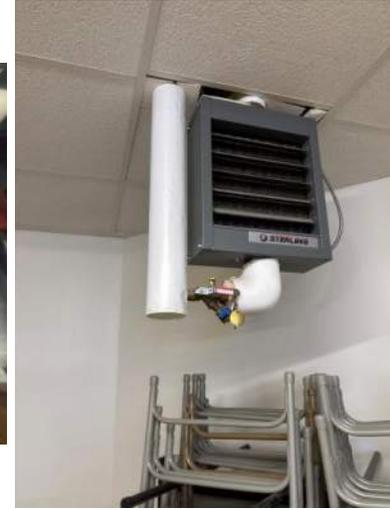
Existing Unit Heater

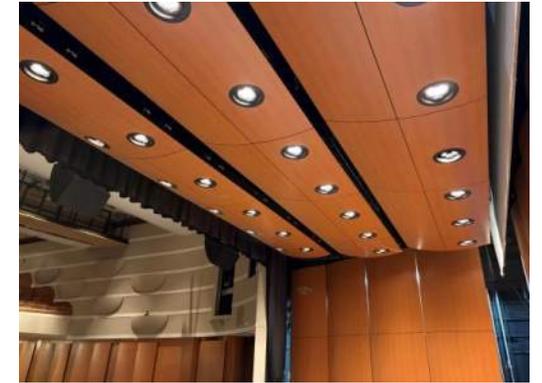
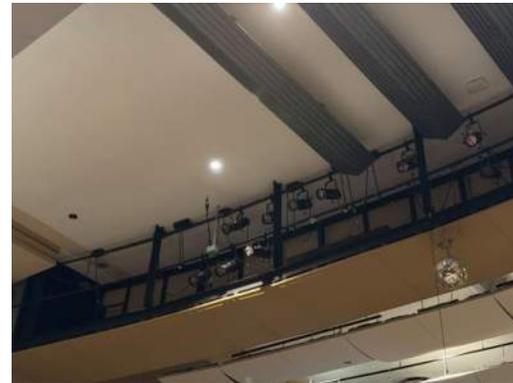
Existing Stage Lights

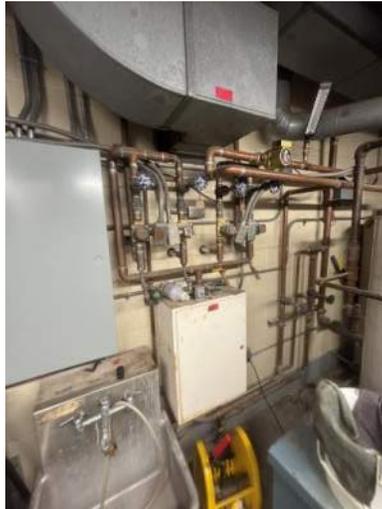
Existing Plumbing Piping

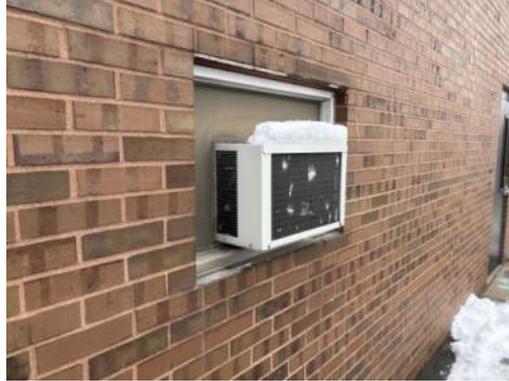
Existing A/C Window Shaker

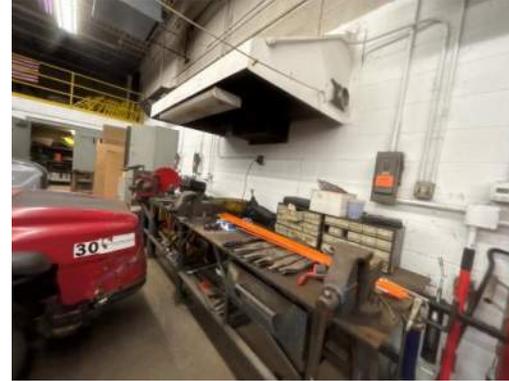
Existing Hood

Decentralized HVAC Equipment	Original welding hood still installed from 1984 construction. Hood is in poor condition and does not meet current design standards for tabletop welding and machine work; would recommend replacement.	X				\$11,406	\$11,976		
------------------------------	--------------------------------------------------------------------------------------------------------------------------------------------------------------------------------------------------------	---	--	--	--	----------	----------	--	--

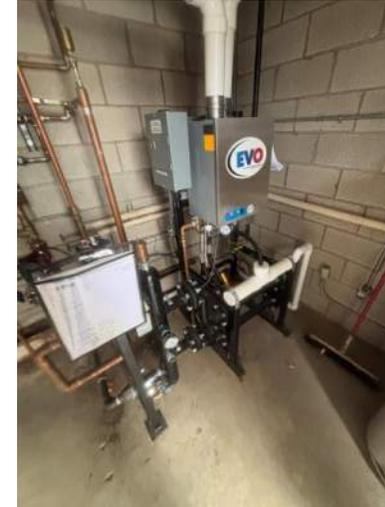
Existing Water Heater

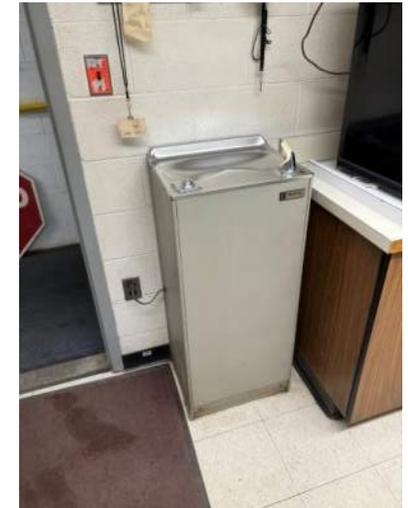
Existing Drinking Fountain

Water Closets & Urinals	Fixtures are original to date of construction (1984). Units are in fair condition, though would recommend replacing flush valves with new low flow fixtures and sensed, low flow flushometers.		X			\$39,116		\$50,068	
Lavatories & Sinks	Fixtures are original to date of construction (1984). Units are in fair condition, though would recommend replacing faucets with newer sensed, low flow faucets.		X			\$16,060		\$20,557	
Electric Water Coolers & Drinking Fountains	Electric water cooler is original to the building; would recommend replacement with bottle filler.		X			\$6,266		\$8,020

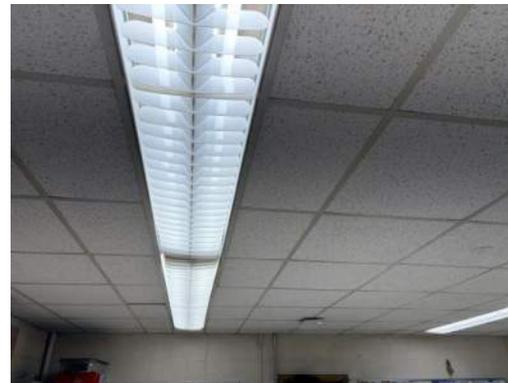
Existing Lighting

Survey Item	Survey Notes	1-3 Years	4-6 Years	7-10 Years	10+ Years	Net Present Value	1-3 Years Escalation Factor = 1.05	4-6 Years Escalation Factor = 1.28	7-10 Years Escalation Factor = 1.48
<b>13.0 Electrical Assessment</b>									
<b>Site Lighting</b>									
Building Exterior Lighting	non-LED wall packs, unclear if retrofitted		x			\$6,692		\$8,566	
<b>Power Distribution &amp; Control Equipment</b>									
Service Disconnects	Main service disconnect, disconnects for panels and equipment feeders, recommend replacing with panelboard to consolidate	x				\$36,504	\$38,329		
Panelboards	Branch, 1980s	x				\$40,608	\$42,638		
Interior Transformers	1980s	x				\$47,450	\$49,823		
Electrical Receptacles & Devices	1980s, upgrade receptacles and devices for equipment connection as needed		x			\$46,842		\$59,958	
<b>Interior Lighting</b>									
Interior Lighting Fixtures	LED retrofit of shop lights			x		\$146,381			\$216,644

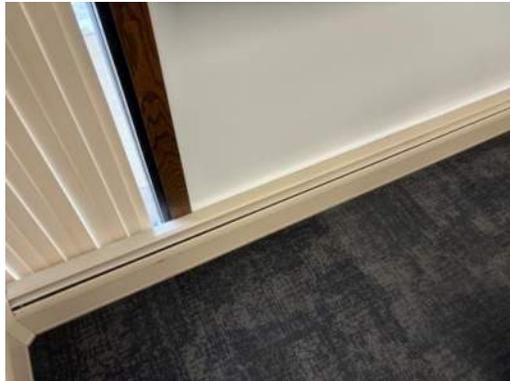
Existing Finned Tube

Finned Tube Heaters	Hydronic baseboard heat is installed around the perimeter of the building in offices, conference rooms, etc. (8) Zones are created with valves located off a common header in the mechanical/server room. Baseboard heat itself is original to the date of building installation and should be replaced. Approximate qty. listed for replacement.	X				\$278,334	\$292,251		
Cabinet Unit Heaters	Electric cabinet heaters installed in vestibules are original to building construction (installed 1969) and are in poor condition; they are currently not utilized. Would recommend replacement with new units and tying in to the new boiler system.	X				\$120,448	\$126,470		
Split Systems	Mitsubishi split system relocated to server room during 2024 renovations but unit is several years older; serves as backup during emergency power situations. Unit is in decent condition but appears to be about 10 years old - anticipated useful life of 15-20 years.			X		\$27,071			\$40,065

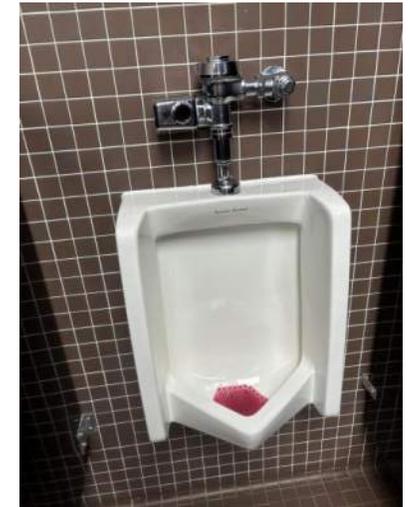
Existing Plumbing Fixture

Water Closets & Urinals	Water closets and urinals have been replaced in (1) of (4) toilet rooms; remaining fixtures are original to building construction and in fair condition. Would recommend replacement of all water closets and urinals with new low flow fixtures and sensed flush valves.			X		\$26,873			\$39,772
Lavatories & Sinks	Lavatories and sinks have been replaced in (1) of (4) toiler rooms, remaining fixtures are original to bilding construction and in fair condition. Would recommend replacement of remaining lavatories with new low-flow faucets.			X		\$18,752			\$27,753
Electric Water Coolers & Drinking Fountains	Electric drinking fountains have been recently replaced and are in good condition.				X	\$0			
<b>12.0 Plumbing Assessment SUBTOTAL</b>						<b>\$927,481</b>	<b>\$462,974</b>	<b>\$0</b>	<b>\$720,098</b>
