# Midland Public Schools

## Facilities Assessment

March 16, 2026

## Executive Summary + Table of Contents

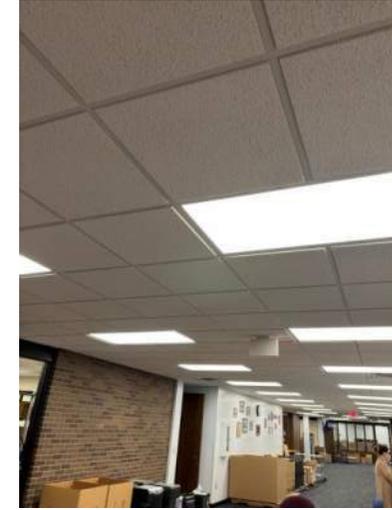
Existing Lighting

<b>Interior Lighting</b>									
Interior Lighting Fixtures	replaced in 2020				x	\$0			
Lighting Controls	replaced in 2020				x	\$0			
Exit Signs	included in interior lighting fixtures				x	\$0

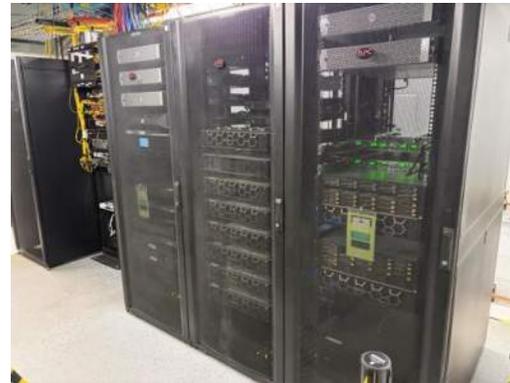
Existing MDF

Communications Cabinets/Racks/Enclosures	MDF			x		\$12,167			\$18,007
Communications Cabinets/Racks/Enclosures	IDF			x		\$24,334			\$36,014
Structured Cabling	CAT6 observed (entire building sqft)			x		\$110,232			\$163,143
Communications Cabinets/Racks/Enclosures	CENTRAL SERVERS					\$0

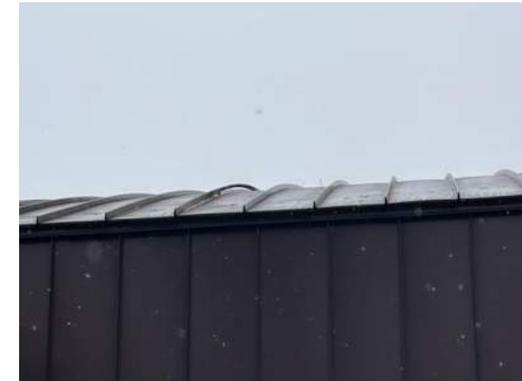
Existing Standing Seem Metal Roof

Survey Item	Survey Notes					Net Present Value	1-3 Years Escalation Factor = 1.05	4-6 Years Escalation Factor = 1.28	7-10 Years Escalation Factor = 1.48
		1-3 Years	4-6 Years	7-10 Years	10+ Years				
<b>5.0 Roof System Assessment</b>									
<b>Roofing Membrane</b>									
Standing Seam Metal	Installed at barrel overhangs and entrances. Rib caps are pulling loose and need to be reinstalled and crimped.	x				\$10,000	\$10,500		
General Comment	Ice gaurds should be installed to prevent snow and ice from falling. Pricing is each.					\$0			
<b>Perimeter / Fascia / Soffit</b>									
Metal Coping	No visible concerns				x	\$0			
<b>5.0 Roof System Assessment SUBTOTAL</b>						<b>\$10,000</b>	<b>\$10,500</b>	<b>\$0</b>	<b>\$0</b>

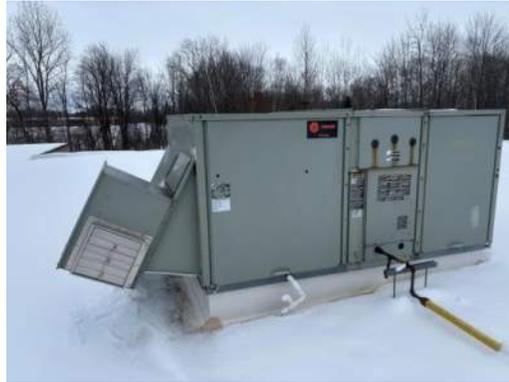
Existing RTU

Mechanical and plumbing systems at Fast Ice Drive are relatively modern and remain reliable as the building itself is approximately 20 years old. Major HVAC equipment and distribution systems are generally in good condition, though rooftop units are approaching the end of their anticipated life cycle and showing signs of age. The district is in the process of installing new controls to allow for proper management of building equipment. Plumbing systems, including domestic water piping and fixtures, are newer or functional and not identified for immediate replacement, with most recommendations focused on long-term life cycle planning. Near-term needs are limited to select components rather than system-wide concerns, reinforcing the facility's overall good condition.
